Pit or Below-Grade Tank Registration or Closure

Additional Comments: The pit has been closed consistent with the "ChevronTexaco Drilling and Reserve Pit Closure General Plan, December 2004" and the NMOCD Pit and Below-Grade Tank Guidelines, November 1, 2004 as promulgated under NMOCD Rule 50 (19.15.2.50 NMAC).

Re: Final C-144
Chevron USA (O-Grid #4323)
W. T. McComack #23 (Ref. #200065)
UL-G, Section 32, Township 21 South, Range 37 East

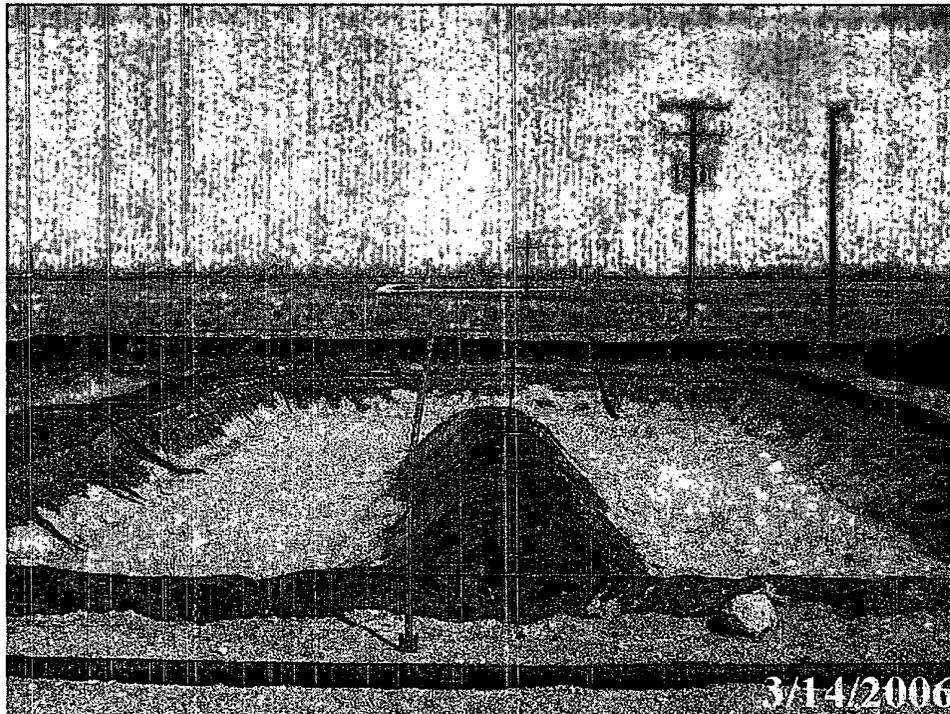
Photograph #2 - Pit and berm looking northerly.

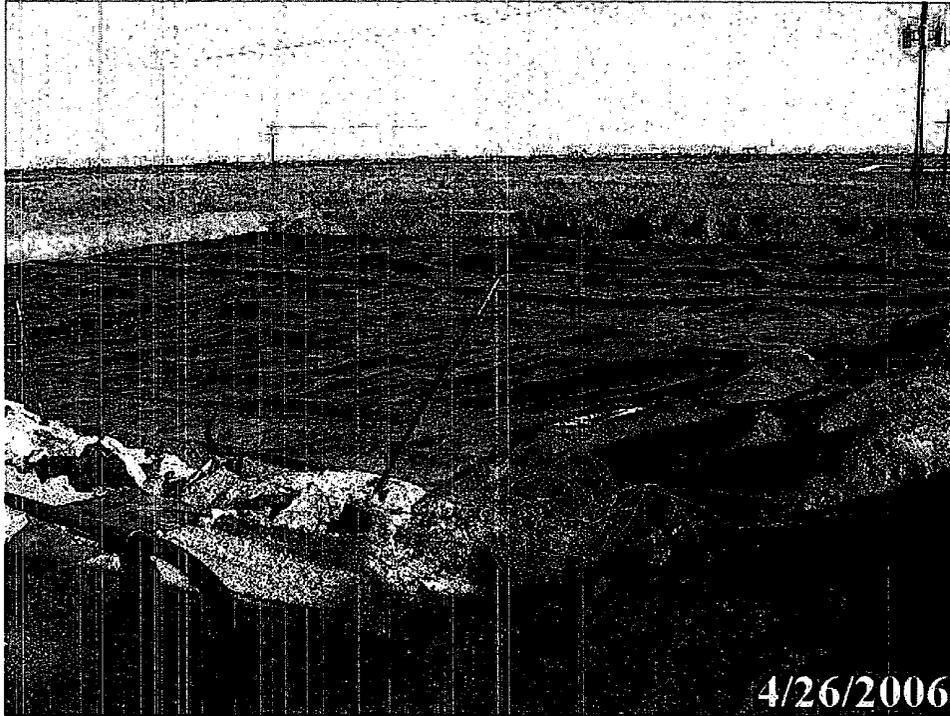
Photograph #3 – Liner covering stiffened pit contents.

Method of Closure: The pit has been closed via encapsulation, which consisted of mixing earthen materials with the pit contents, as necessary to stiffen the pit contents sufficiently to provide physical stability and support the pit cover. Upon the pit contents being stiffened as required, the edges of the liner were folded over the edges of the stiffened mud and cuttings and the pit covered with a 20-mil thick impervious, reinforced synthetic polyethylene liner meeting ASTM standards designed to be resistant to the material encapsulated. The liner was then covered with a minimum of three feet of clean soil or like material capable of supporting native plant growth.
