**Pit or Below-Grade Tank Registration or Closure**

Operator: <u>Range Operating New Mexico, Inc</u> Telephone: <u>(505) 631-0926</u> e-mail address: <u>salmager@rangeresources.com</u>		
Address: <u>P.O. Box 2510 Hobbs, NM 88241</u>		
Facility or well name: <u>Elliott "B" Federal Well #12</u> #: <u>30-025-37735</u> U/L or Qtr/Qtr <u>SW/SE</u> Sec <u>6</u> T <u>22S</u> R <u>37E</u>		
County: <u>Lea</u> Latitude <u>N 32° 24.874'</u> Longitude <u>W 103° 11.992'</u> NAD: 1927 <input type="checkbox"/> 1983 <input checked="" type="checkbox"/>		
Surface Owner: Federal <input type="checkbox"/> State <input type="checkbox"/> Private <input checked="" type="checkbox"/> Indian <input type="checkbox"/>		
<b>Pit</b> Type: Drilling <input checked="" type="checkbox"/> Production <input type="checkbox"/> Disposal <input type="checkbox"/> Workover <input type="checkbox"/> Emergency <input type="checkbox"/> Lined <input checked="" type="checkbox"/> Unlined <input type="checkbox"/> Liner type: Synthetic <input checked="" type="checkbox"/> Thickness <u>20</u> mil Clay <input type="checkbox"/> Pit Volume <u>      </u> bbl	<b>Below-grade tank</b> Volume: <u>      </u> bbl Type of fluid: <u>      </u> C

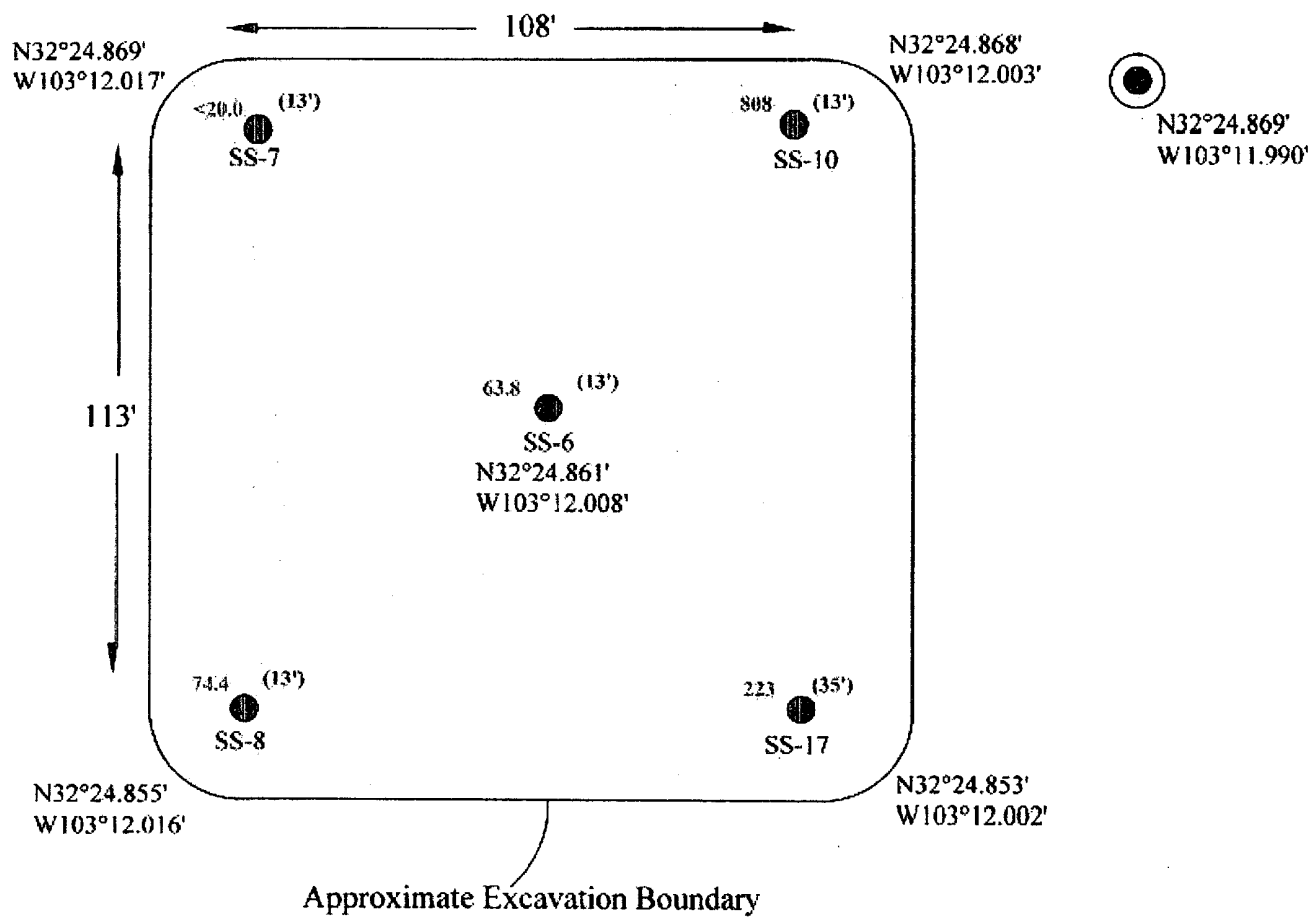
<p>63.8 (13')</p> <p>SS-6</p> <p>Soil sample location taken at a depth, feet, with chloride concentration (mg/kg).</p> <p>Wellhead location</p> <p>N32°24.861' W103°12.008' GPS Coordinates</p>	<p><b>LEGEND</b></p>
---	----------------------

Additional Comments: All fluids were removed from the pit. The burial pit was constructed adjacent to the drilling pit. The burial pit was lined with a 12 ml liner. Impacted material was placed in the burial pit, completely encapsulated and capped with a 20 ml liner, and covered with 3 feet of topsoil to grade.
Hydrocarbon impacted soil was disposed at an NMOCD approved facility.
