**Pit or Below-Grade Tank Registration or Closure**

Re: Final C-144  
Chevron USA (O-Grid #4323)  
R. E. Cole NCT-A #5 (Ref. #200105)  
API#30-025-10318  
UL-I, Section 16, Township 22 South, Range 37 East

**TABLE 2**  
**Chevron USA**  
**R.E. Cole NCT-A #5 Pit Analytical Results Summary**

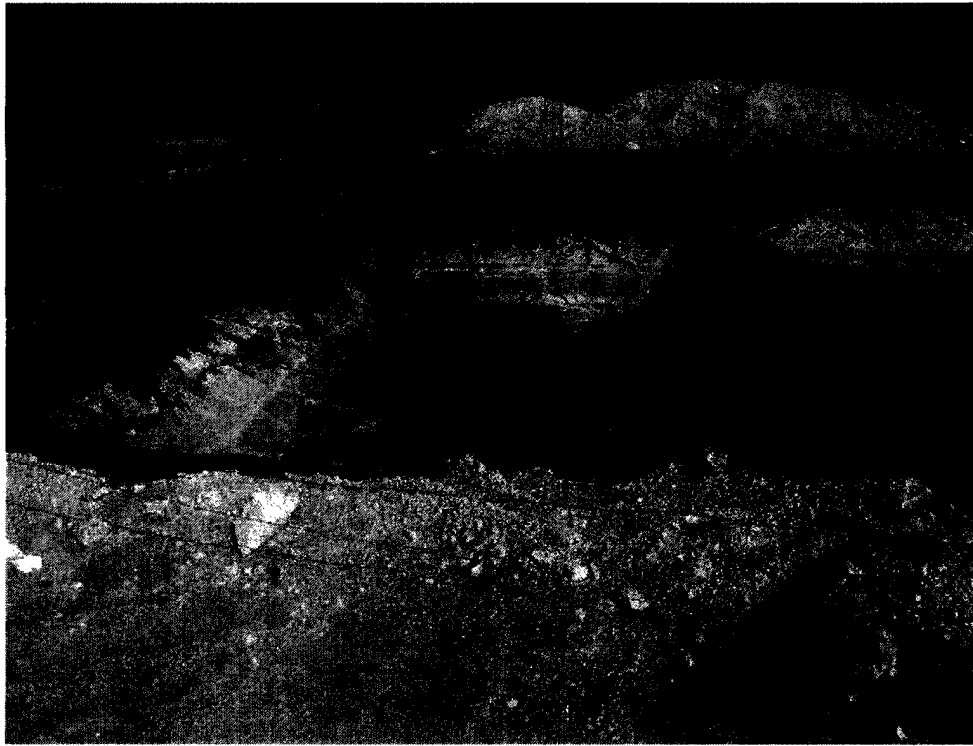
Photograph #3 - Pit with berms, looking easterly.

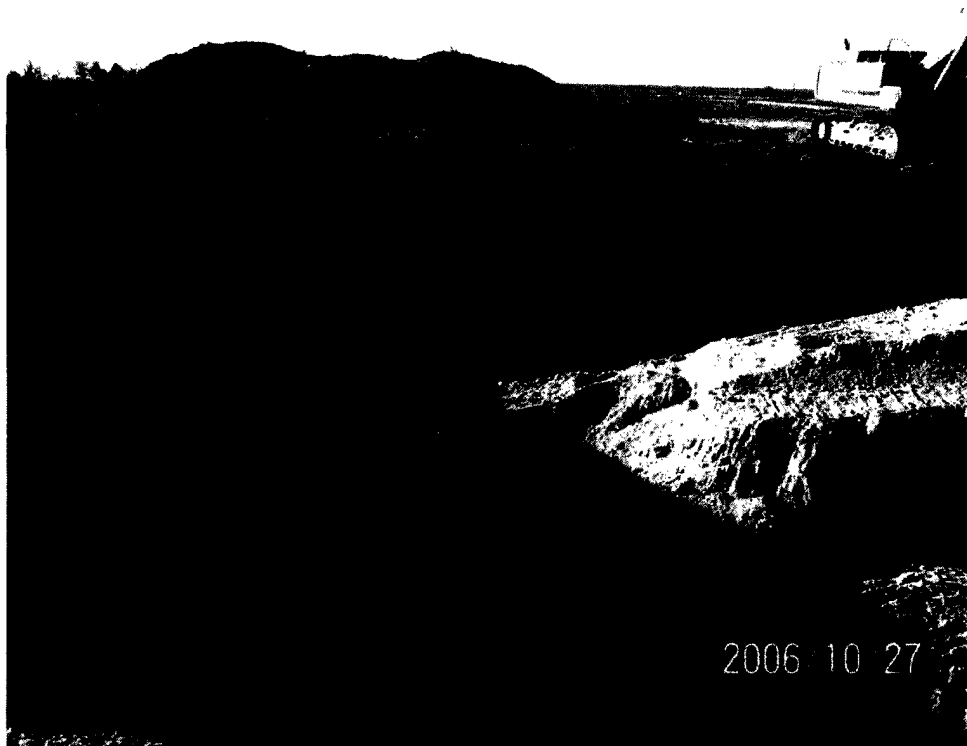
Photograph #5 – Excavating and hauling pit contents.

| Method of Closure: Disposal (the pit contents were stiffened and hauled to disposal facility, excavation was tested and found to be acceptable (i.e. Chloride <1,000 mg/kg, TPH and BTEX are Non-Detect; reference Table 2 and Laboratory Analytical data), the pit was then backfilled with local soil.) Attached is a copy of the e-mail from EPI documenting our discussion and your approval of the revised C-144 allowing Chloride residuals in excess of 250 mg/Kg. | |
