Pit or Below-Grade Tank Registration or Closure

Facility or well name: H.S. Turner #10 API#: 30-025-38296 U/L or Qtr/Qtr UL-N Sec 29 T 21S R 37E

FIGURE #1	
LEA COUNTY, NEW MEXICO	
HS Turner # 10 Sec.29, T21S, R37E	
Site Drawing (Not to Scale)

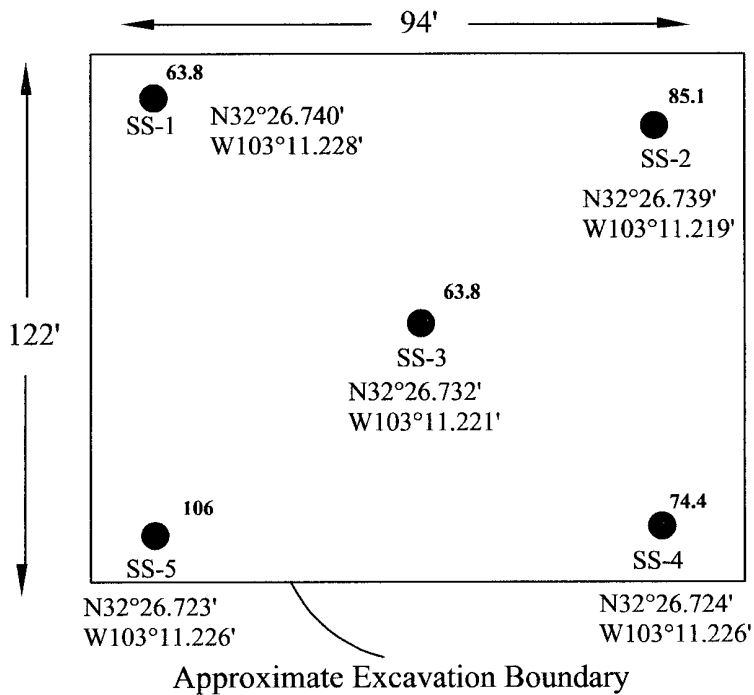
Burial Pit
100'x30'x19'

N32°26.739'
W103°11.208'

LEGEND	
	Soil sample location with chloride concentration (mg/kg).
	Wellhead location
	GPS Coordinates

Additional Comments: All fluids were removed from the pit. The burial pit was constructed adjacent to the drilling pit, and lined with a 12 ml liner. Impacted material was placed in the burial pit, completely encapsulated and capped with a 20 ml liner, and covered with 3 feet of topsoil to grade.

Hydrocarbon impacted soil was disposed at an NMOCD approved facility. Soil samples were collected below the liner. A map is attached that shows the sample locations.

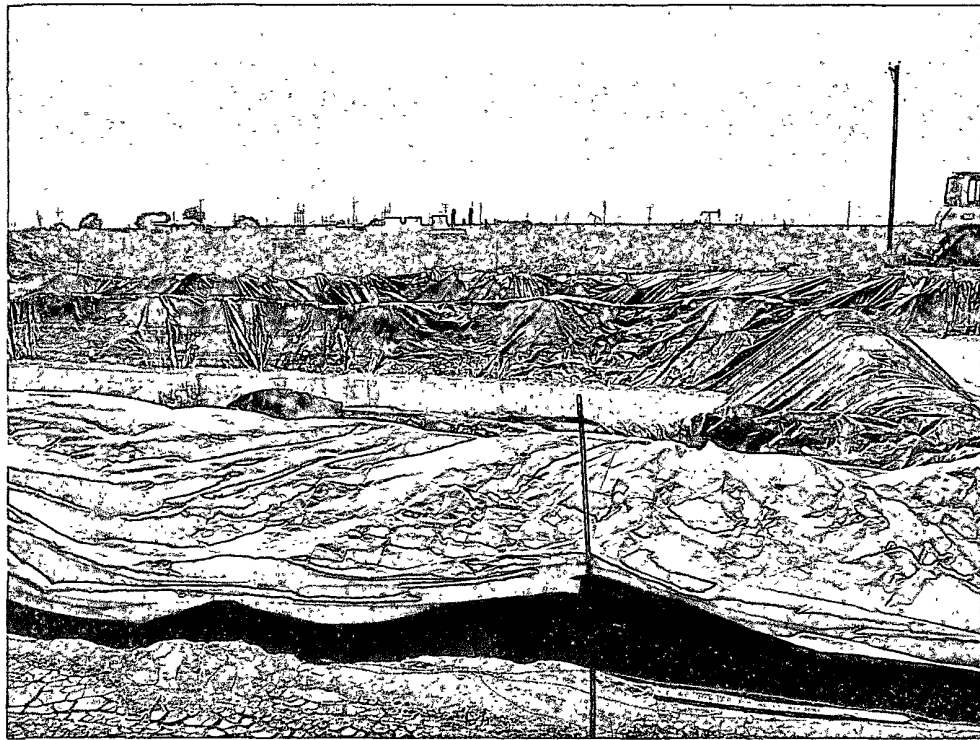
1. View to north of pit.

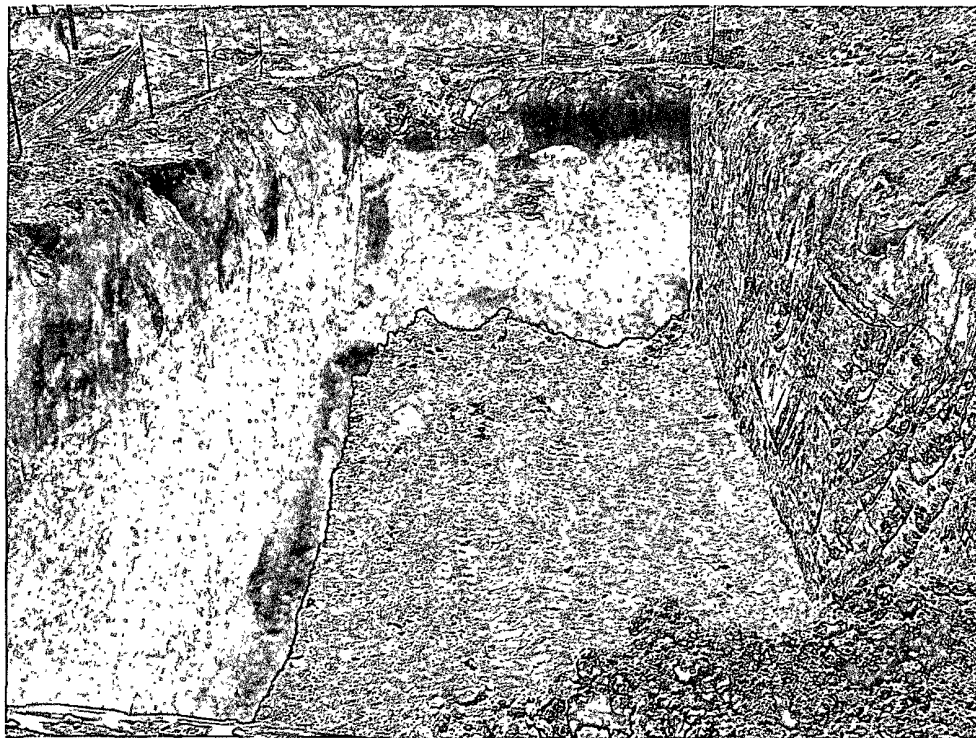
2. View to north of burial pit.

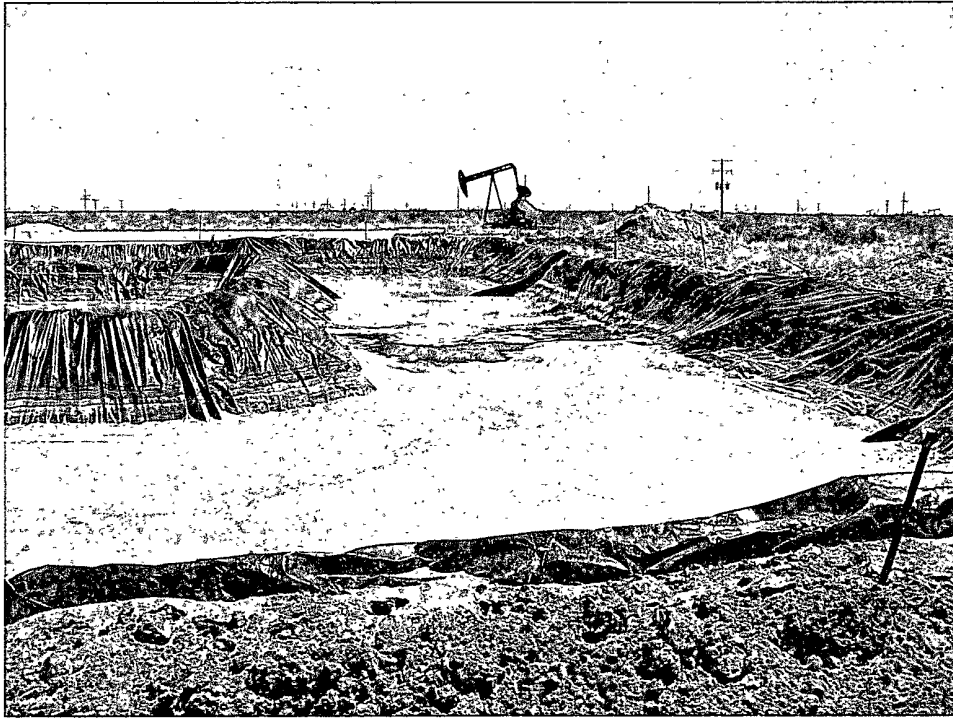
3. View to west of pit.
