Pit or Below-Grade Tank Registration or Closure

Operator: <u>Chevron MidContinent Alaska</u> Telephone: <u>(505) 394-1237</u> e-mail address: <u>BillyAnderson@chevron.com</u>		
Address: <u>Box 1949, Eunice, NM 88231</u>		
Facility or well name: <u>Eaves #8</u> #: <u>30-025-38384</u> U/L or Qtr/Qtr <u>A</u> Sec <u>10</u> T <u>22S</u> R <u>37E</u>		
County: <u>Lea</u> Latitude <u>N 32 deg 41 164'</u> Longitude <u>W 103 deg 14646'</u> NAD: 1927 <input checked="" type="checkbox"/> 1983 <input type="checkbox"/>		
Surface Owner: Federal <input type="checkbox"/> State <input type="checkbox"/> Private <input type="checkbox"/> Indian <input checked="" type="checkbox"/>		
Pit Type: Drilling <input checked="" type="checkbox"/> Production <input type="checkbox"/> Disposal <input type="checkbox"/> Workover <input type="checkbox"/> Emergency <input type="checkbox"/> Lined <input checked="" type="checkbox"/> Unlined <input type="checkbox"/> Liner type: Synthetic <input checked="" type="checkbox"/> Thickness <u>20</u> mil Clay <input type="checkbox"/> Pit Volume <u>7000</u> bbl	Below-grade tank Volume: _____ bbl Type of fluid: _____ Construction material: _____ Double-walled, with leak detection?

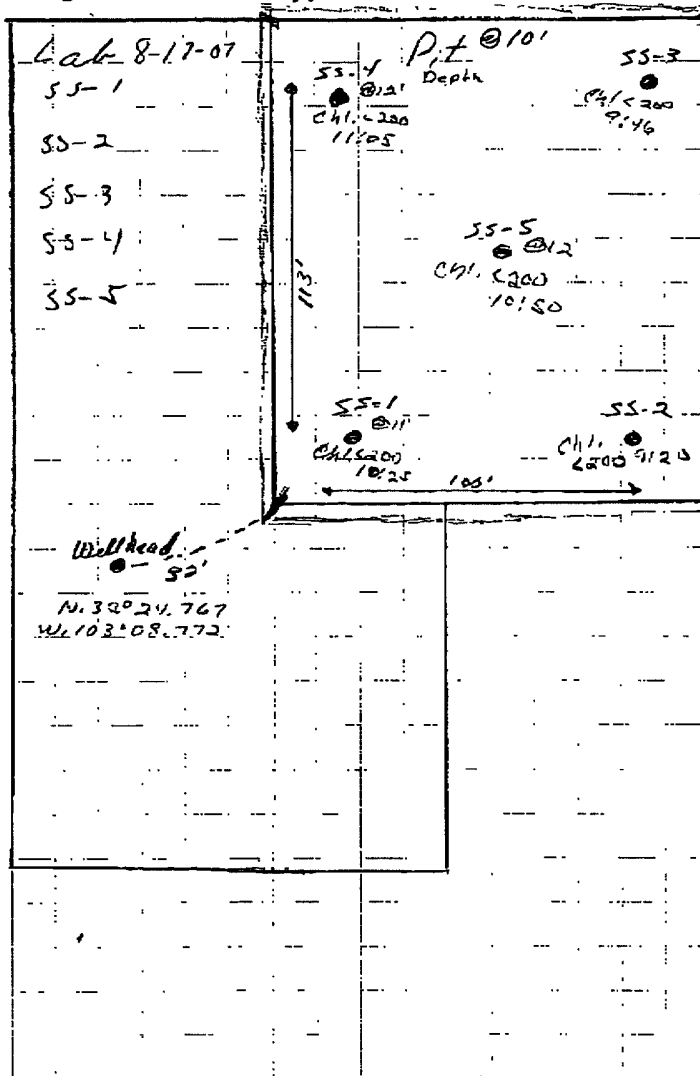
Chevron Eaves #8 7-0904
8-14-07 N

Pit Coordinates

Sample Coordinates
