**NM1 - \_\_\_\_66\_\_\_\_**

**Operational  
Infrastructure and Cell  
E-1 Construction  
Certification Report**

## **APPENDIX D: CQA DAILY FIELD REPORTS**

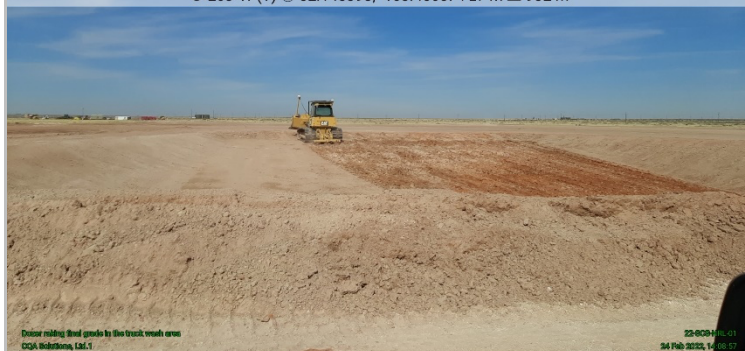
- A dozer was used to rake the truck wash area, followed by a water truck spreading water within the area. After this was done, a compactor compacted the soil. This series of actions were done repeatedly.
- 3 density tests were taken. All 3 tests were taken from the final grade of the truck wash area, which was cut down to grade.
- 2 tests failed due to being outside of the acceptable Standard Proctor Range. 1 test passed.

Filename: 22-SCS-NRL-01-2022-02-24-14-08-57-Dozer raking final grade in the truck wash area (1)

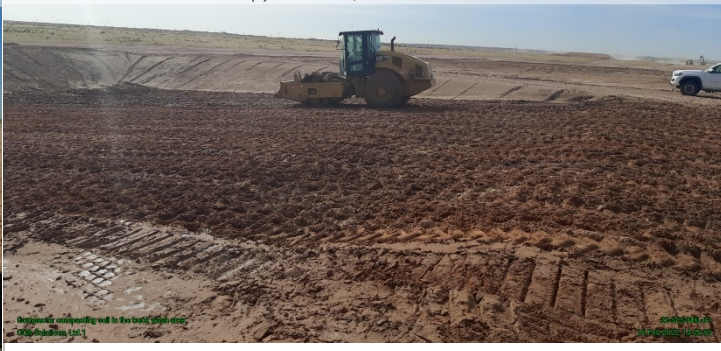
Filename: 22-SCS-NRL-01-2022-02-24-14-45-53-Compactor compacting soil in the truck wash area (1)

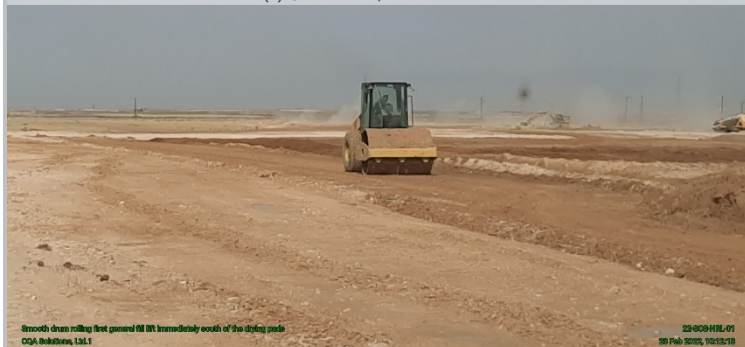
- 1 dozer was used to spread material from the southwestern stockpile to the adjacent area south of the truck wash and drying pads
- 1 smooth drum was used to compact the general fill lift, which was 12 inches.
- 4 density tests were taken in the area. All 4 tests were within the acceptable Proctor and OMC range for general fill and did not fail.

Smooth drum rolling first general fill lift immediately south of the drying pads

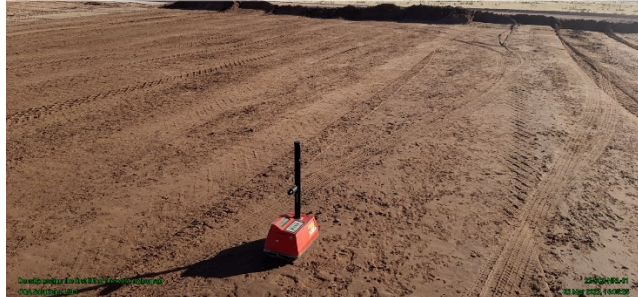
- 7 tests were taken initially for the west drying pad. 5 of the 7 tests failed due to being outside the acceptable range of OMC and Proctor.
- 3 of the 7 tests initially taken for the east drying pad failed due to being outside the acceptable range of OMC.

Filename: 22-SCS-NRL-01-2022-03-02-16-05-25-Density testing the first lift of the west drying pad (1)

- After the testing, a dozer was used to rake and spread the material, followed by a water truck was used to spread water throughout the failed sections, with compaction finishing the sequence prior to retesting.

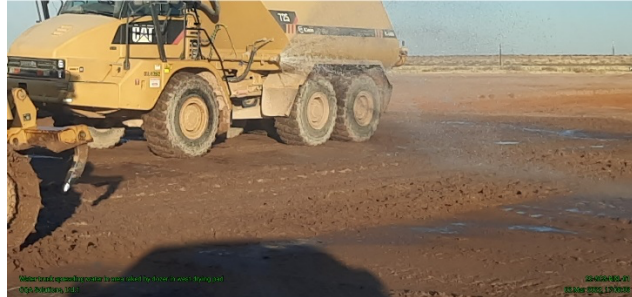
Filename: 22-SCS-NRL-01-2022-03-02-17-08-03-Water truck spreading water in area raked by dozer in west drying pad (1)

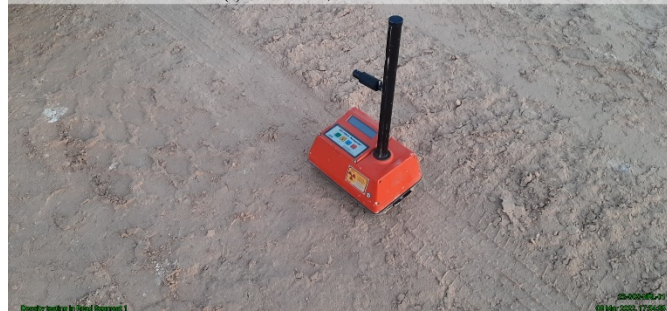
Filename: 22-SCS-NRL-01-2022-03-08-17-54-38-Density testing in Road Segment 1 (1)

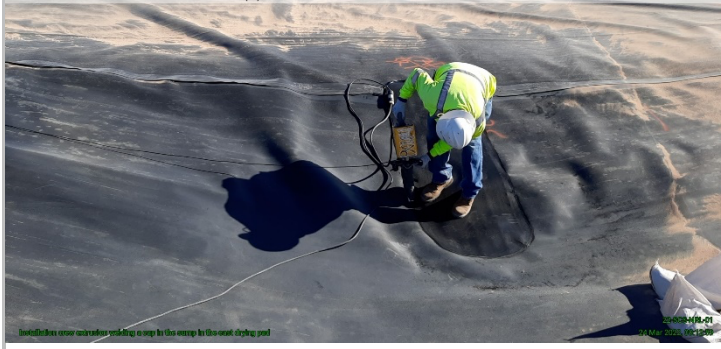
Filename: 22-SCS-NRL-01-2022-03-24-09-12-59-Installation crew extrusion welding a cap in the sump in the east drying pad (1)

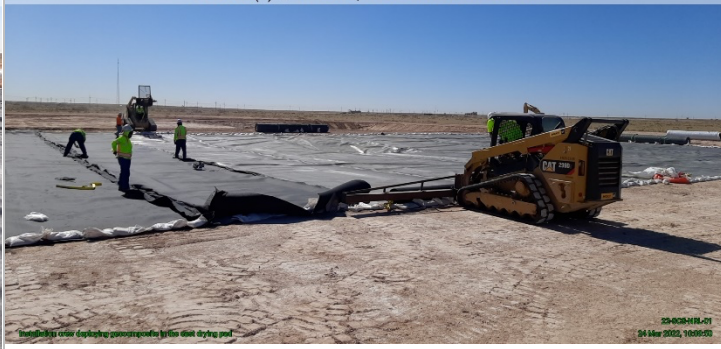
Filename: 22-SCS-NRL-01-2022-03-24-10-09-50-Installation crew deploying Geocomposite in the east drying pad (1)

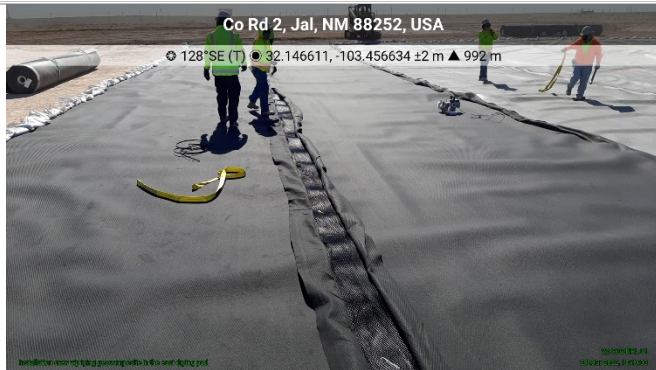
Filename: 22-SCS-NRL-01-2022-03-24-10-10-33-Installation crew zip tying Geocomposite in the east drying pad (1)

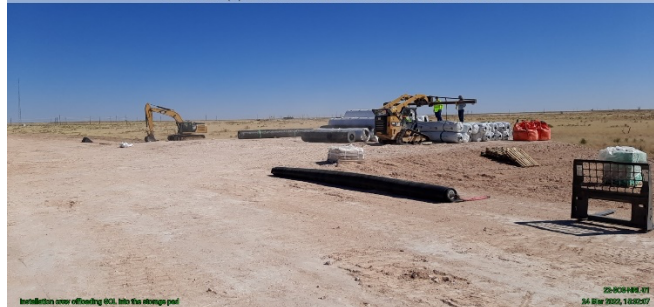
Filename: 22-SCS-NRL-01-2022-03-24-15-32-07-Installation crew offloading GCL into the storage pad (1)

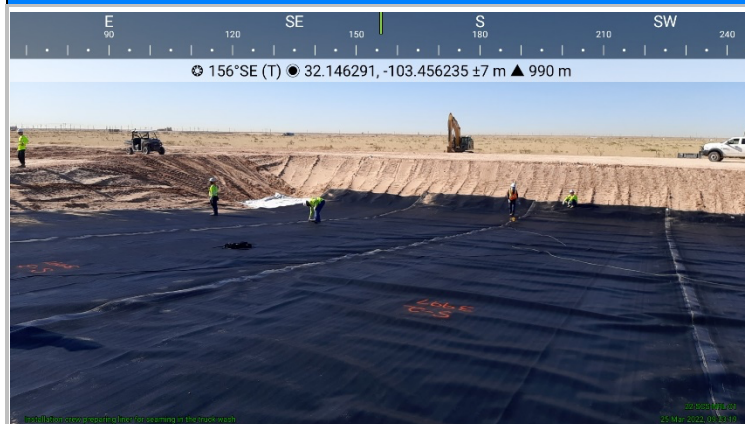
Filename: 22-SCS-NRL-01-2022-03-25-09-23-19-Installation crew preparing liner for seaming in the truck wash (1)

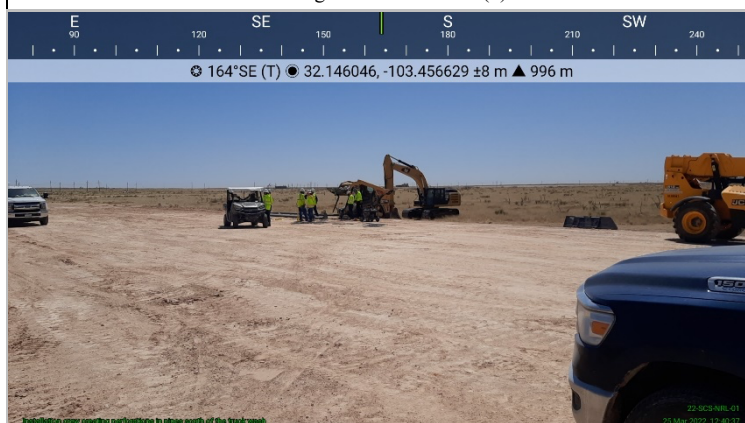
Filename: 22-SCS-NRL-01-2022-03-25-12-40-37-Installation crew creating perforations in pipes south of the truck wash (1)

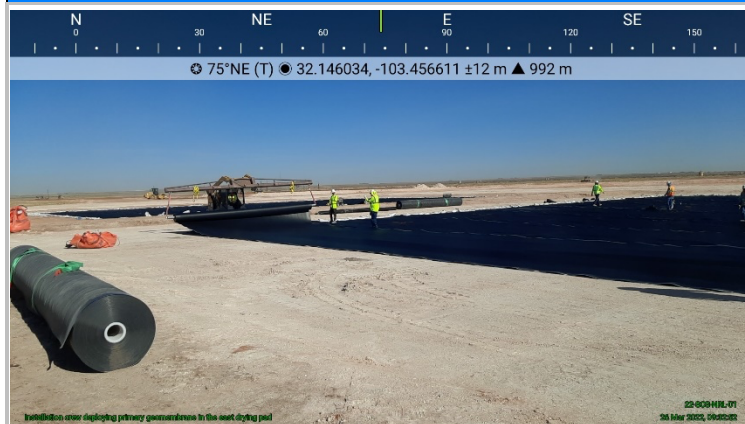
Filename: 22-SCS-NRL-01-2022-03-26-09-32-52-Installation crew deploying primary geomembrane in the east drying pad (1)

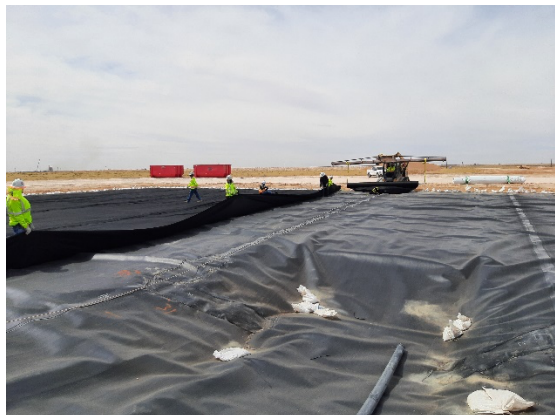
Description: Installation Crew placing geotextile in the west drying pad

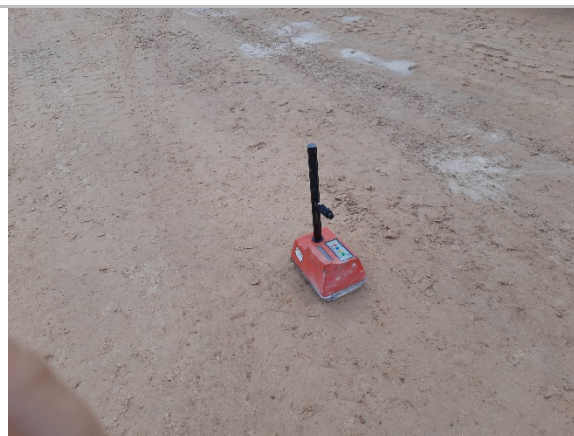
Description: Density testing in the northwest berm area.

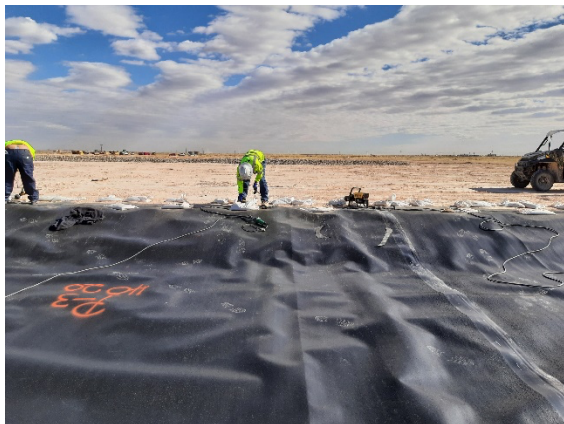
Description: Installation crew removing sandbags to extrusion the overlap area of the truck wash

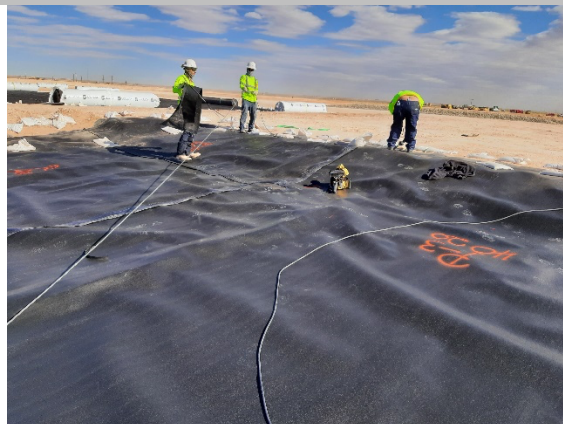
Description: Installation crew heat tacking patches in the overlap area of the truck wash

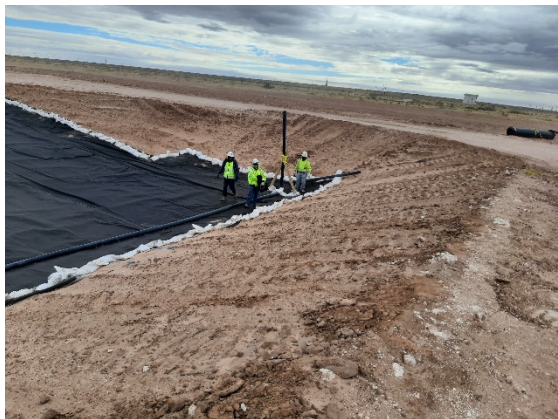
Filename: 20220330\_095052  
Description: Installation crew propping up pipe in truck wash

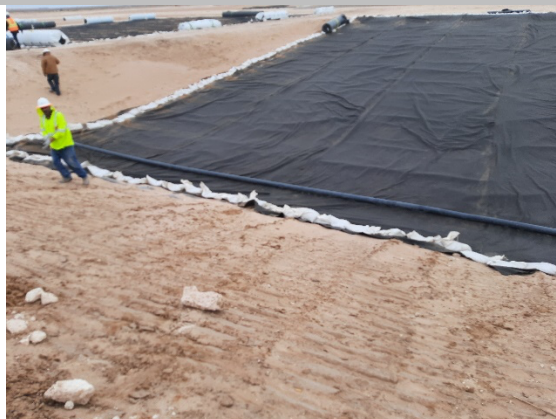
Filename: 20220330\_095056  
Installation crew placing additional sandbags in the truck wash.

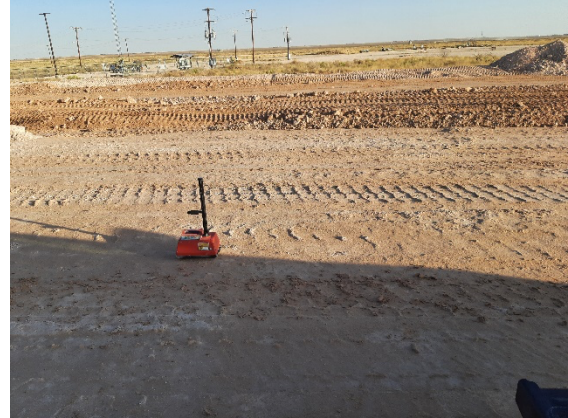
Filename: 20220404\_073648  
Taking a density test on the north berm of Cell E1

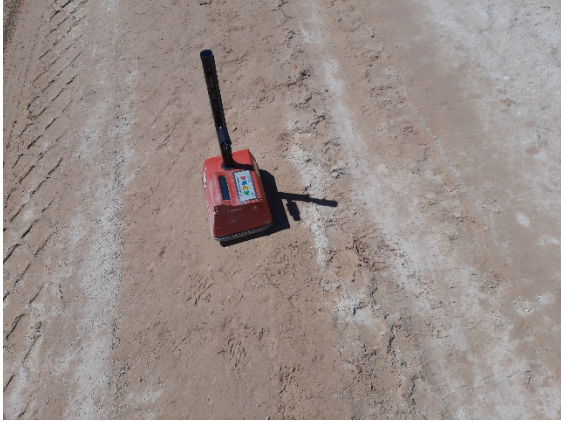
Filename: 20220405\_113323  
Taking a density test on the east berm of Cell E1

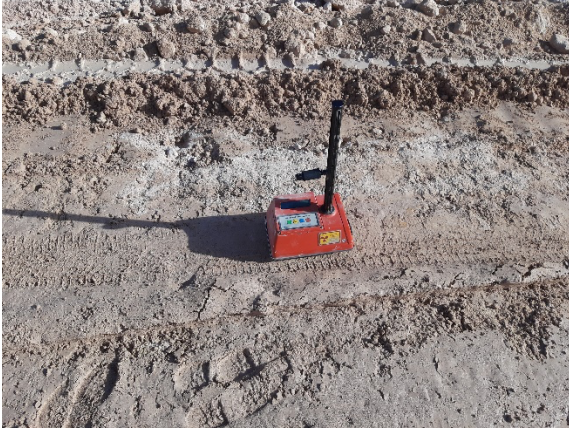
Filename: 20220407\_171141  
Taking a density test in the north berm of Cell E1

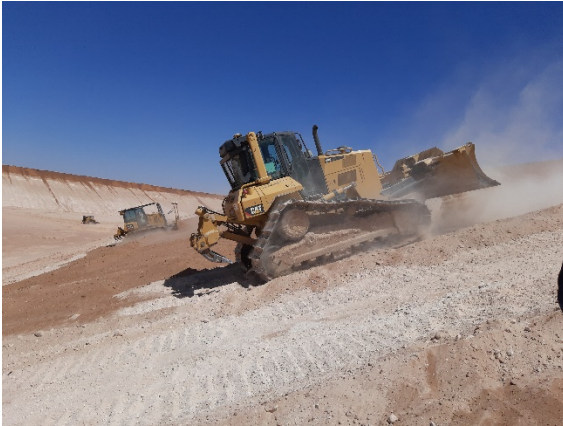
Filename: 20220413\_132625

Dozer pushing excess material up slope on south side of the east berm of Cell E1

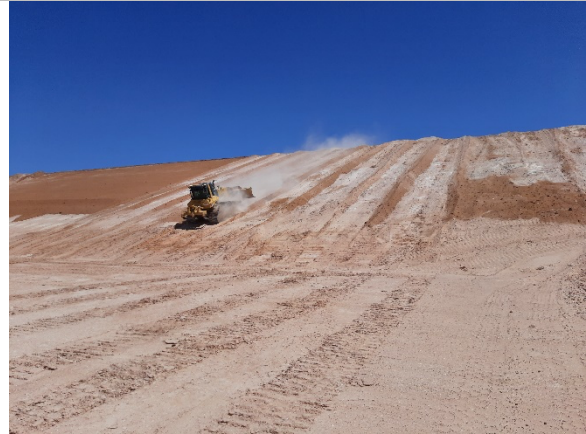
Filename: 20220413\_140721

Dozer pushing excess material up slope on north side of the east berm of Cell E1

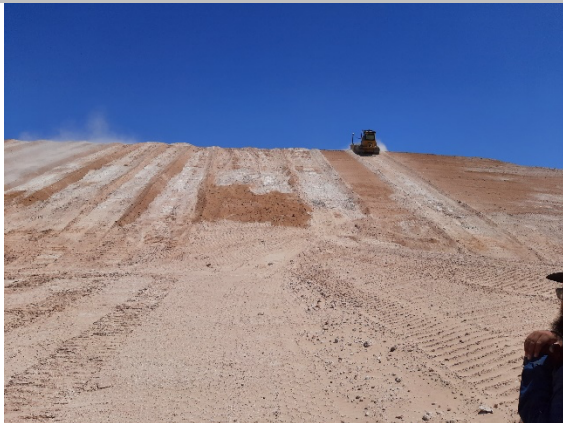
Filename: 20220413\_140723

Dozer pushing excess material up slope on the north berm of Cell E1

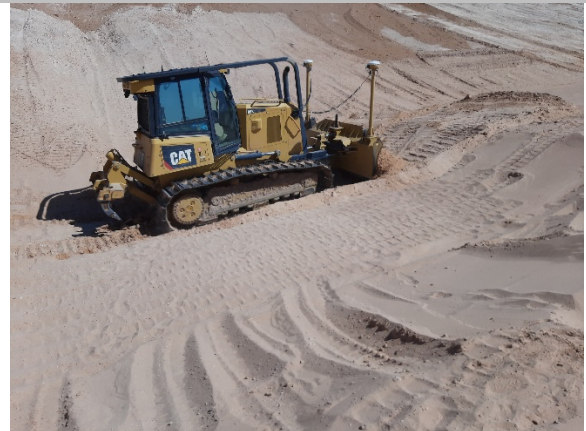
Filename: 20220413\_162916

Dozer pushing excess material out of the sump of Cell E1

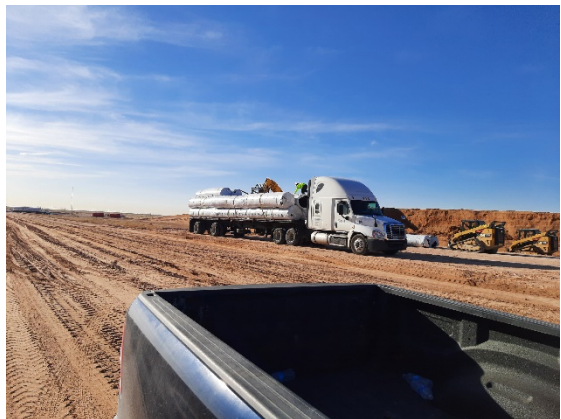
Filename: 20220414\_091042

Truck containing geocomposite offloaded at the storage pad south of Cell E1

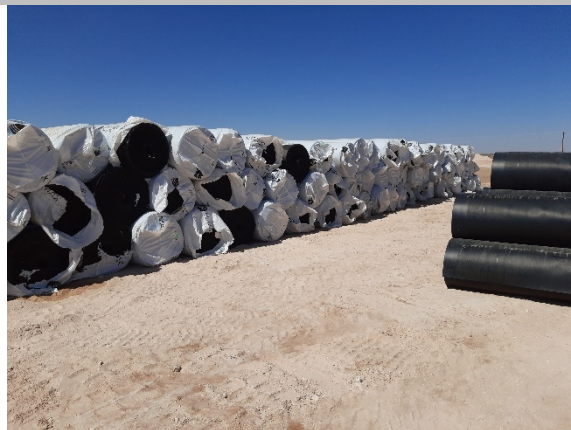
Filename: 20220414\_114938

Geocomposite and geomembrane stockpiled on the storage pad south of Cell E1

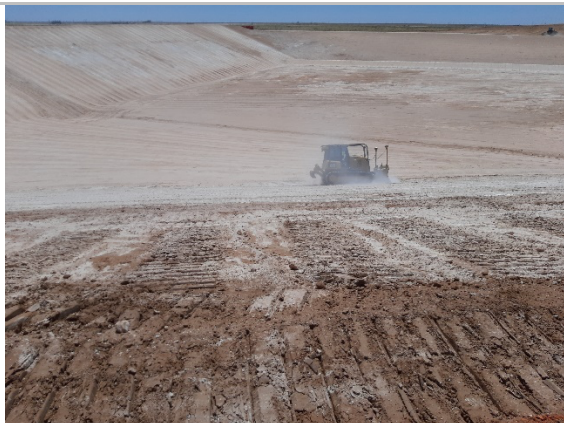
Filename: 20220414\_135512

Dozer removing excess material on the north berm of Cell E1

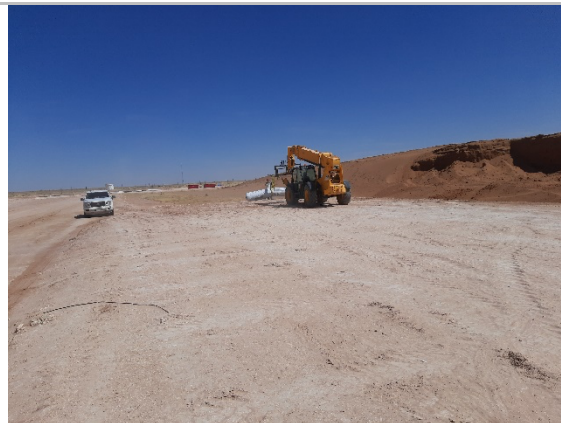
Filename: 20220414\_155323

Forklift being used to stockpile GCL on the storage pad south of Cell E1
