NM1 - ____66____

**Operational
Infrastructure and Cell
E-1 Construction
Certification Report**

July 2022

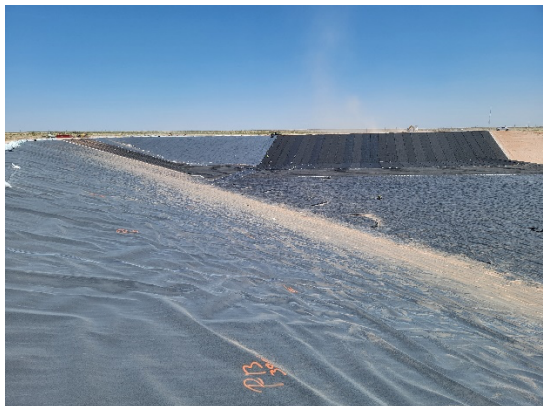
Filename: 20220506_134957
Installation crew deploying material on the east slope of Cell E1

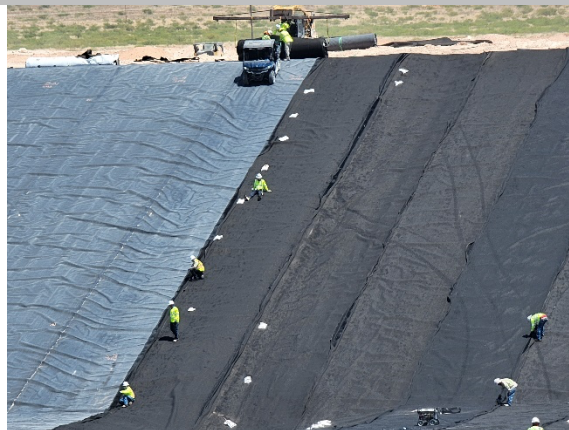
Filename: 20220506_135004
Installation crew securing exposed composite edge on the east slope

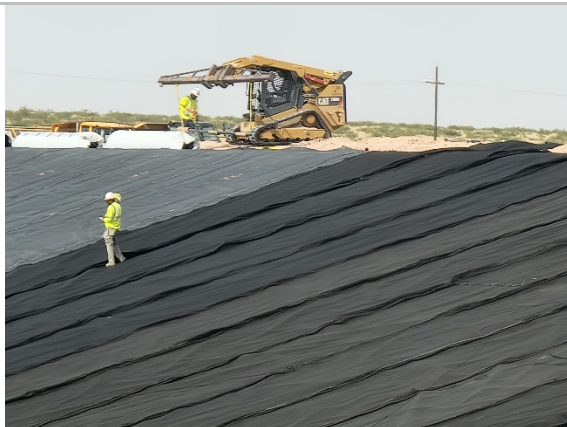
Filename: 20220506_161357
Skidsteer moving to transport geocomposite on the northeast corner of Cell E1

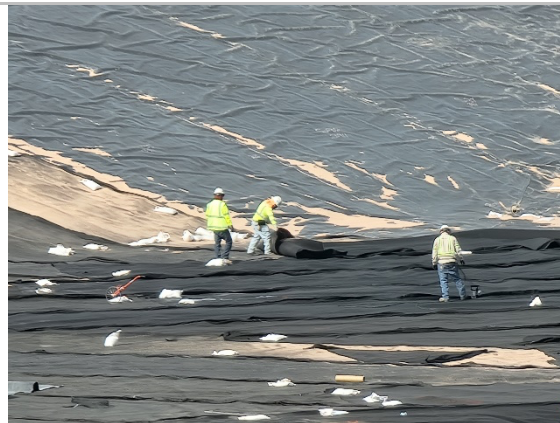
Filename: 20220506_161408
Installation crew pulling geocomposite into place on the floor of Cell E1

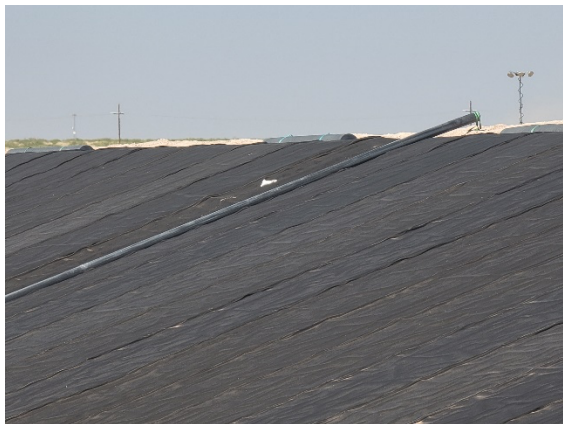
Filename: 20220509_155046
12" pipe being placed within the east trench riser

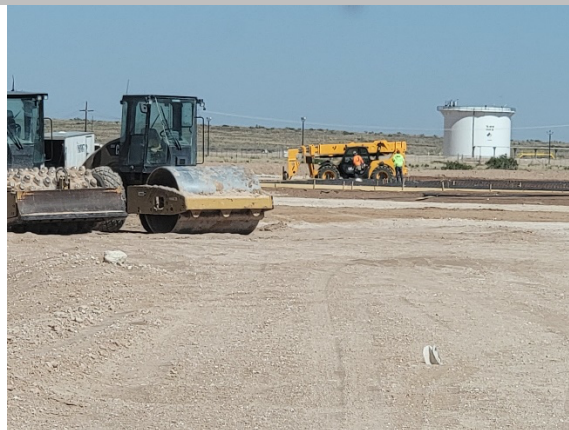
Filename: 20220509_155101
Construction crew preparing rebar forms in the east drying pad

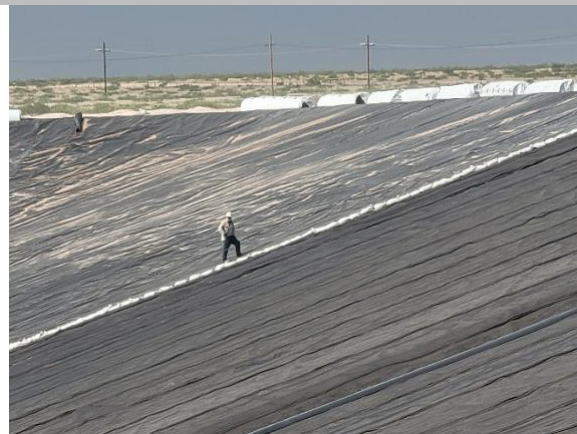
Filename: 20220510_171832
Installation crew anchoring the geomembrane with sandbags on the east slope

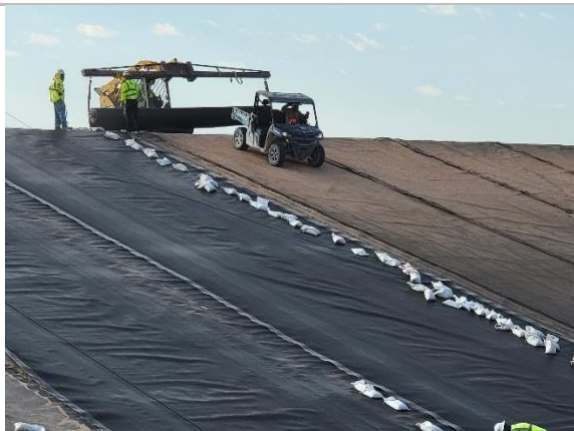
Filename: 20220510_075309
Installation crew using an ATV to deploy liner on the north slope of Cell E1

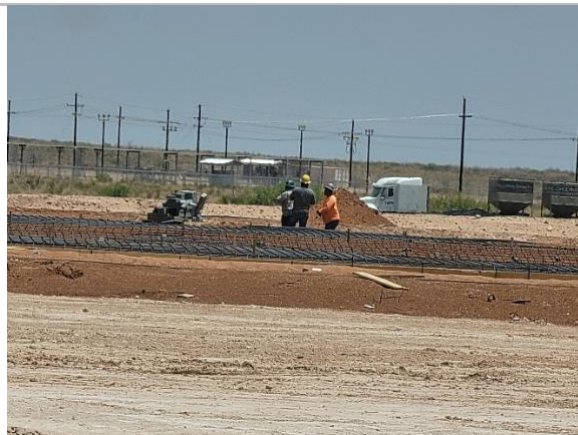
Filename: 20220511_133040
Construction crew preparing more rebar forms in the east drying pad.

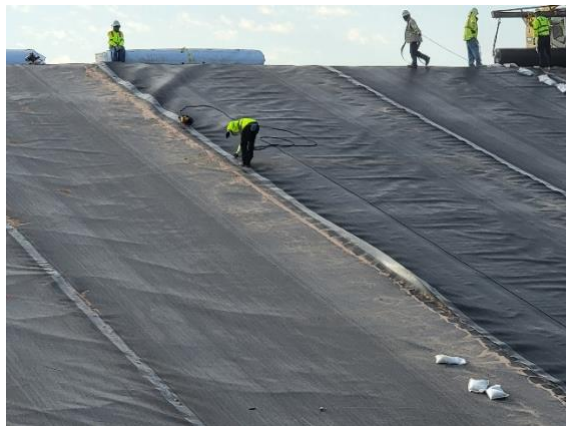
Filename: 20220511_075306
Welder cleaning and preparing overlap for welding on the east slope

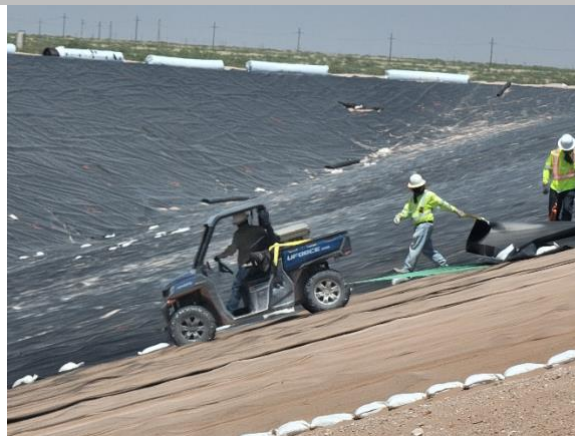
Filename: 20220511_133032
Installation crew using ATV to assist deploying liner on the east slope

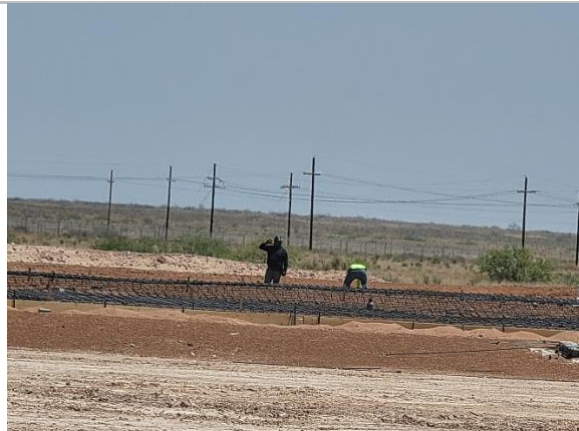
Filename: 20220511_133047
Construction crew preparing forms in the center of the east drying pad

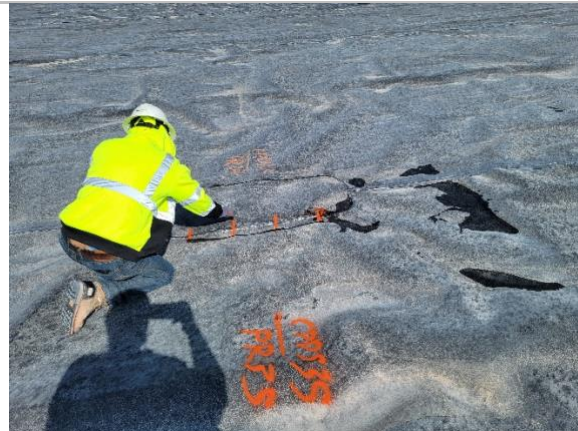
Filename: 20220511_091047
Installation crew QC cutting marked destruct in the northeast part of Cell E1

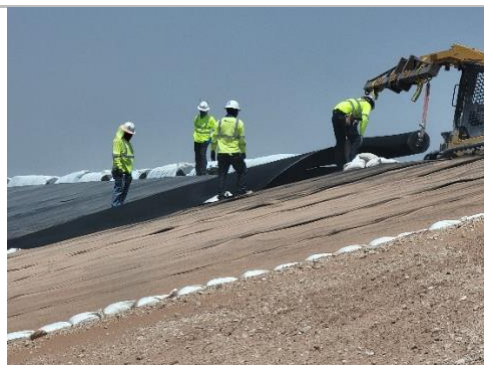
Filename: 20220511_133034
Installation crew straightening out the liner on the east slope of Cell E1

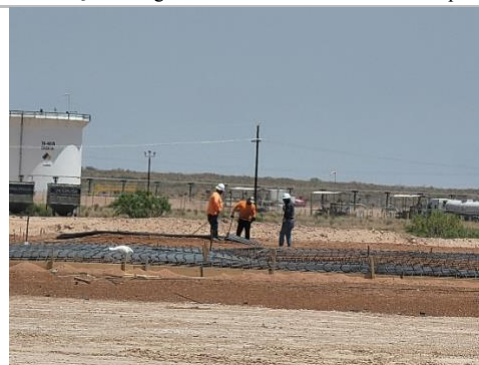
Filename: 20220511_133043
Construction crew preparing steel forms in the northern part of the east drying pad

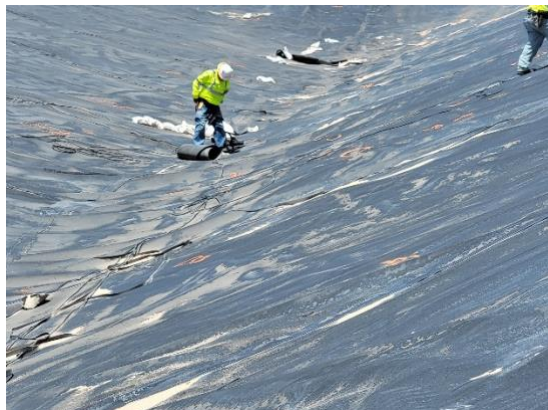
Filename: 20220512_140241
Welder preparing patch to be welded in the northeast corner

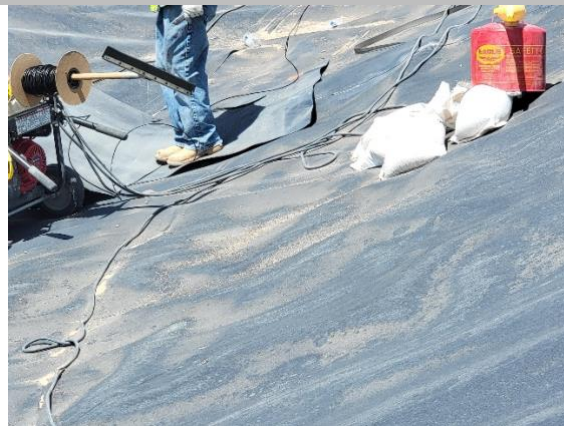
Filename: 20220512_140243
Installation crew cutting scrap liner to make a patch in the northeast corner

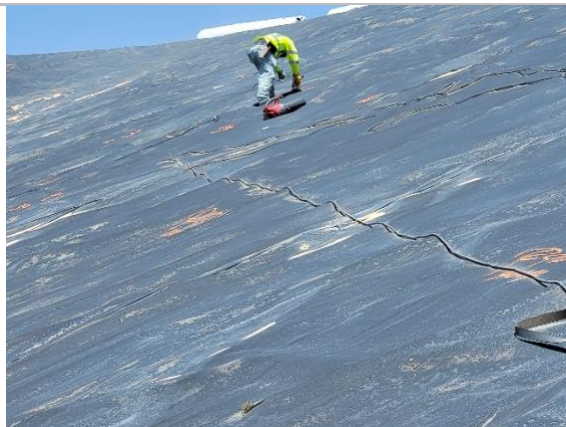
Filename: 20220512_140245
Installation crew cleaning and grinding a section to be repaired in the east slope

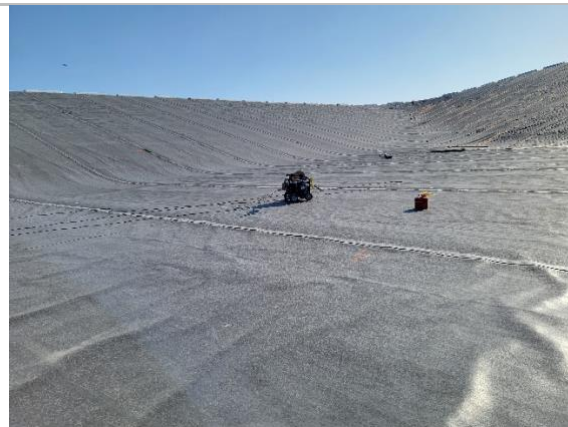
Filename: 20220512_080224
Mobile generator being used to power extrusion guns in the northeast corner

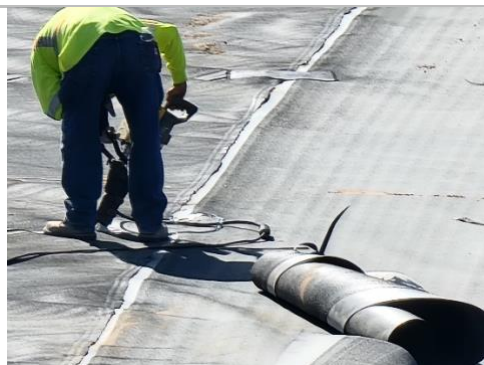
Filename: 20220512_082924
Extrusion welder welding a repair on the floor of Cell E1

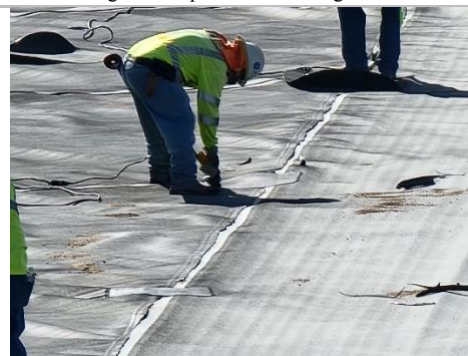
Filename: 20220512_082929
Installation crew leistering a patch on the floor of Cell E1

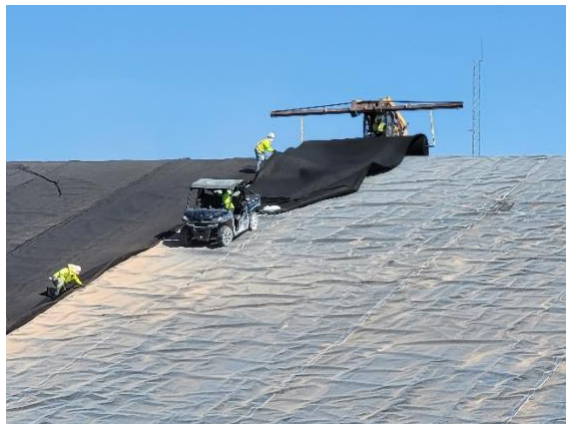
Filename: 20220513_092902
Installation crew using ATV to assist deploying geocomposite in Cell E1

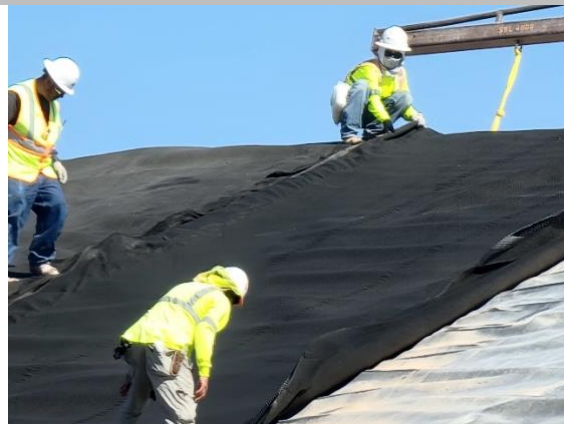
Filename: 20220513_093042
Installation crew pulling the geocomposite in line with adjacent panel

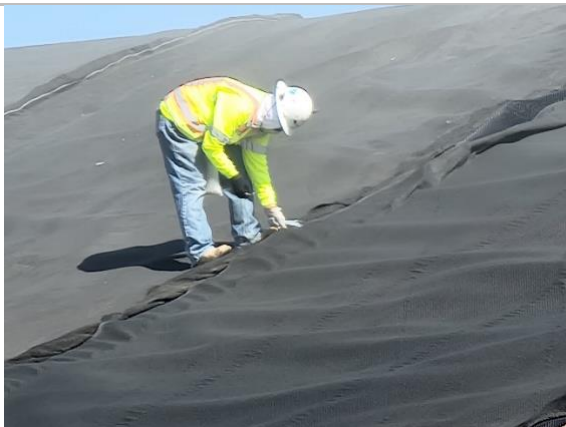
Filename: 20220513_093128
Installation crew opening overlap of panels for zip ties on the north slope of Cell E1

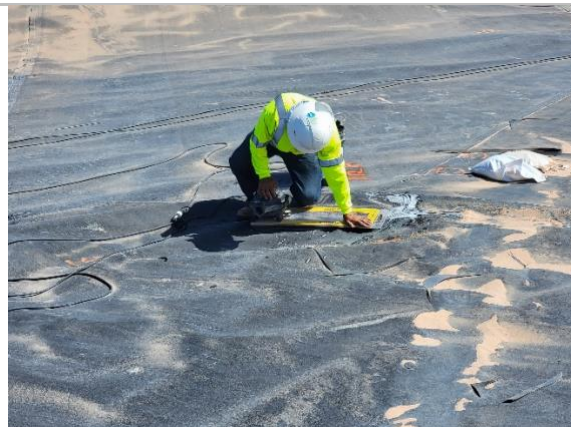
Filename: 20220513_094938
Installation crew vacuum boxing repairs within the floor of Cell E1

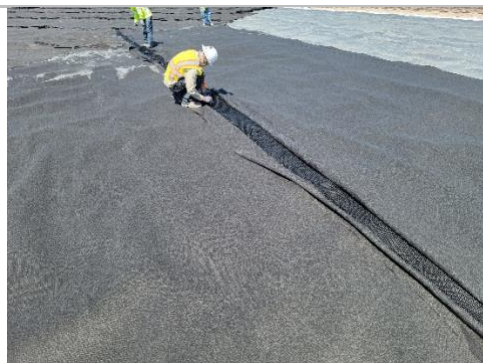
Filename: 20220513_145304
Installation crew using zip ties to connect geocomposite in Cell E1

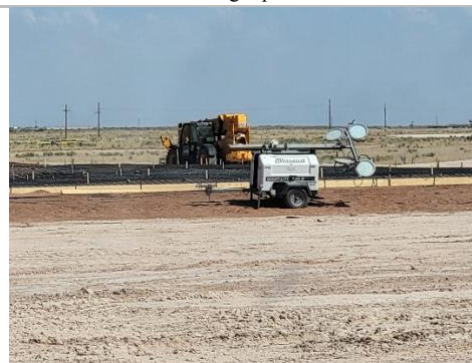
Filename: 20220513_153124
Construction crew placing light plant adjacent to western drying pad.

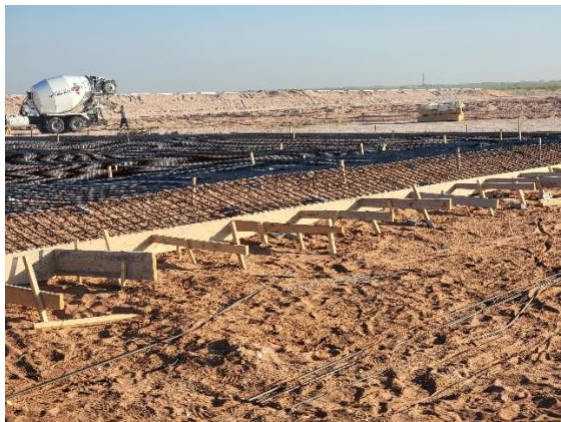
Filename: 20220514_071430
Rebar forms being made in the east drying pad

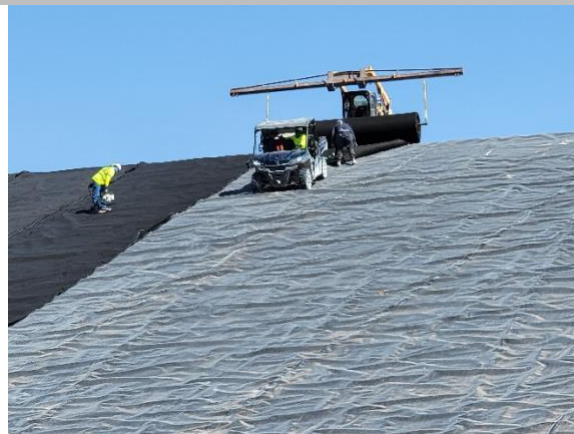
Filename: 20220514_100125
Installation crew using an ATV to assist pulling the liner on the north slope.

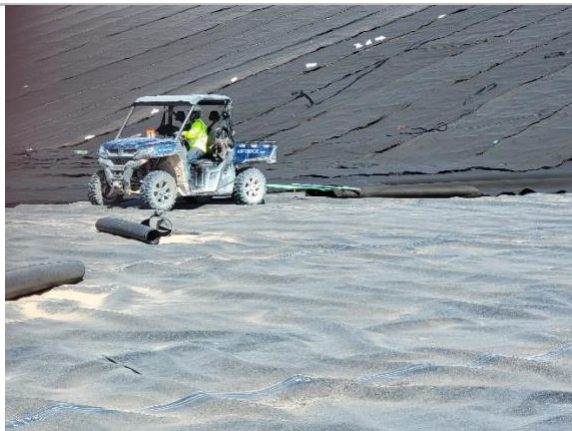
Filename: 20220514_100234
ATV being used to assist deploy the liner near the northeast corner of the floor.

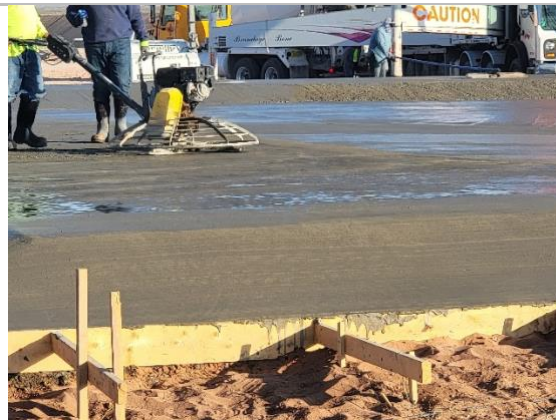
Filename: 20220514_071235
Concrete crew using device to cool the concrete in the west drying pad.

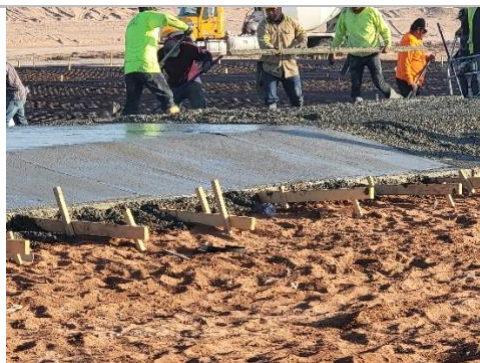
Filename: 20220514_071239
Concrete crew spreading material in the eastern part of the west drying pad.

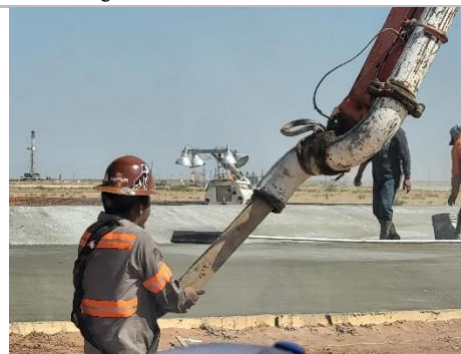
Filename: 20220514_154232
Construction crew clearing clog in the extended arm of the concrete mixer.

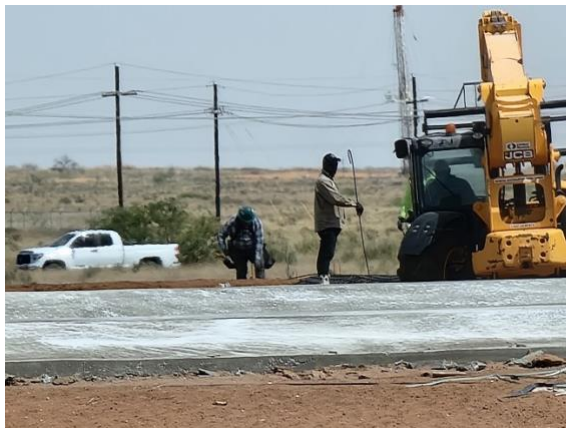
Filename: 20220516_150044
Construction crew using a forklift to assist with building the forms

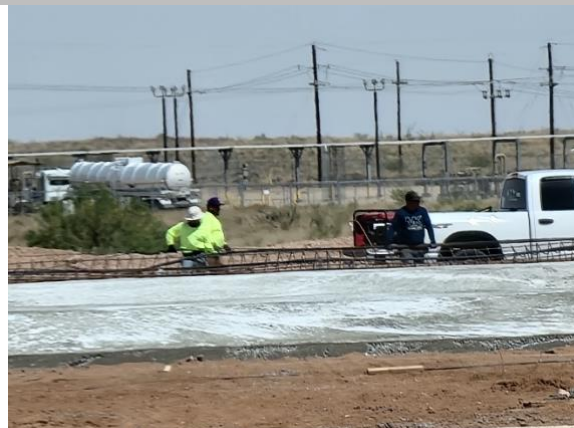
Filename: 20220516_150052
Construction crew adjusting rebar to build the forms in the east drying pad

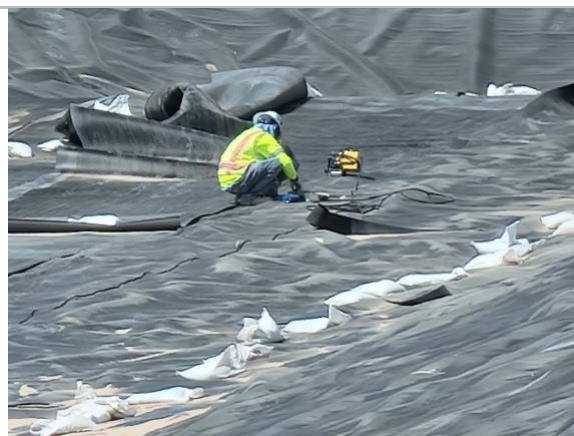
Filename: 20220516_150007
Welder cleaning the overlap for welding on the floor near the east slope

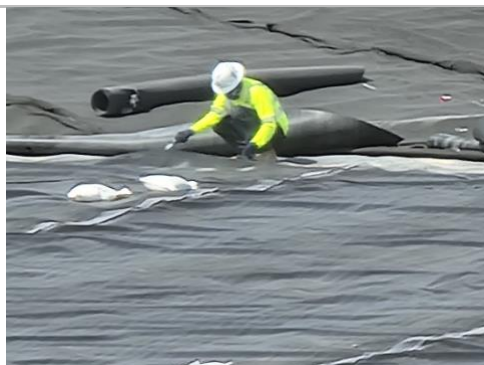
Filename: 20220516_150020
Installation crew cleaning overlap area in the center of the floor for welding

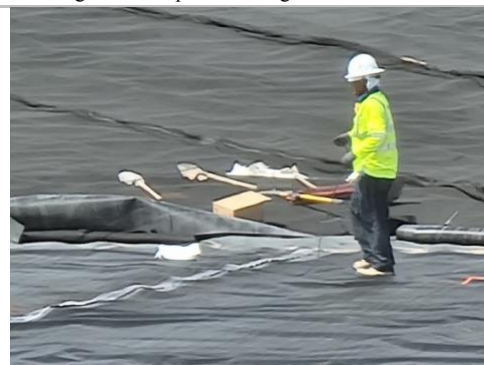
Filename: 20220516_150026
Welder maintaining the position of the wedge in the center of the floor.

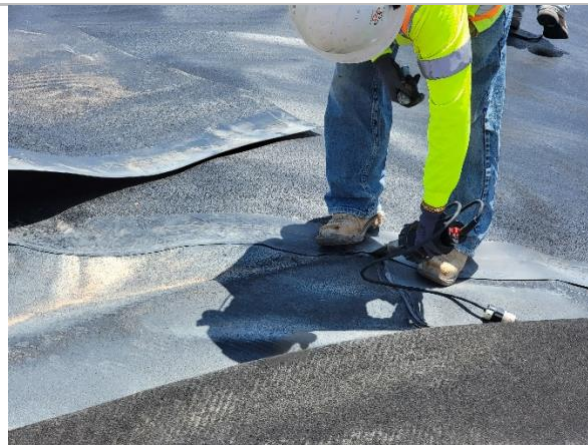
2 panels had to be dealt with due to having horizontal cross-seams on the slope of Cell E1. P16 had a panel extrusion welded over it with a 45-degree cross seam. P124 was removed and replaced with a panel with a 45-degree cross seam in it.

Filename: 20220517_112201
Installation crew leistering the repair panel over P16

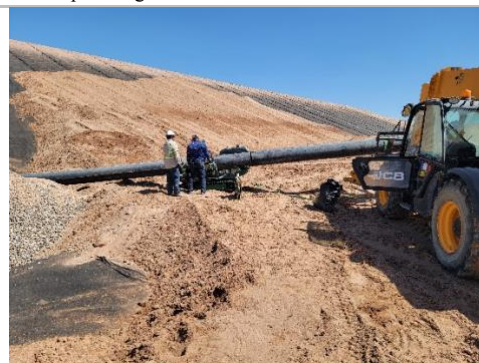
Due to the elbow of the 18" pipe, the pipe was unable to lay on the floor of the sump, so the bend is to be removed, and replaced with a straight pipe.

Filename: 20220526_152459
Pipe crew welding the straight 18" pipe end to the remainder of the 18" pipe

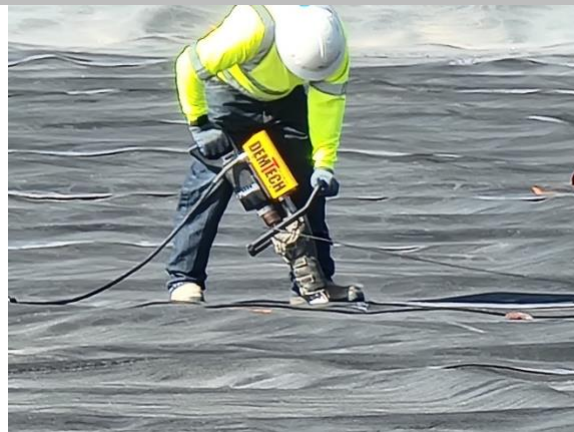
Filename: 20220528_085935
Welder extrusion welding a repair on the floor of the leachate pond

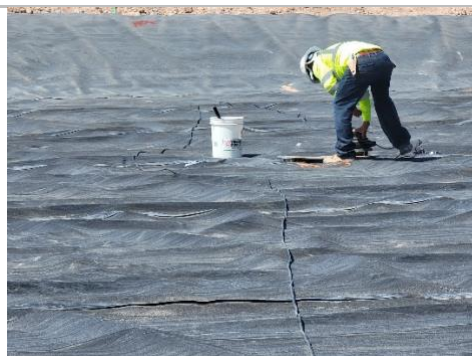
Filename: 20220528_100751
Installation crew doing vacuum box testing on the repairs in the leachate pond
