**CQA / CQC
REPORT**

**ENGINEERING CERTIFICATION REPORT
FOR
EVAPORATION POND 3 CONSTRUCTION**

**BASIN DISPOSAL, INC.
BLOOMFIELD, NEW MEXICO**

**Re: Basin Disposal Inc: [OCD Permit No. 1-0005]
Engineering Certification Report: Evaporation Pond 3 Construction [520.01.01]**

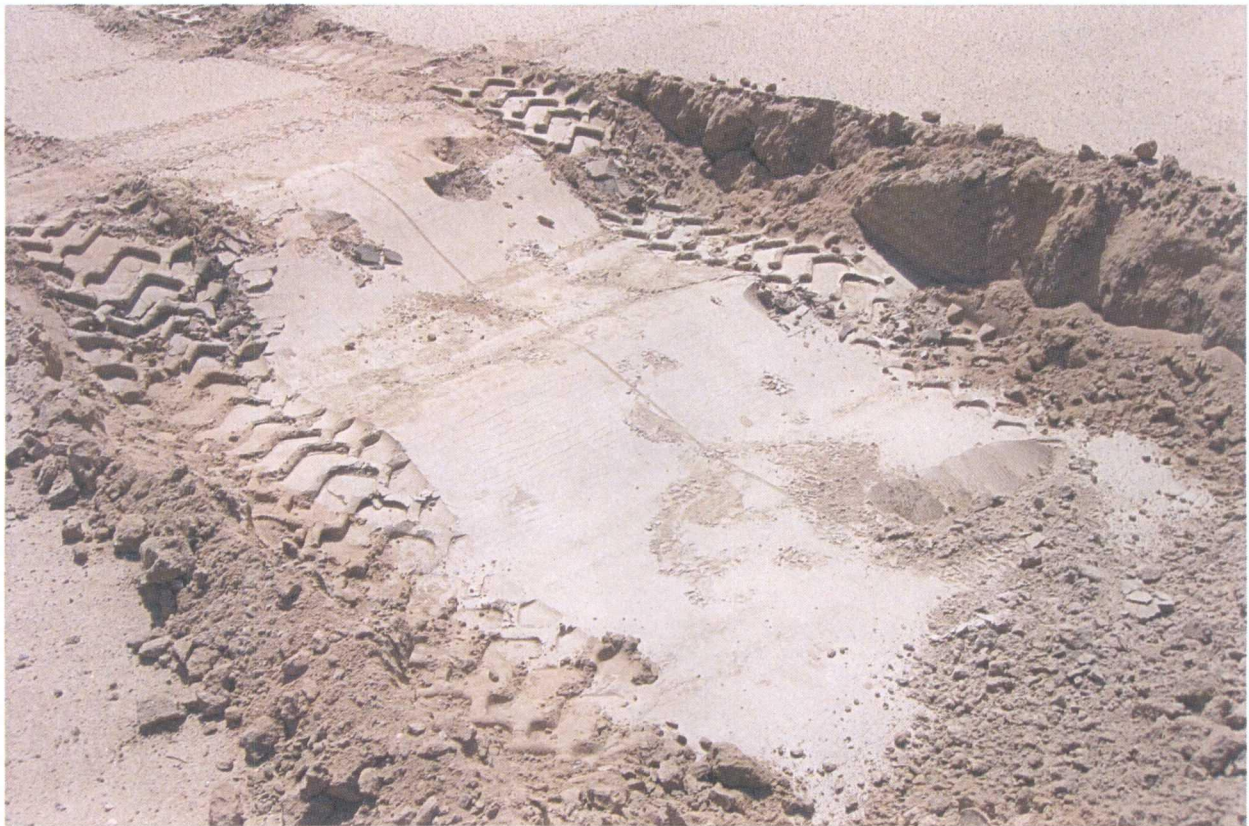
2. 4-24-09 Collection of soil sample for analysis

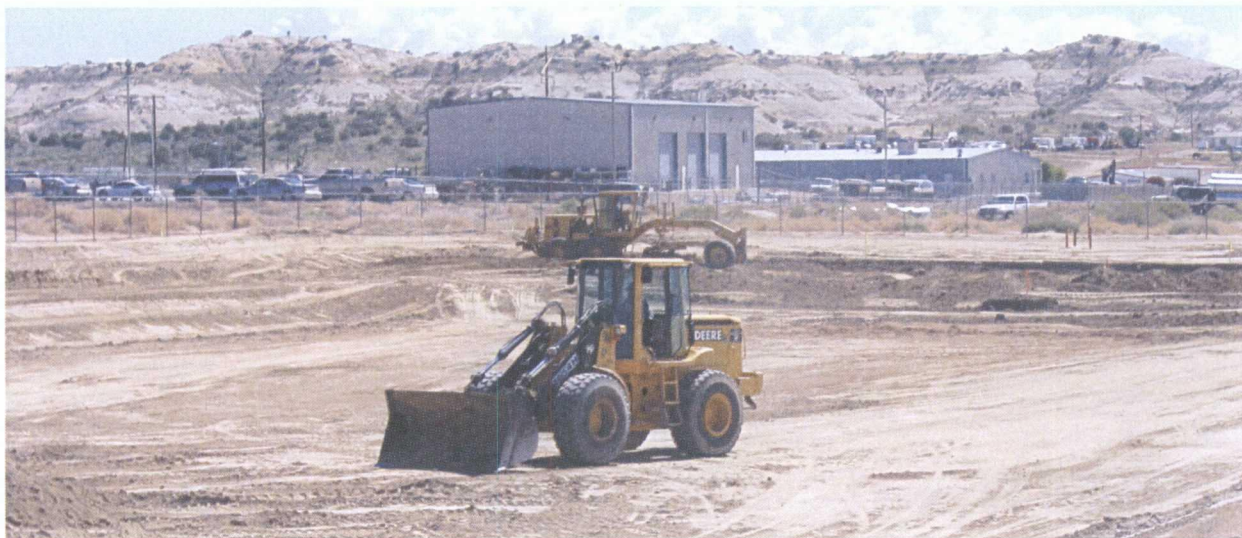
3. 5-27-09 Pond construction

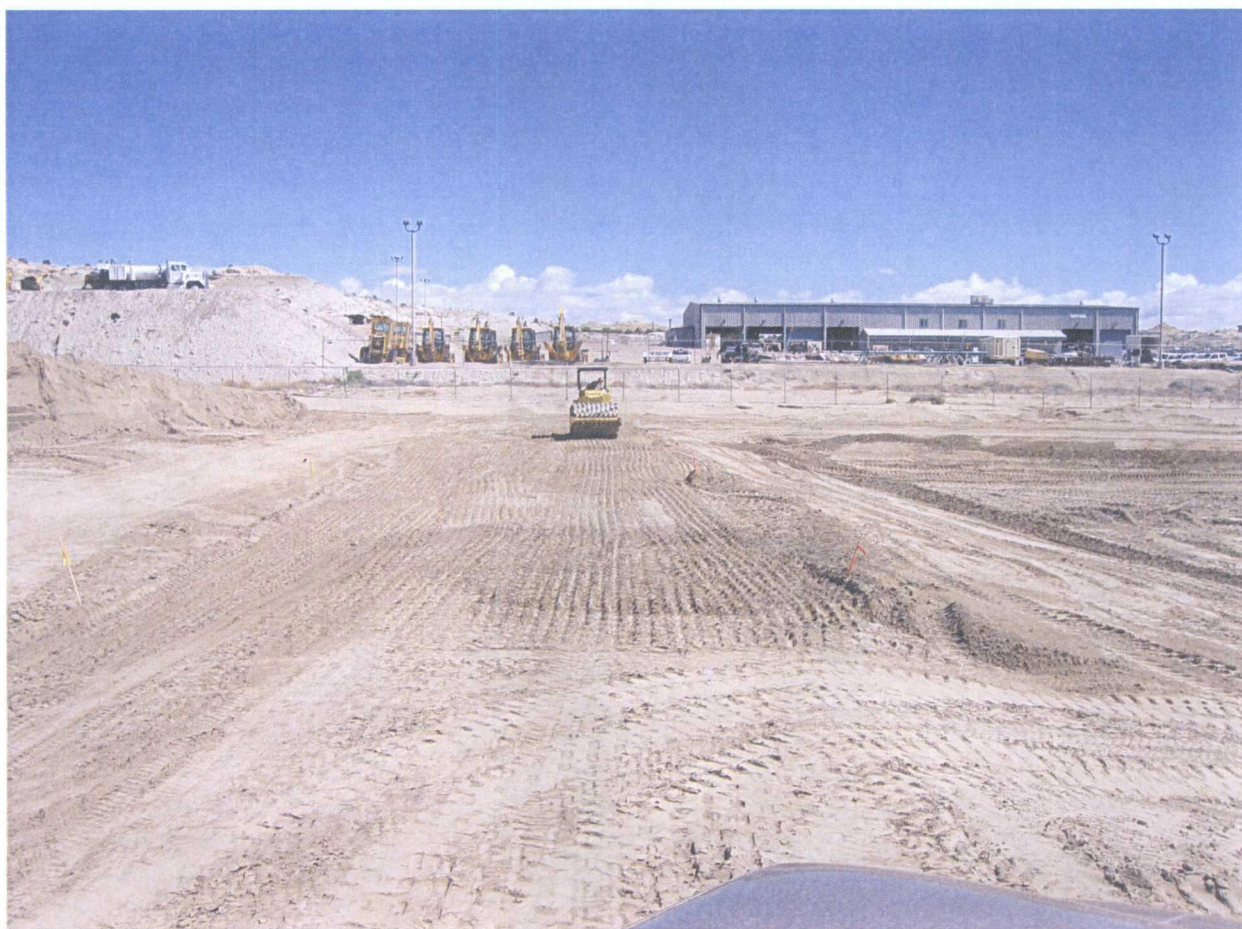
4. 5-27-09 Berm compaction during construction

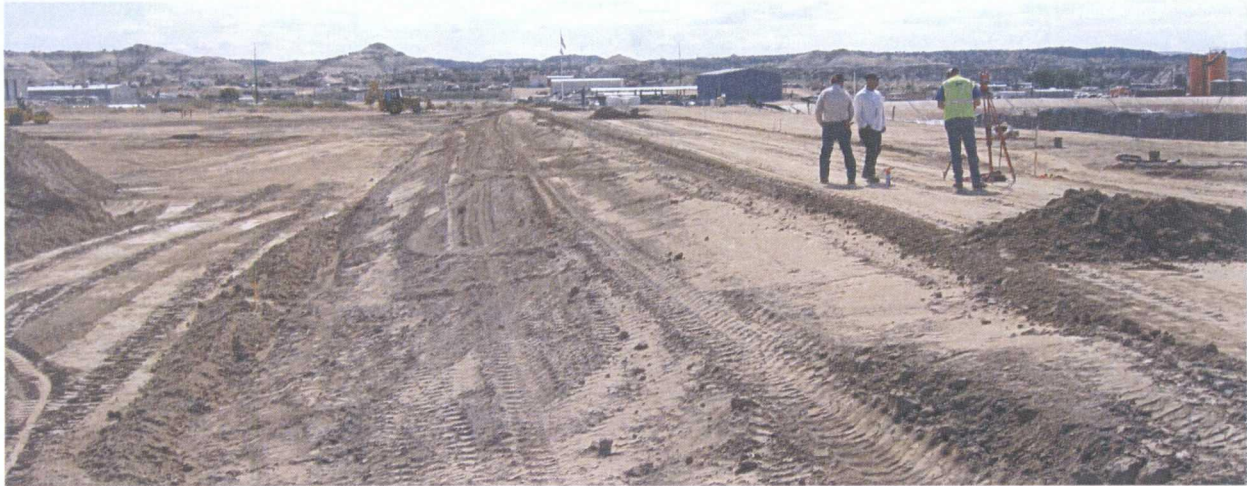
5. 5-29-09 Surveying during construction

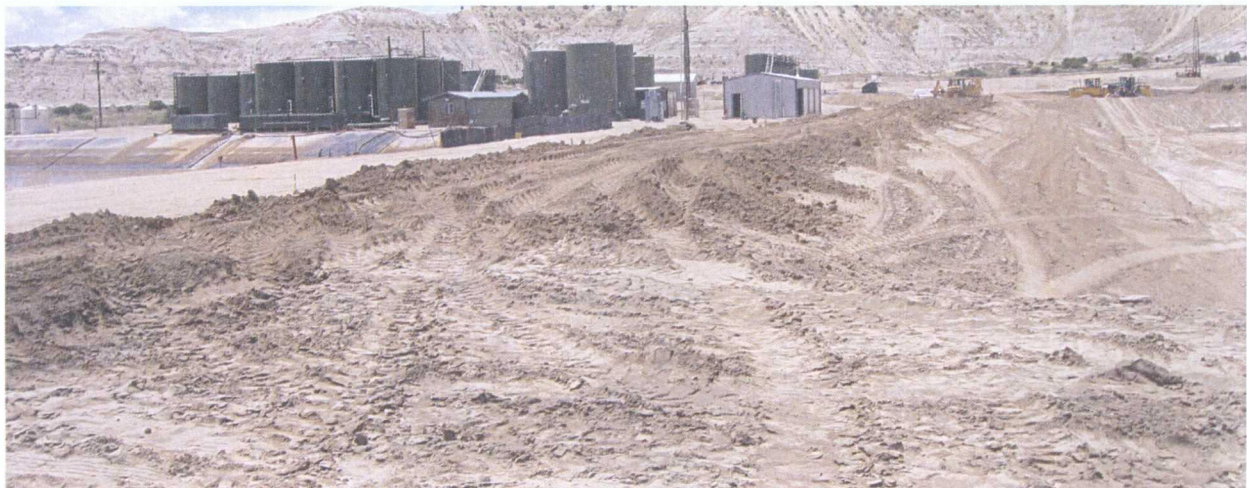
6. 6-1-09 Soil placement for additional lifts on southern berm

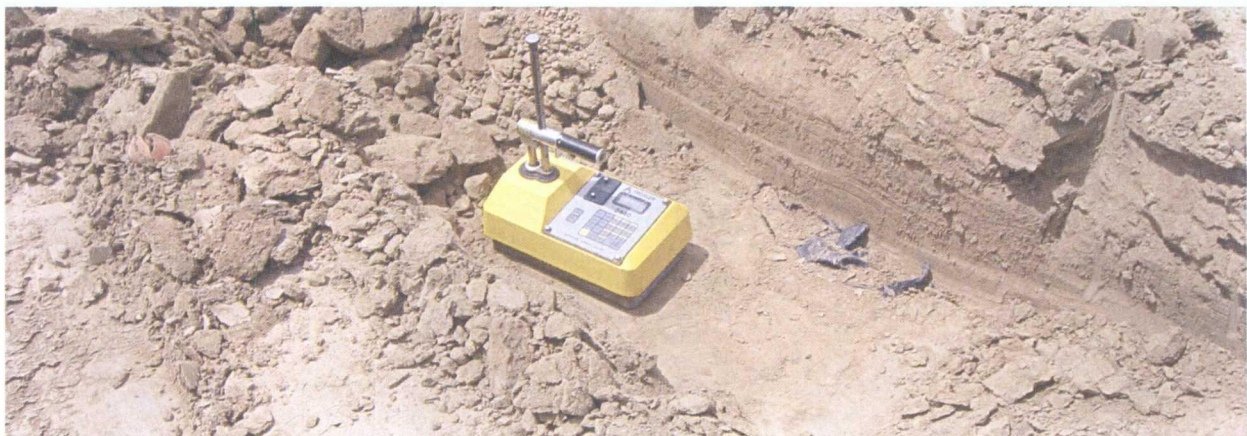
7. 6-1-09 Density testing on 1st of two lifts constructed

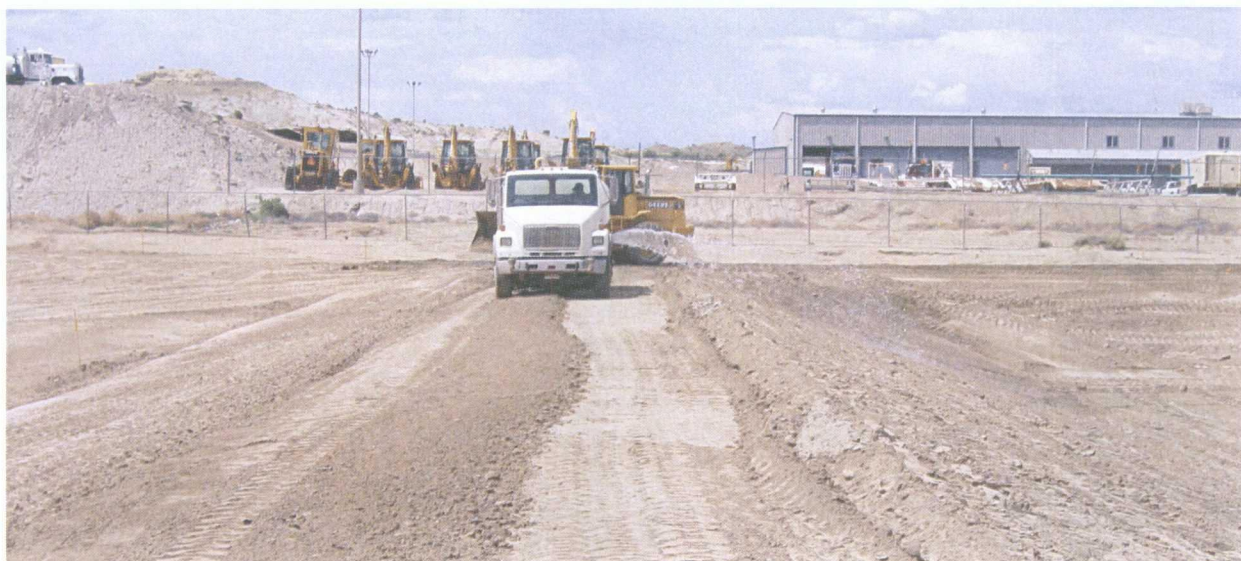
8. 6-2-09 Application of water for compaction of soils used in berm construction

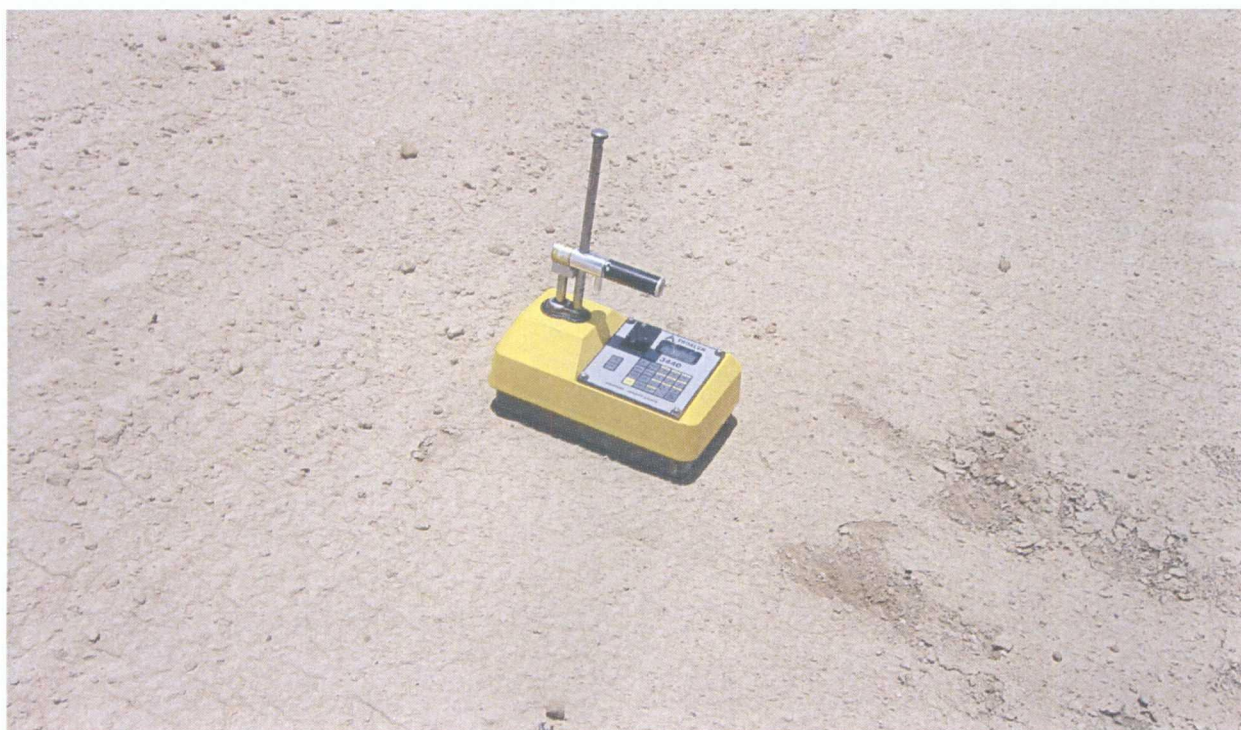
9. 6-9-09 Density testing the sideslope of Evaporation Pond 3

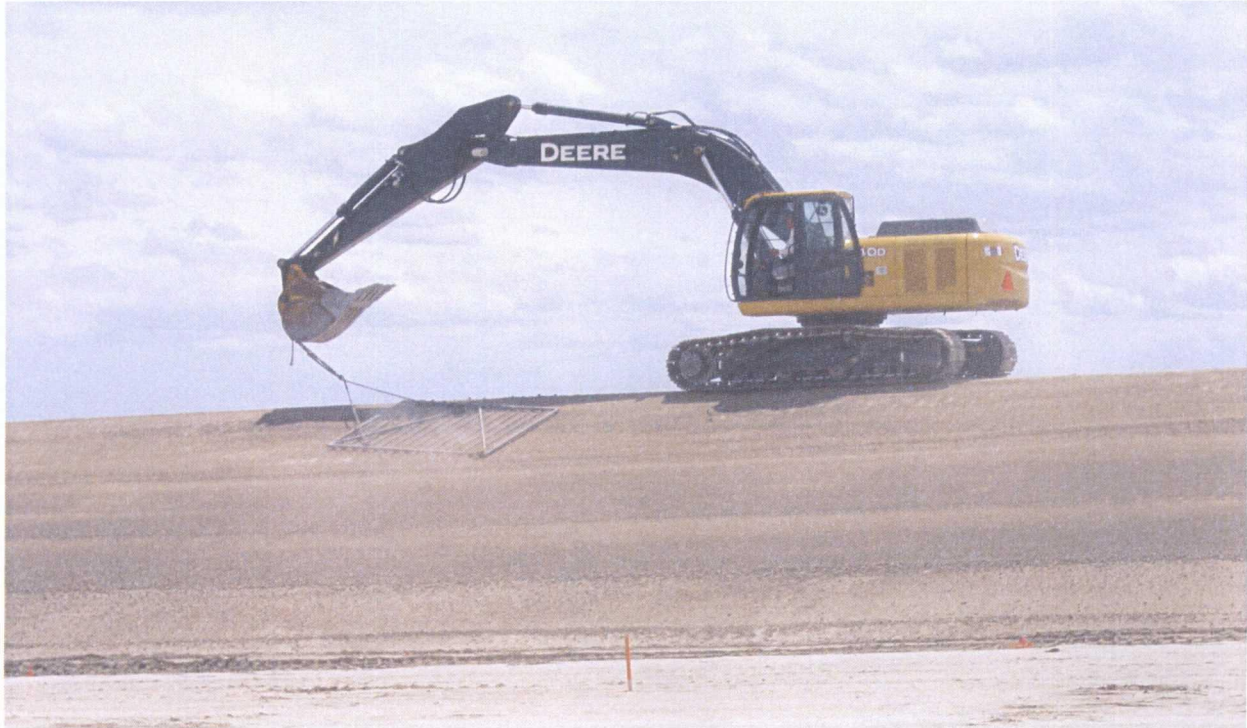
10. 6-9-09 Use of a metal grate to clear dirt clods from sideslopes

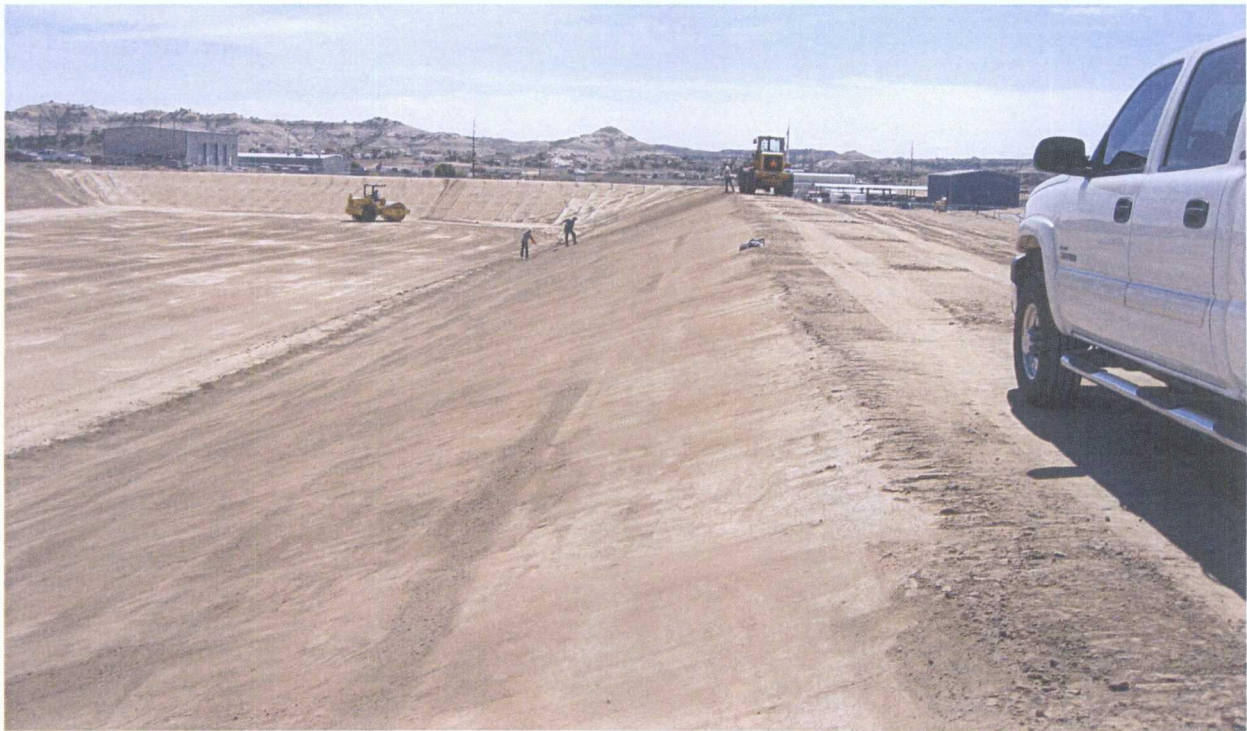
11. 6-11-09 Use of rakes, brooms and shovels to complete cleaning of sideslopes

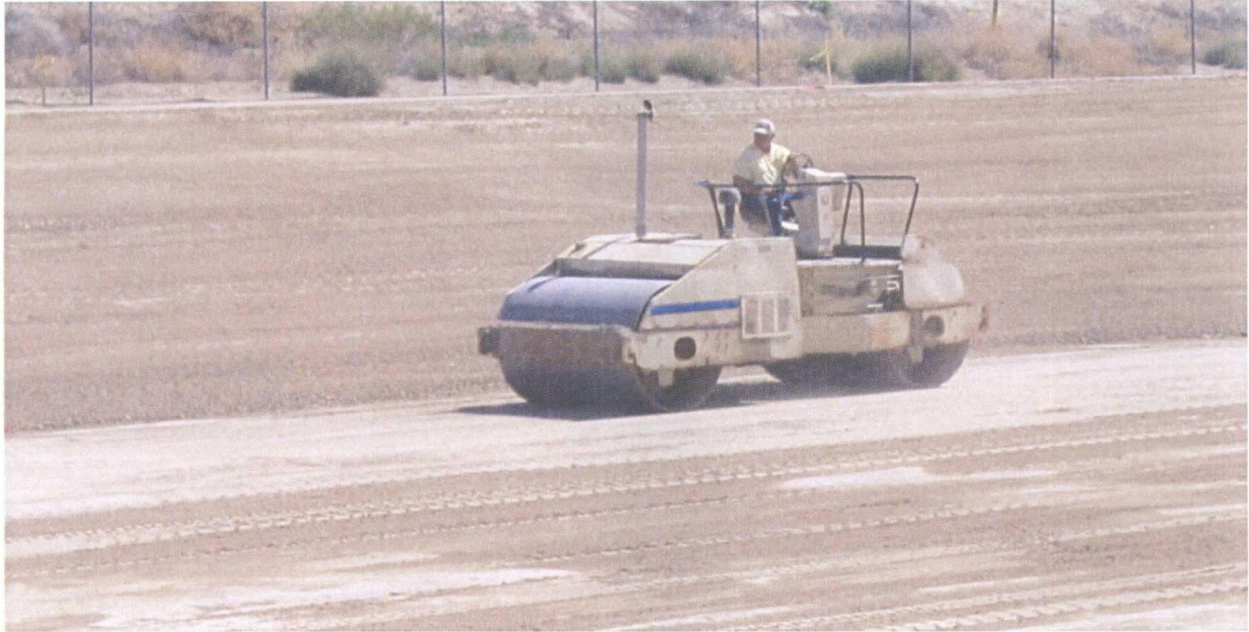
12. 6-11-09 Rolling floor of Evaporation Pond 3

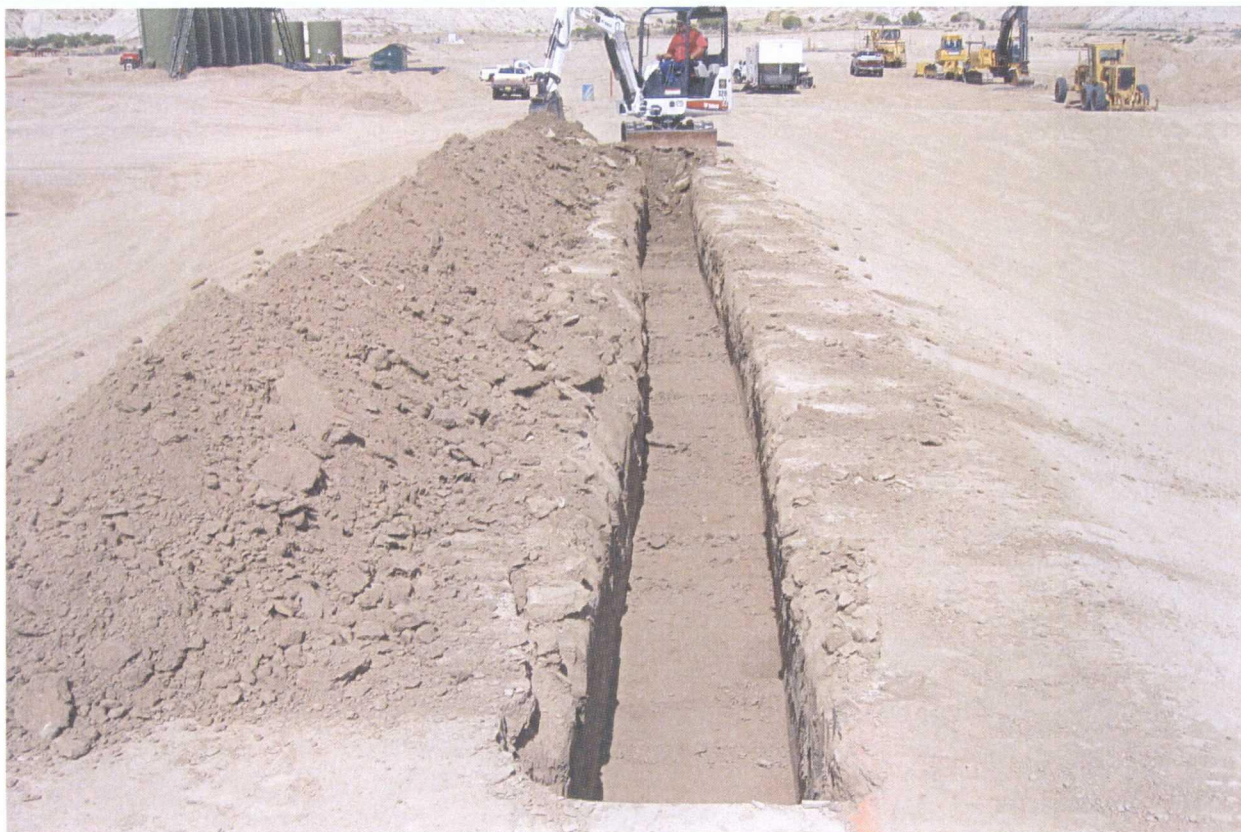
14. 6-15-09 Anchor trench construction on southern berm

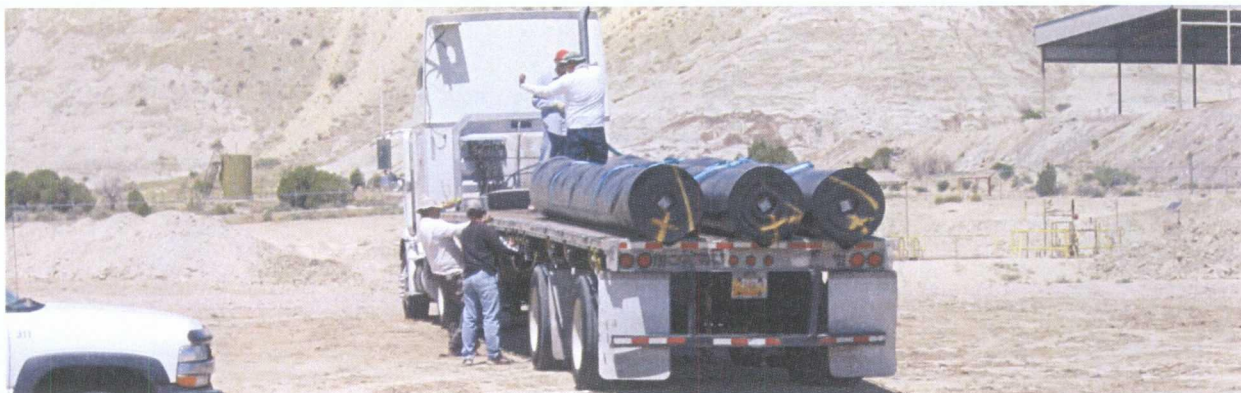
16. 6-15-09 Arrival of FML material

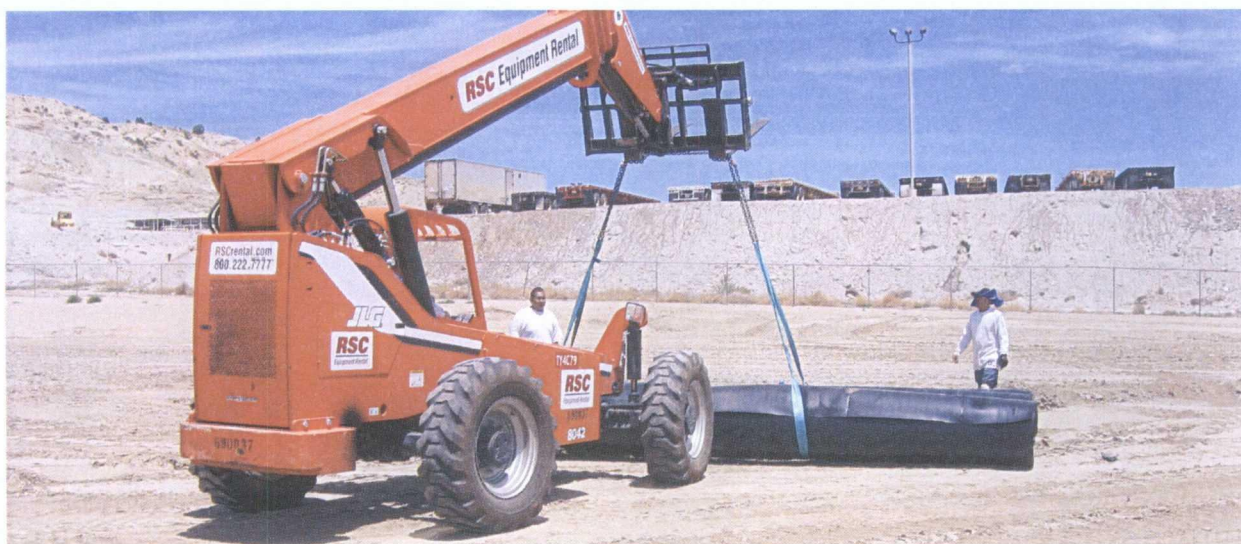
17. 6-15-09 Unloading of FML material

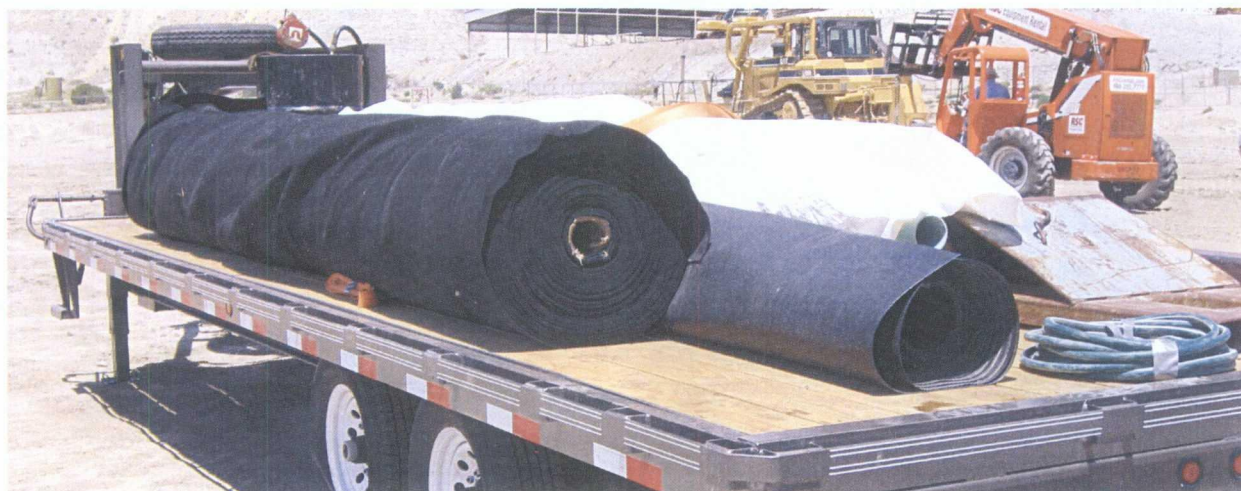
18. 6-15-09 GCL, Geotextile and Textured FML

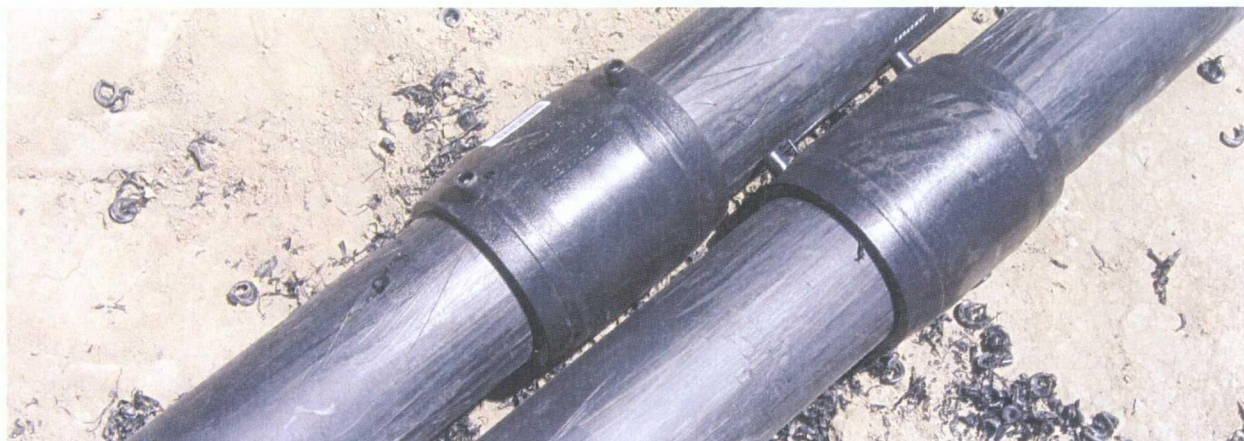
19. 6-15-09 Leak detection riser pipes fused using thermal butt joints

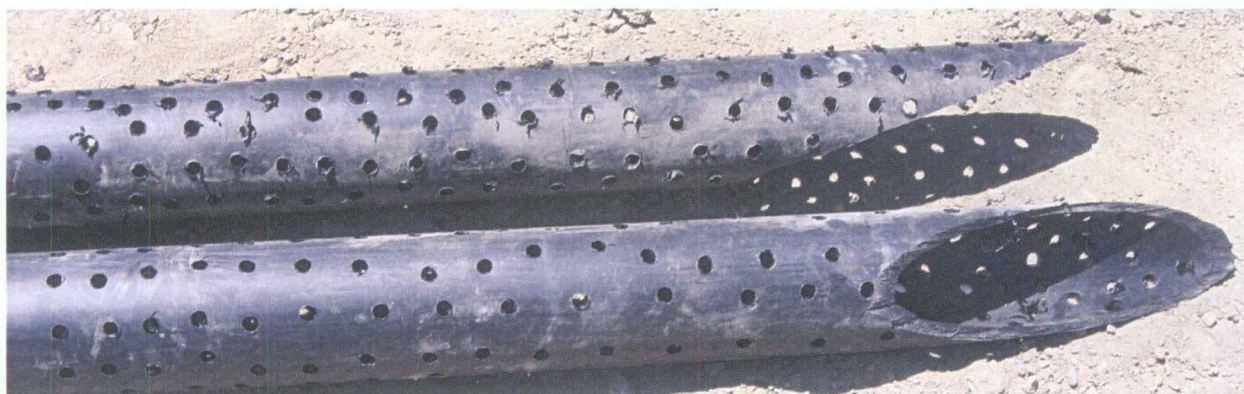
20. 6-15-09 Holes drilled in leak detection riser pipes

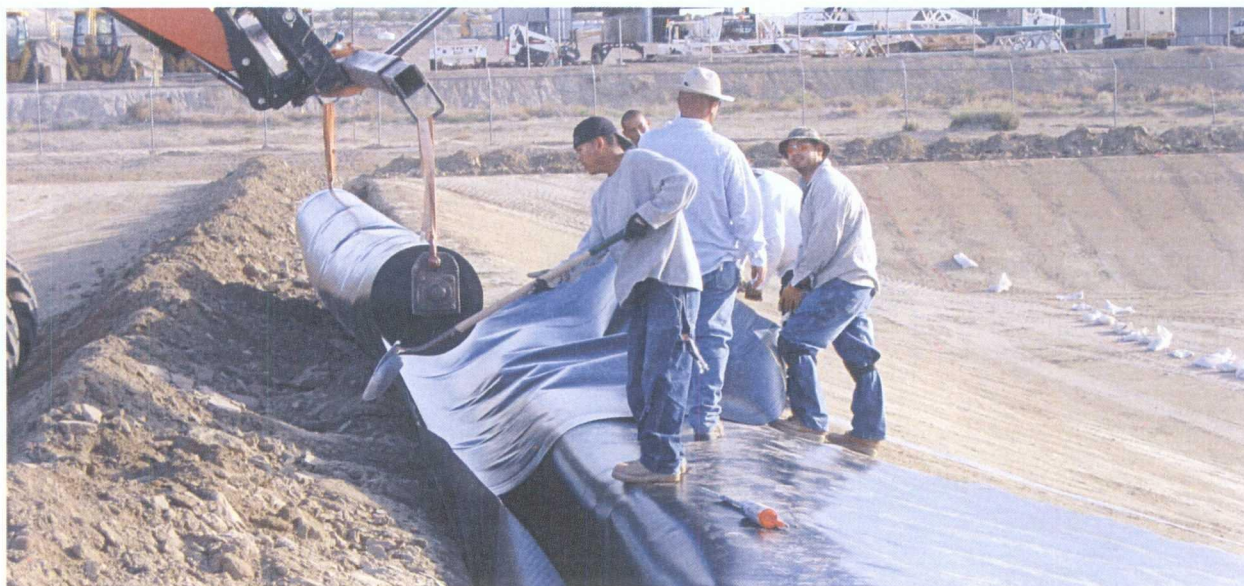
21. 6-15-09 Installation of secondary liner

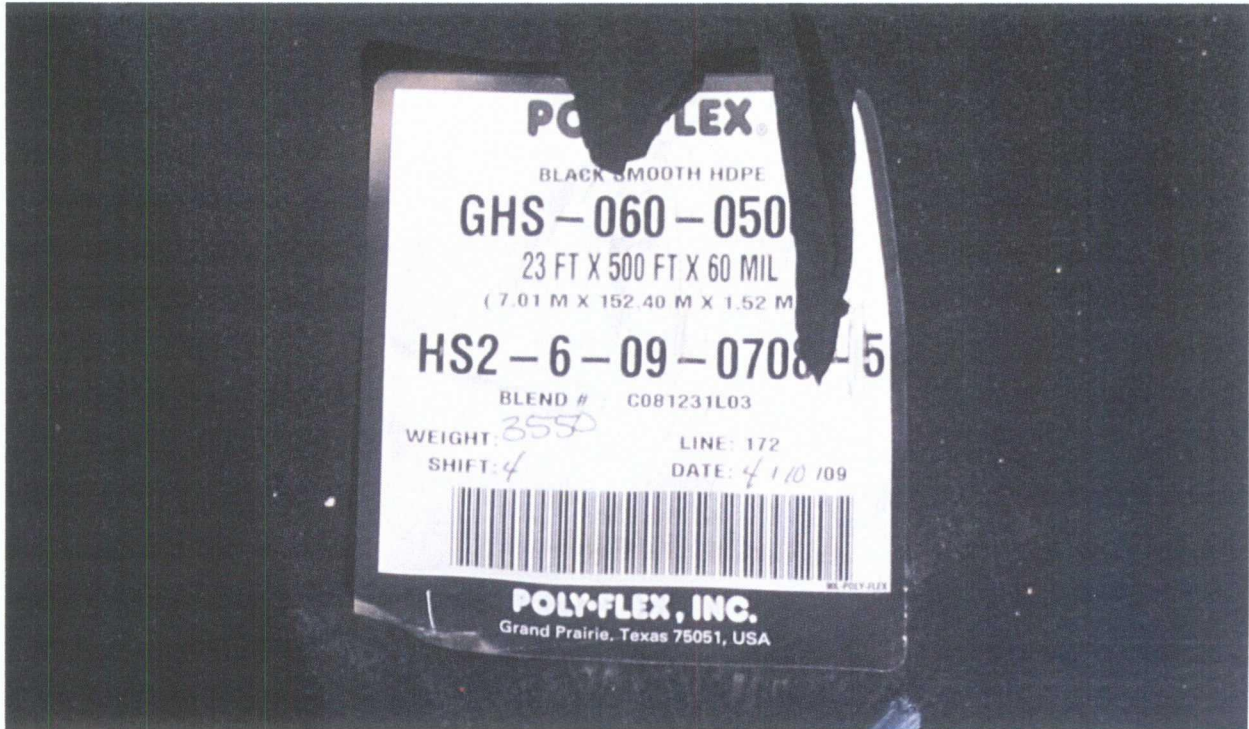
24. 6-16-09 Manufacturer roll number identification

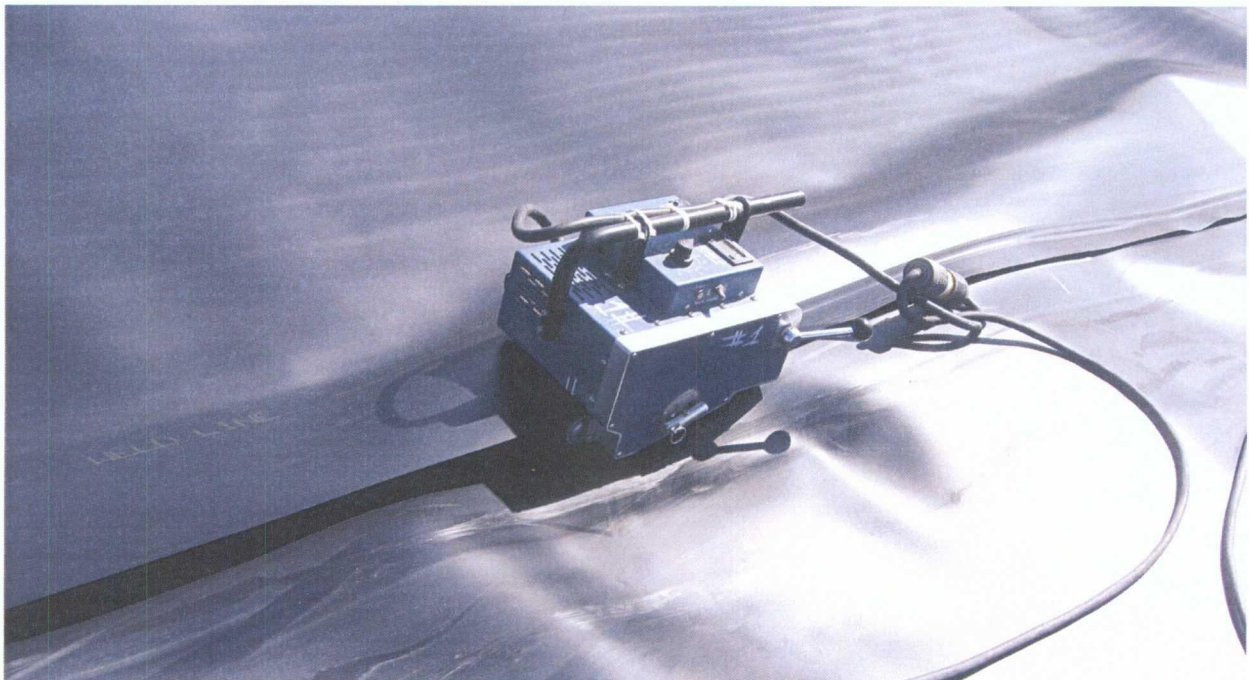
25 6-16-09 Seaming "Wedge welding" in progress

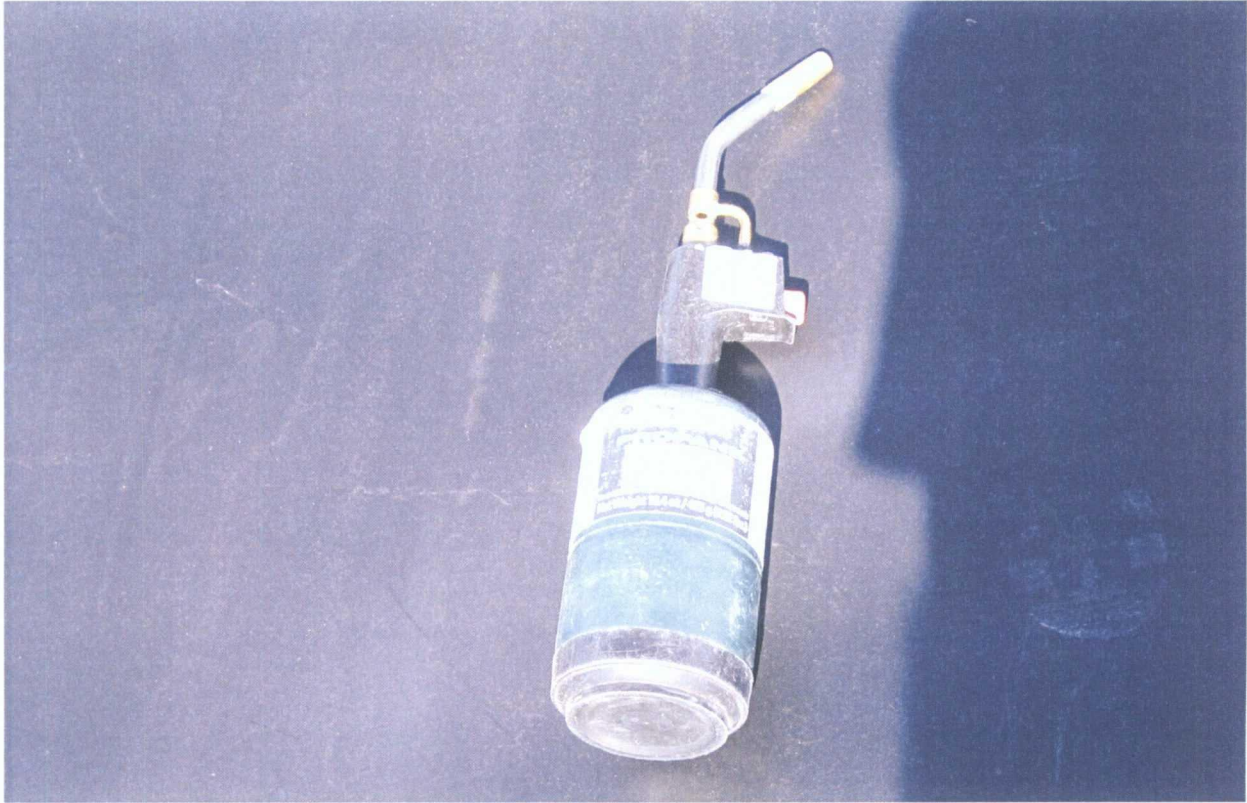
26. 6-16-09 Torch used for seaming wedge welds to do air pressure tests

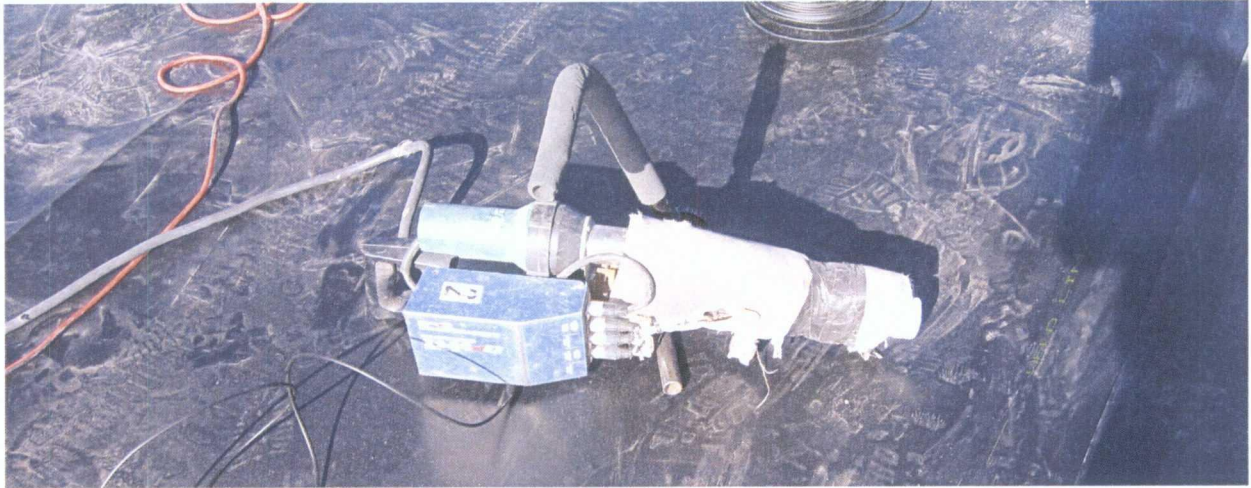
28. 6-16-09 Extrusion welder

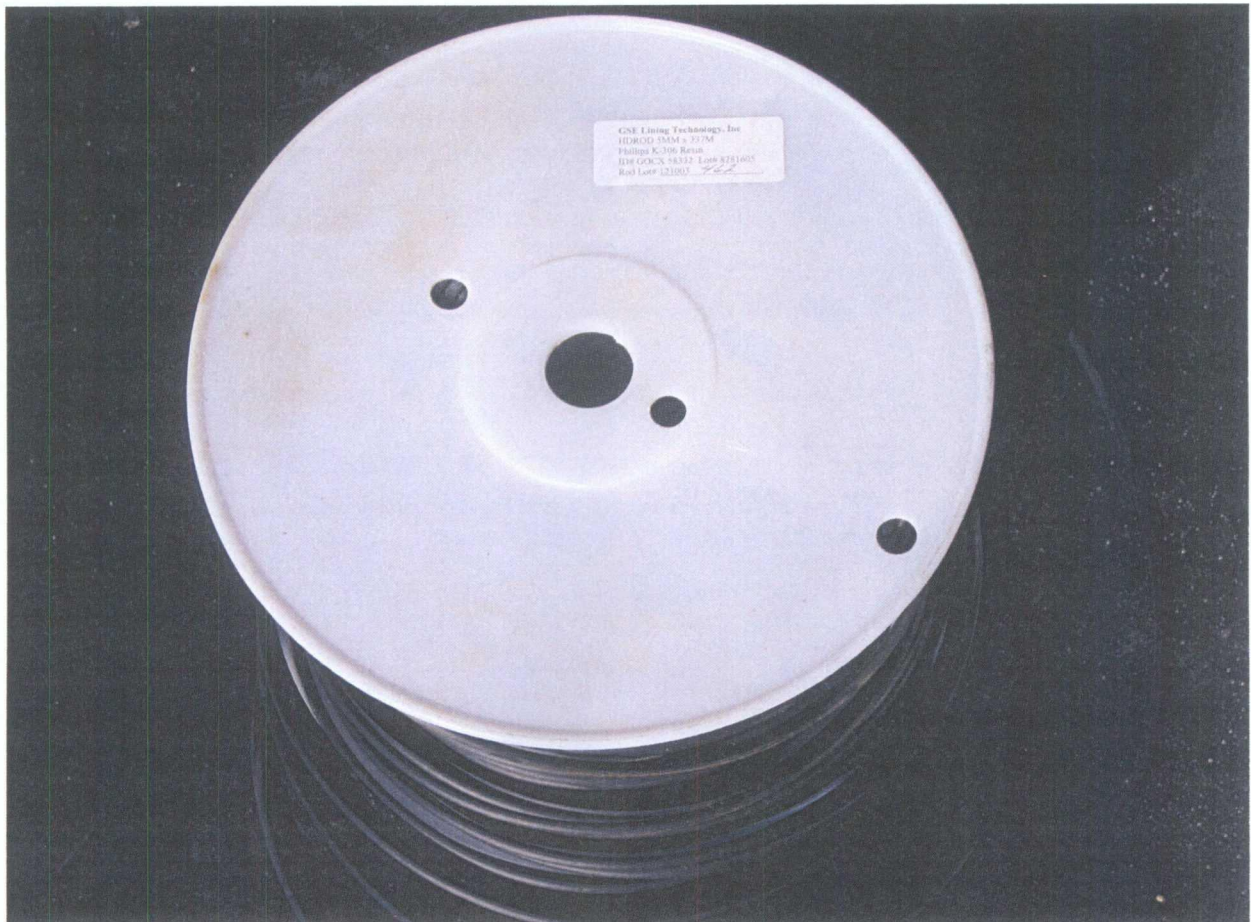
29. 6-16-09 Extrusion welding rod

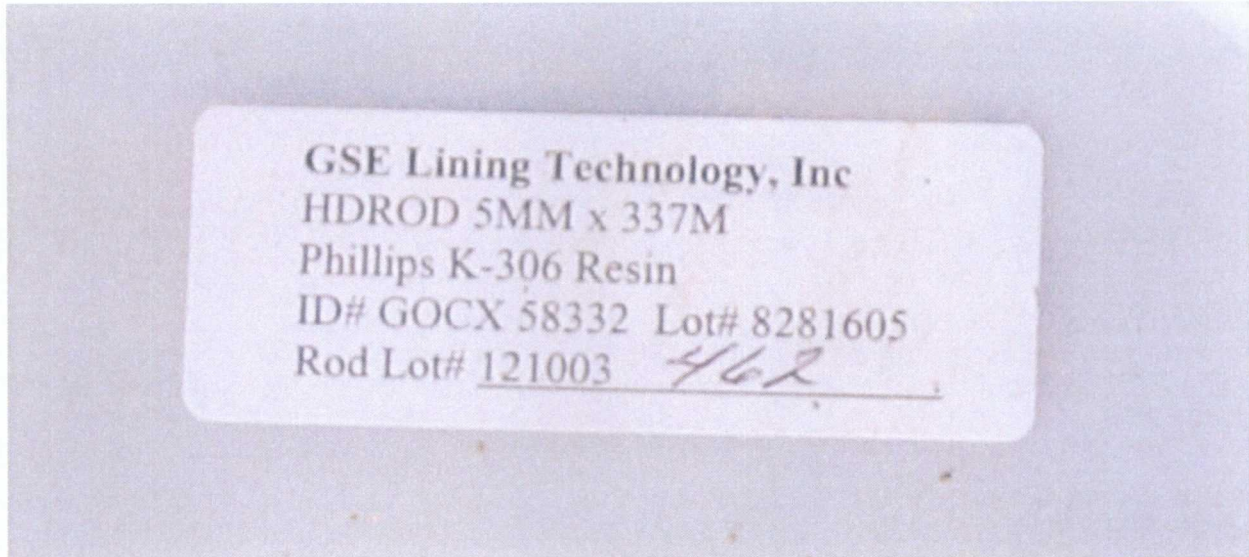
30. 6-16-09 Manufactures tag on extrusion welding rod

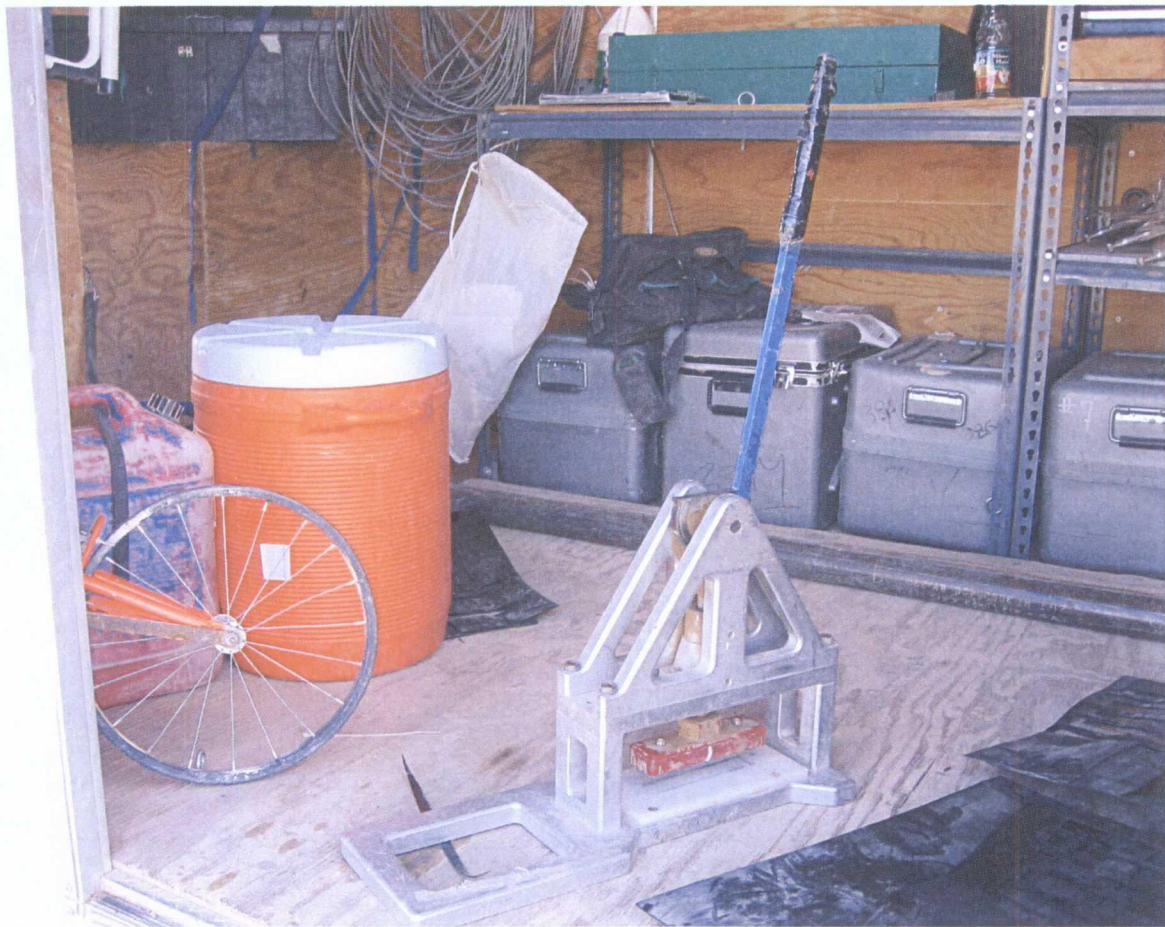
31. 6-16-06 Punch used for cutting destructive tests and pre-weld tests

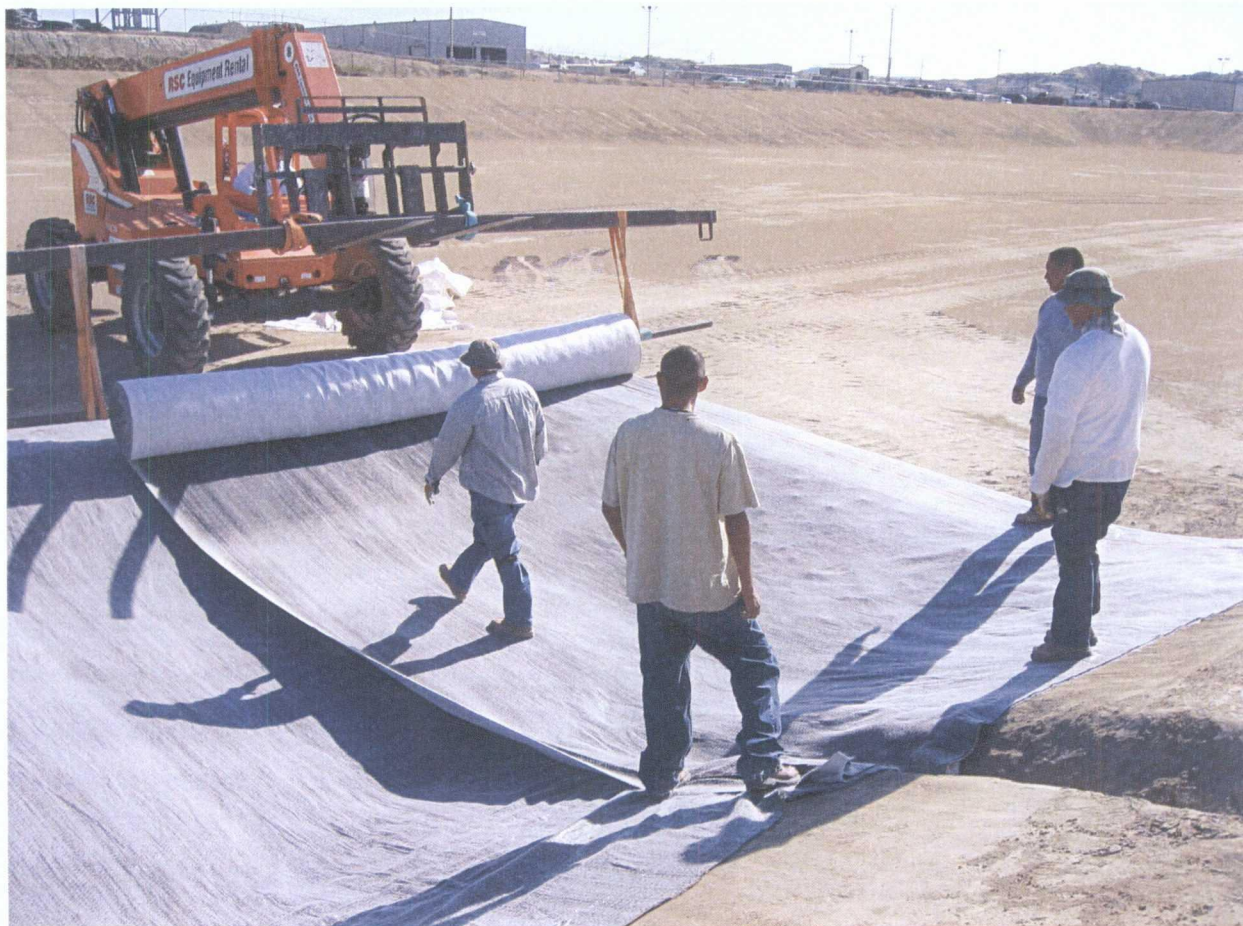
32. 6-16-09 GCL placement under leak detection sumps

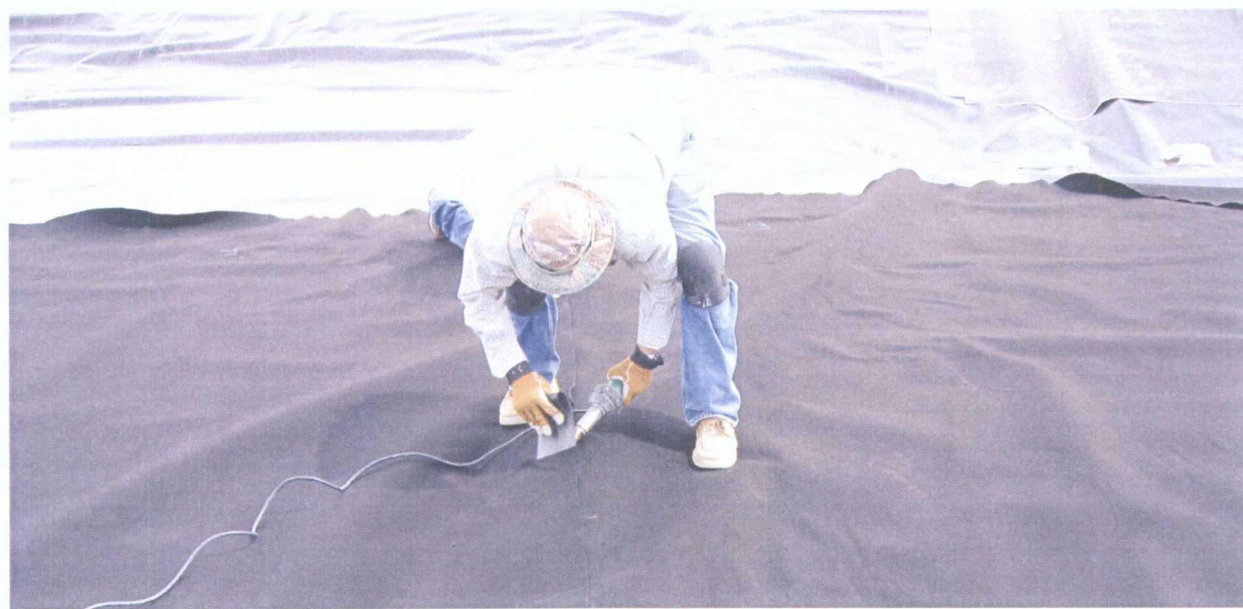
33. 6-16-09 Using Lyster to heat weld geotextile

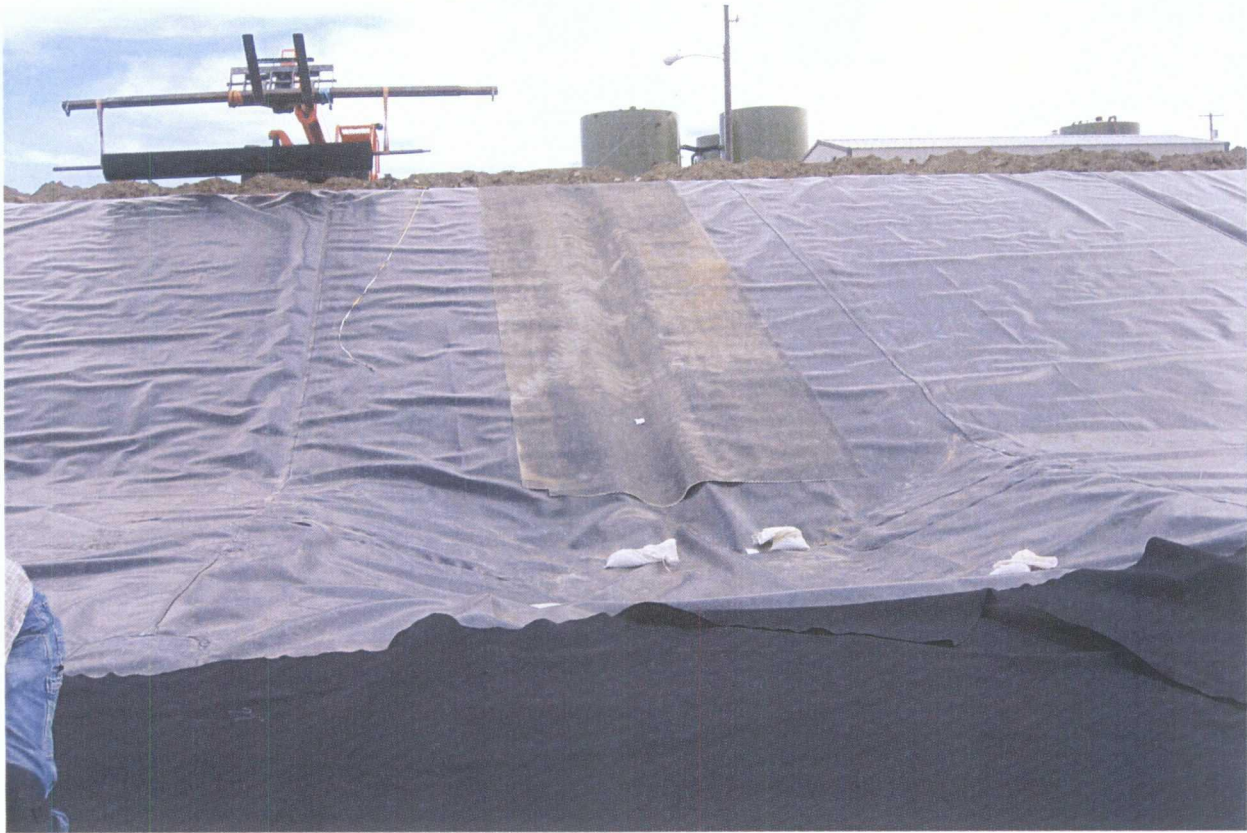
34. 6-16-09 Textured panel in leak detection riser pipe trench for soil stability
