**CQA / CQC
REPORT**

**ENGINEERING CERTIFICATION REPORT
FOR
EVAPORATION POND 3 CONSTRUCTION**

**BASIN DISPOSAL, INC.
BLOOMFIELD, NEW MEXICO**

**Re: Basin Disposal Inc: [OCD Permit No. 1-0005]
Engineering Certification Report: Evaporation Pond 3 Construction [520.01.01]**

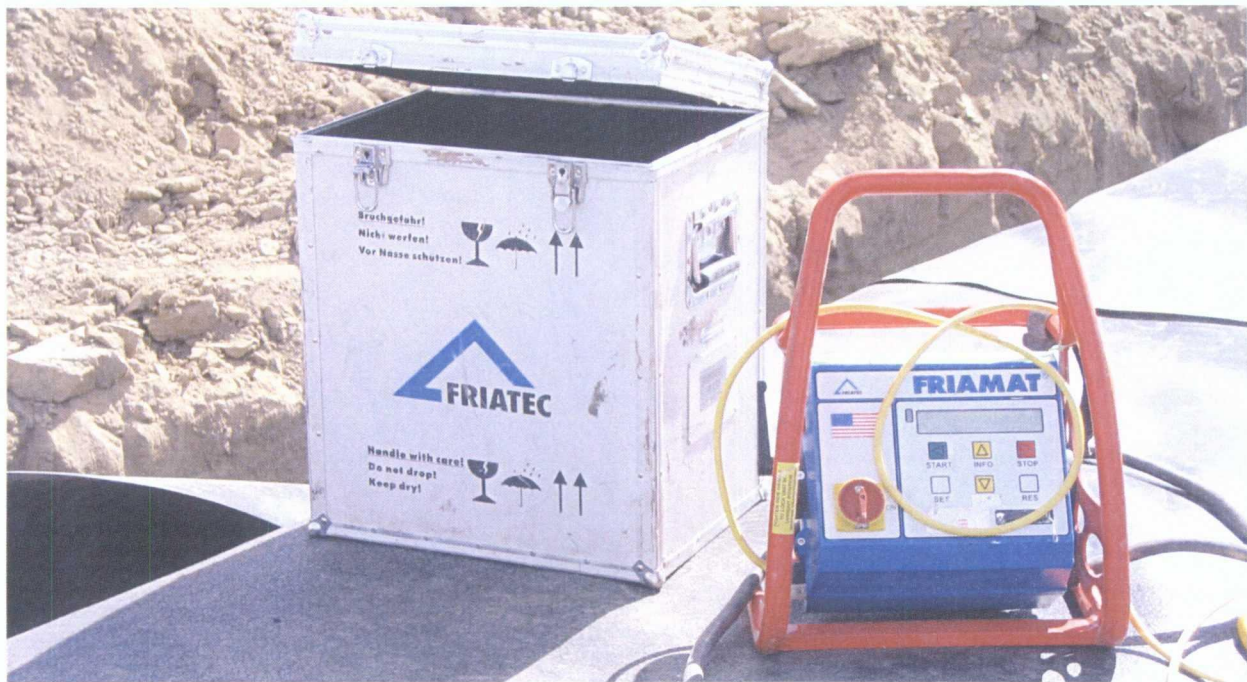
35. 6-16-09 Equipment for use thermal butt fusion welds

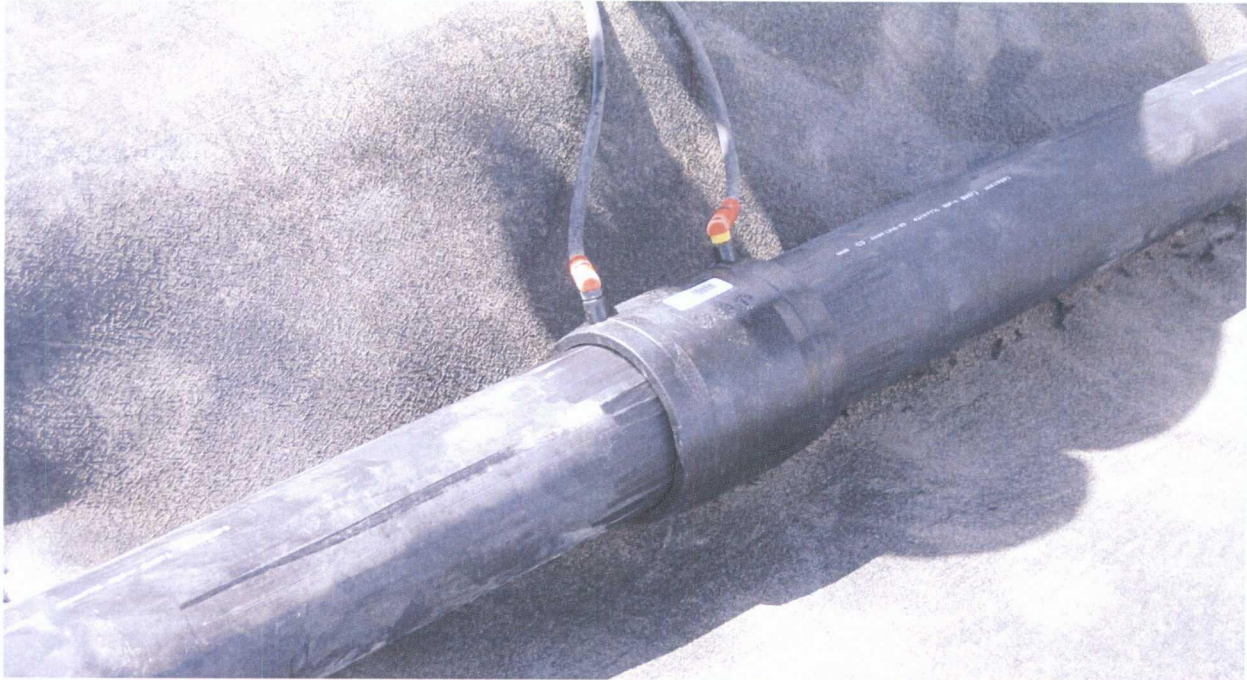
36. 6-16-09 Thermal butt fusion in progress

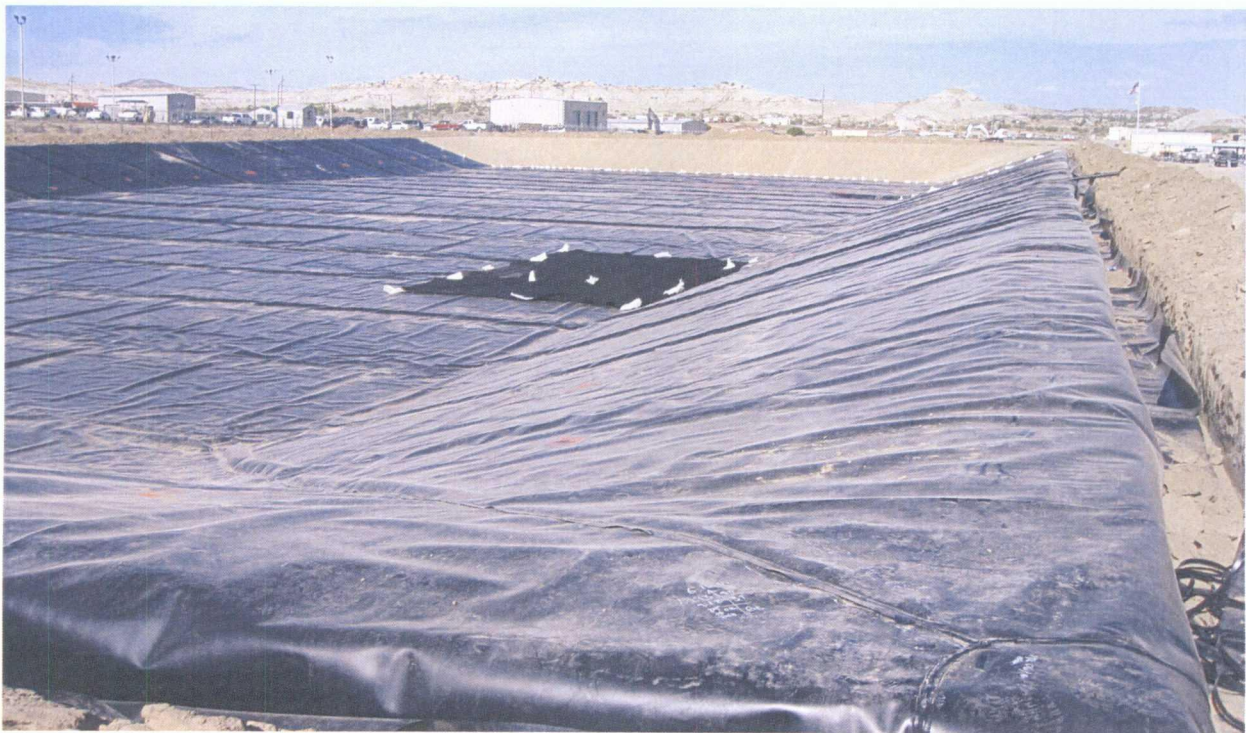
37. 6-16-09 End of day progress, first day of lining activities

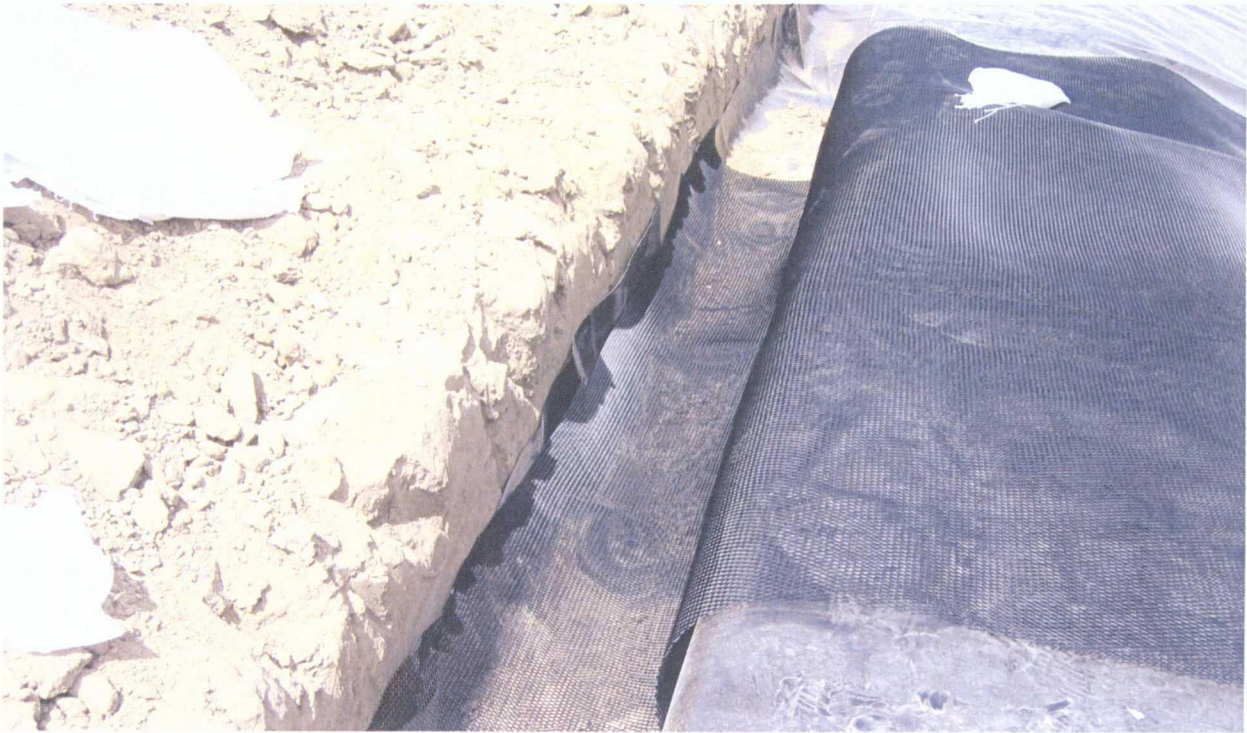
38. 6-17-09 Geonet installation in anchor trench

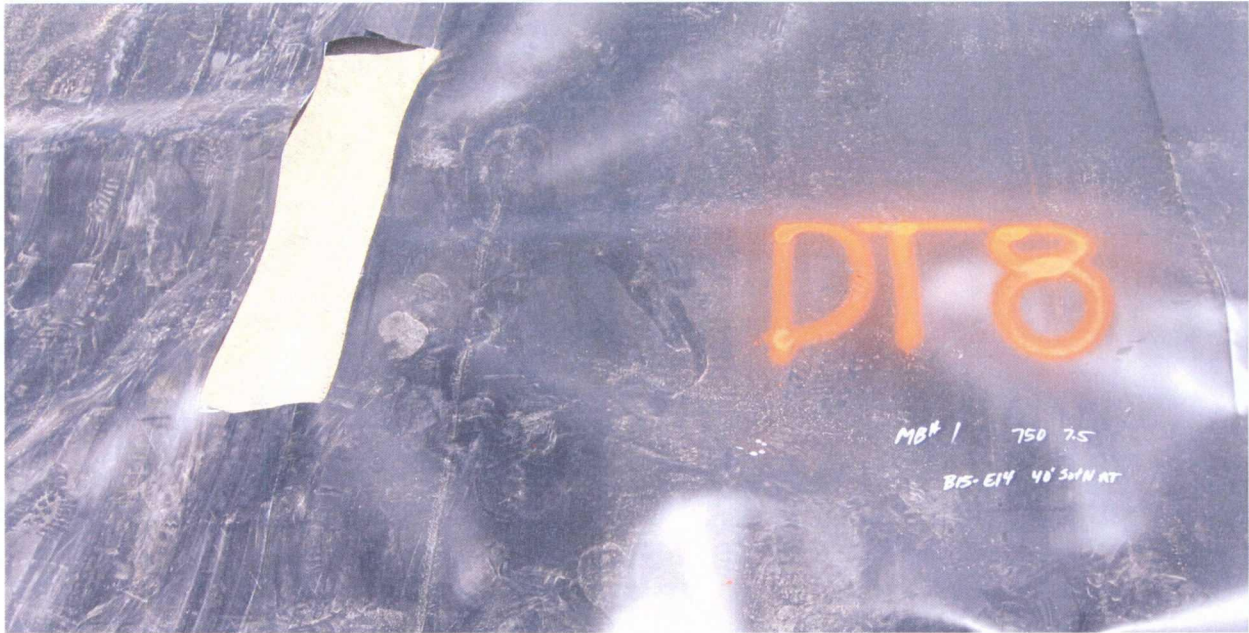
40. 6-17-09 Secondary liner Destructive Test (DT) cut and ready for patching

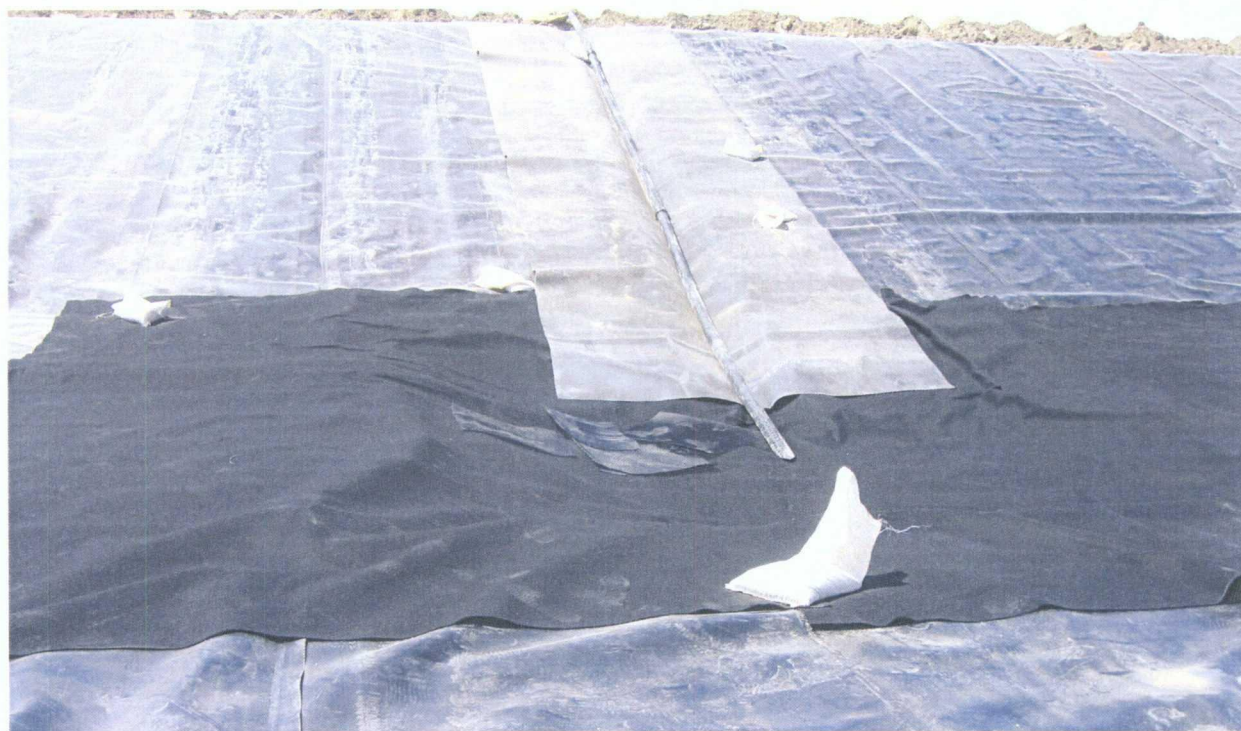
43. 6-17-09 Four geonet panels to be attached to leak detection riser pipe to protect secondary liner, and geotextile for leak detection sump construction.

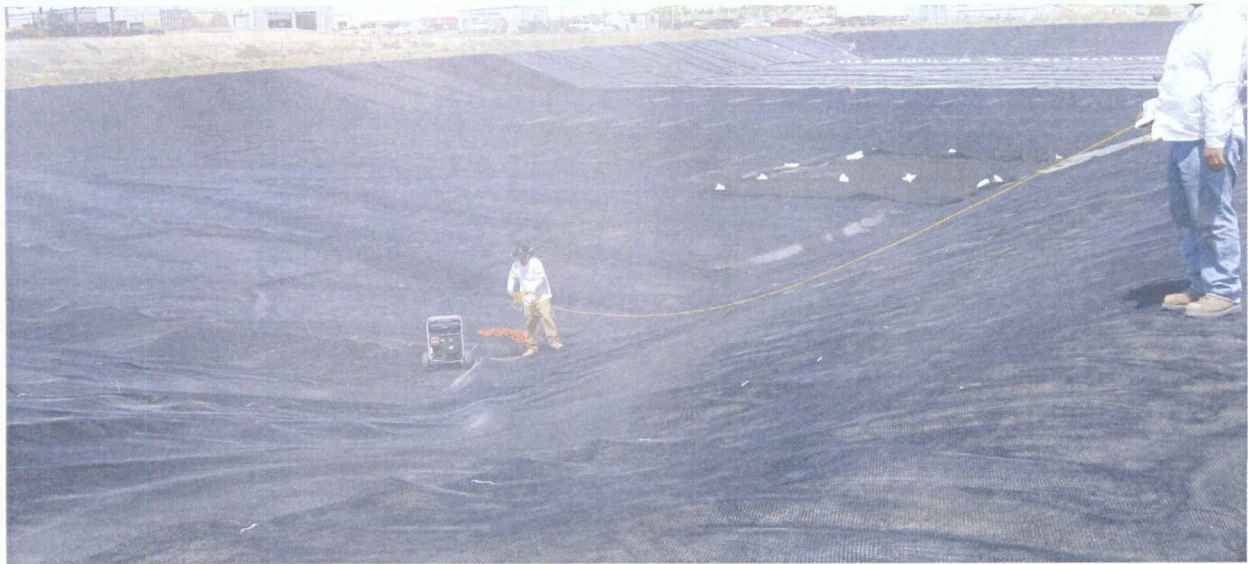
45. 6-17-09 End of day progress – Geonet placement

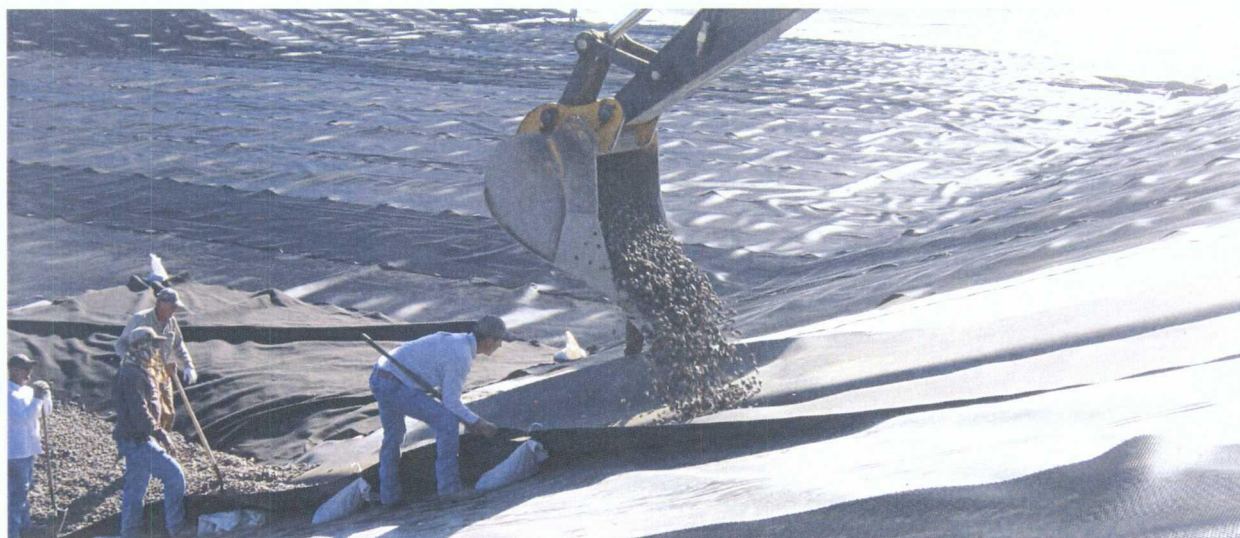
47. 6-18-09 Installation of aggregate for leak detection system, a sacrificial piece of liner used as protection for the secondary liner underneath

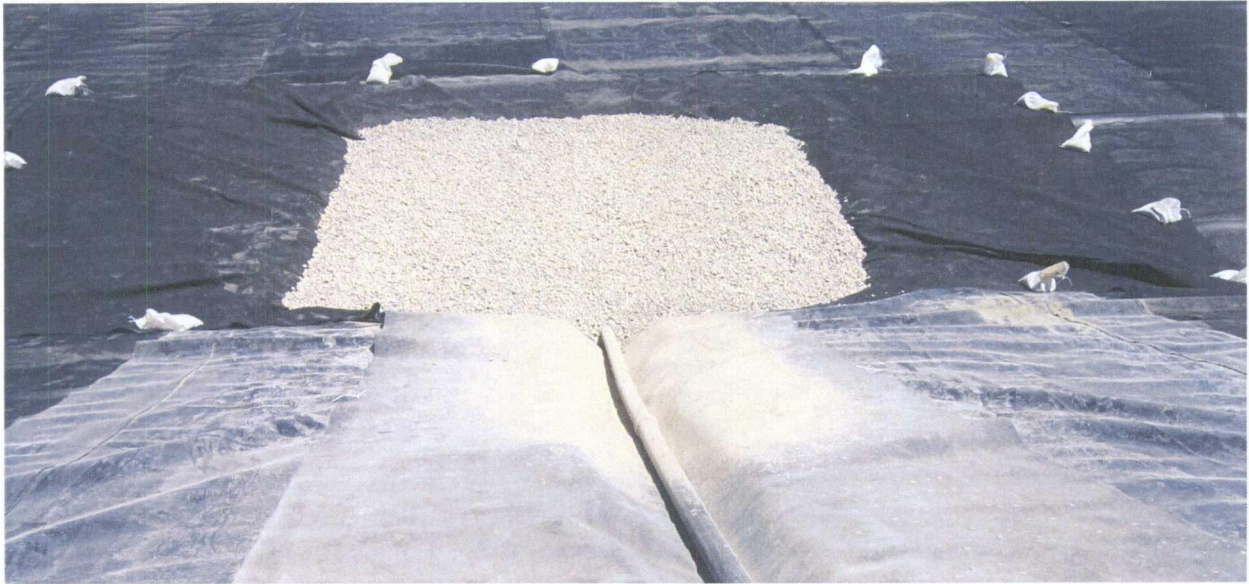
49. 6-18-09 Leak detection sump filled with aggregate

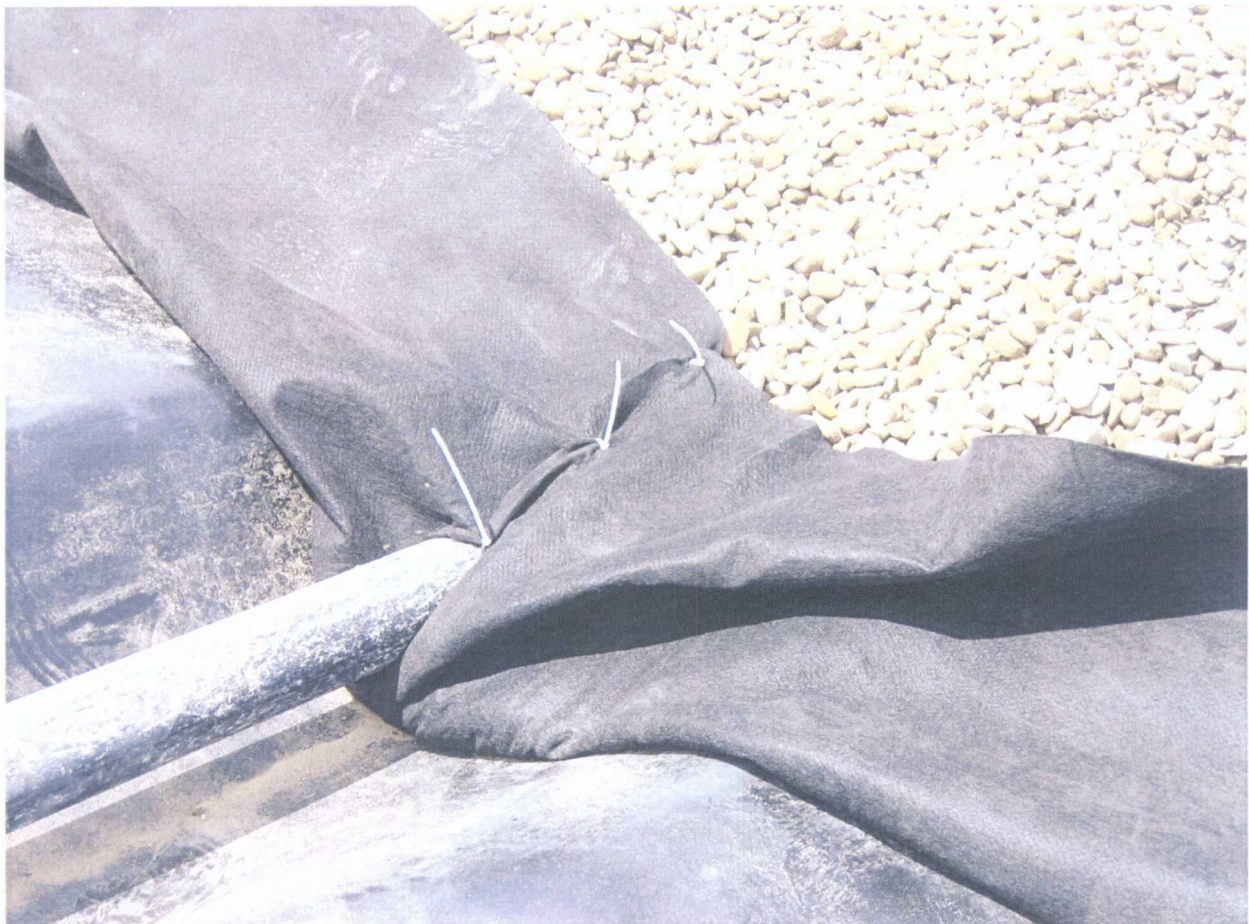
50. 6-18-09 Use of zip ties to anchor geotextile around leak detection riser pipe

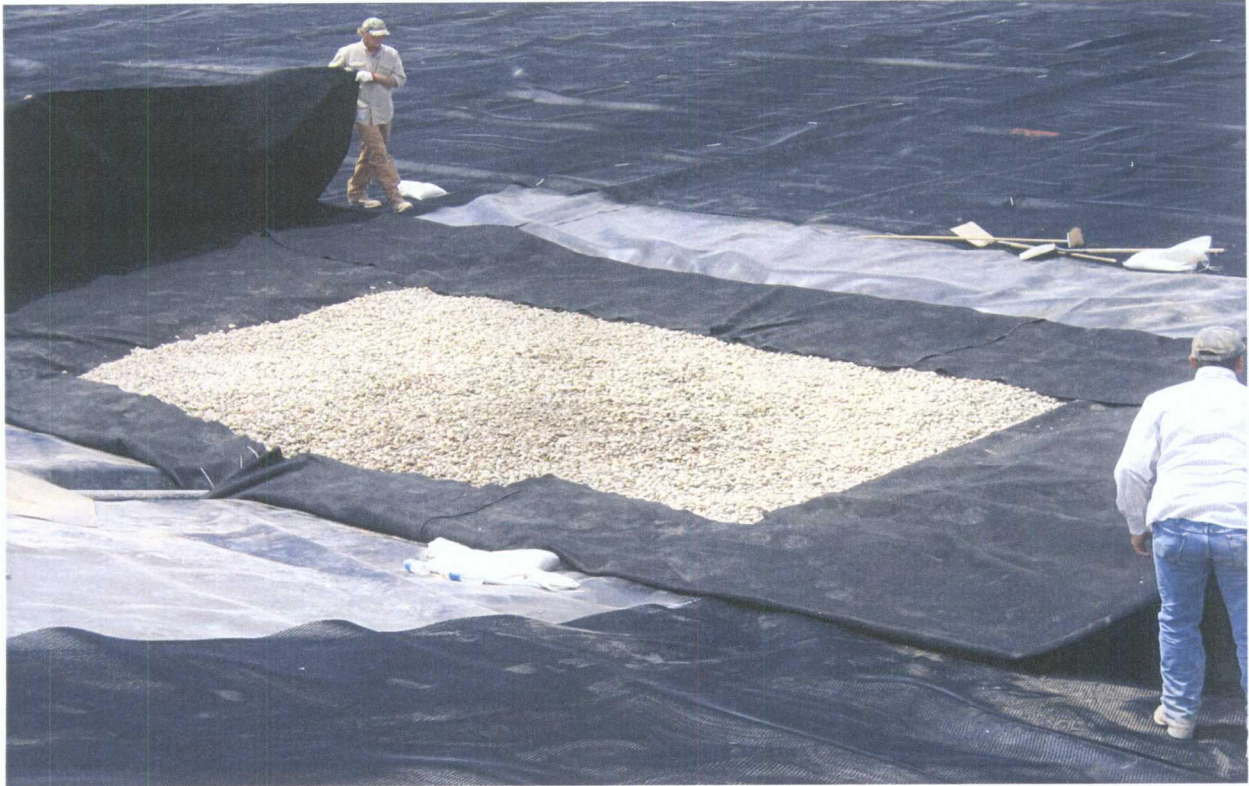
51. 6-18-09 Folding over of geotextile to “burrito” the leak detection sump

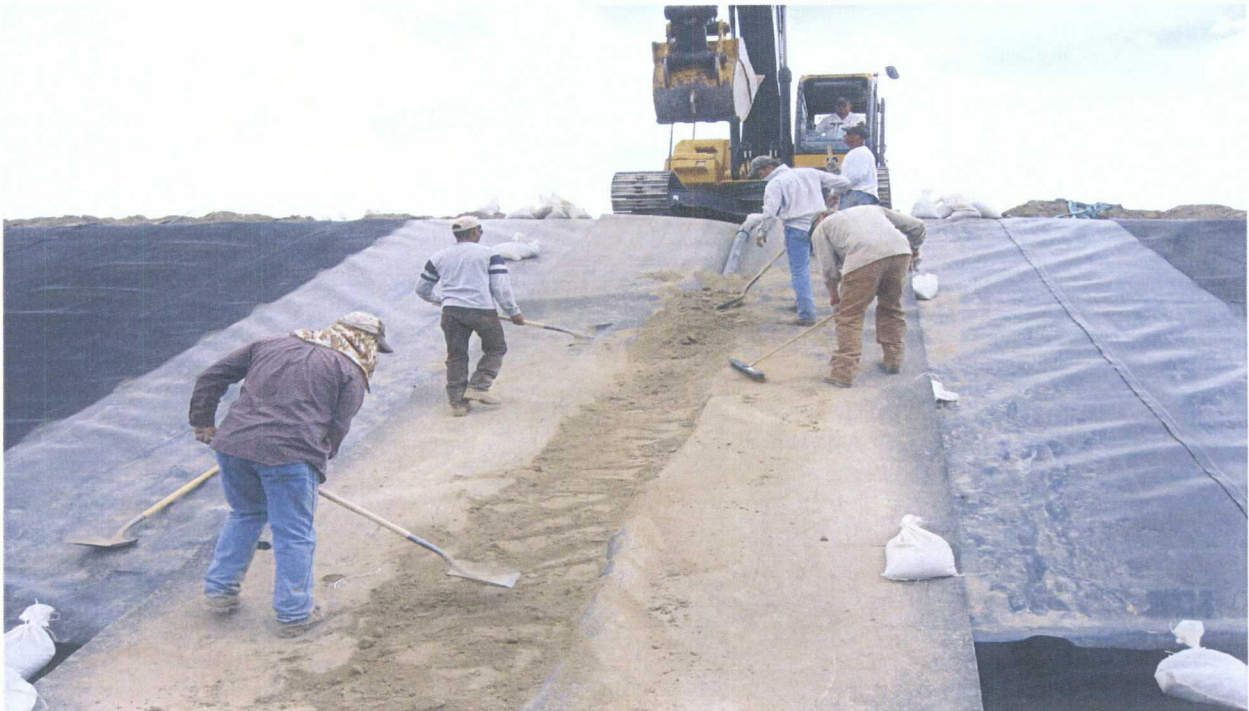
52. 6-18-09 Installation of protective soil around leak detection riser pipe

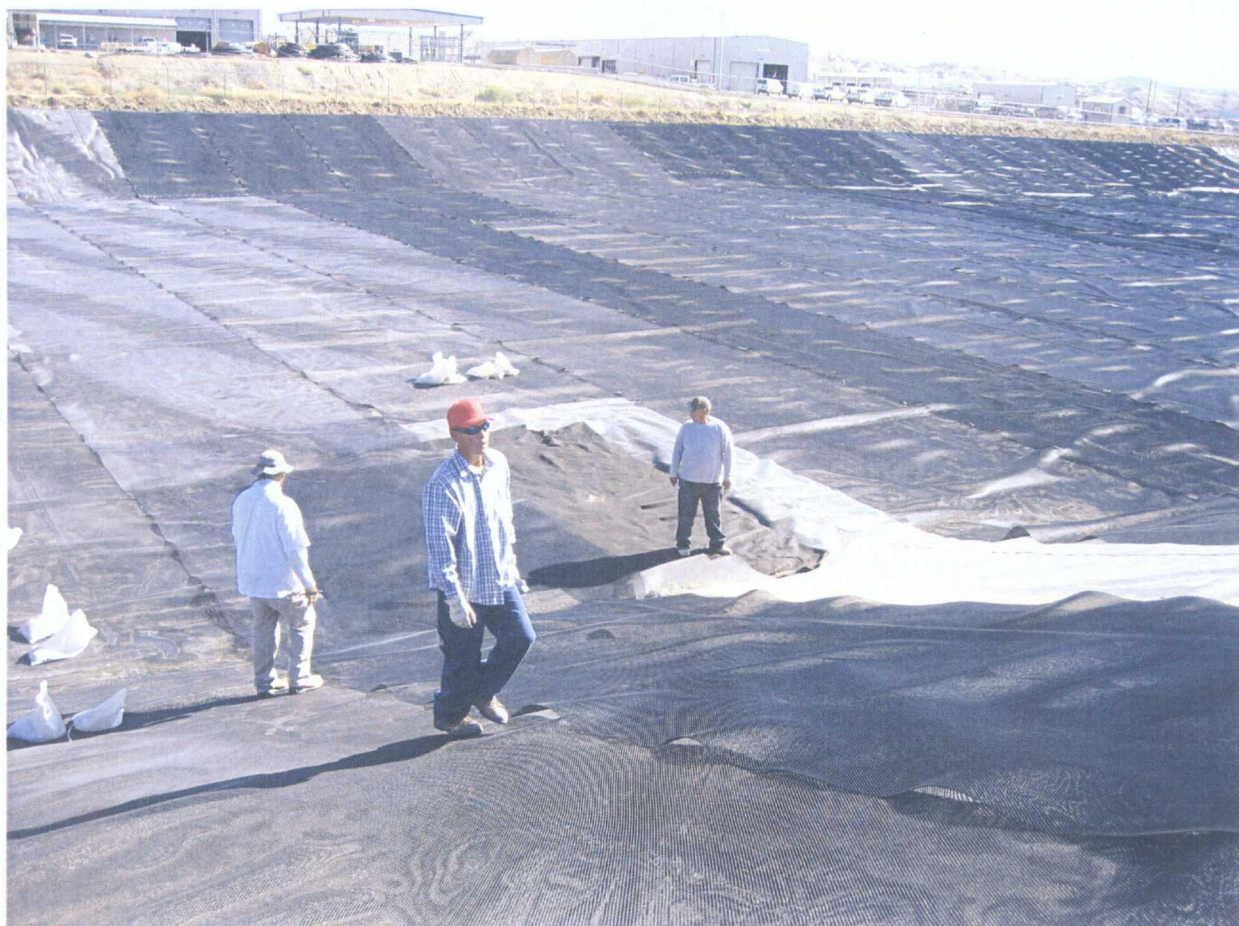
54. 6-22-09 Installation of geonet over leak detection sumps and riser pipes

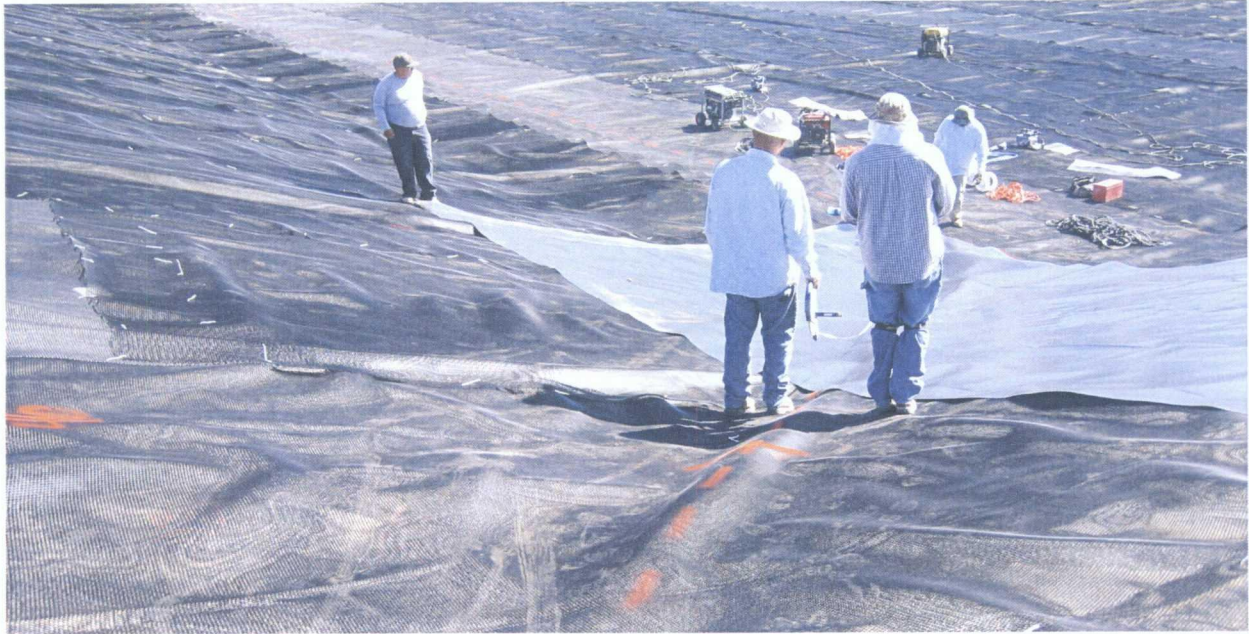
55. 6-22-09 Installation of primary liner

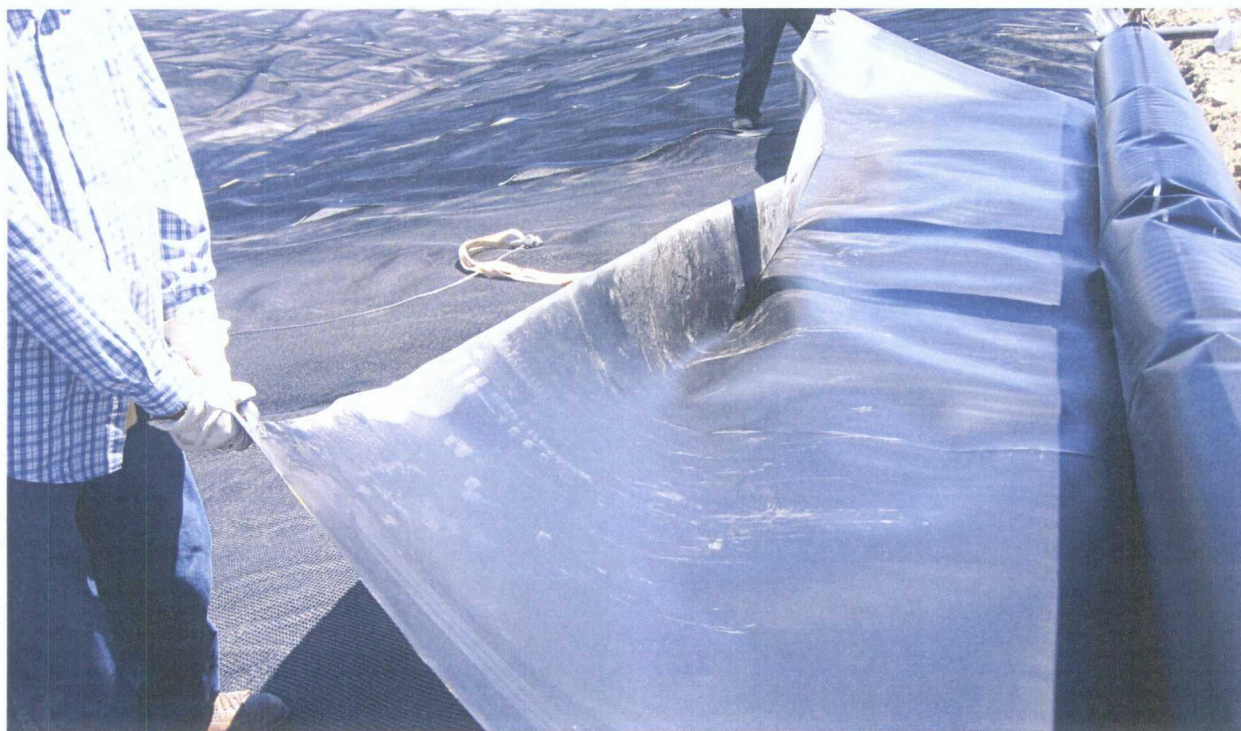
58. 6-22-09 Use of clamp and cable set up to pull primary liner across pond

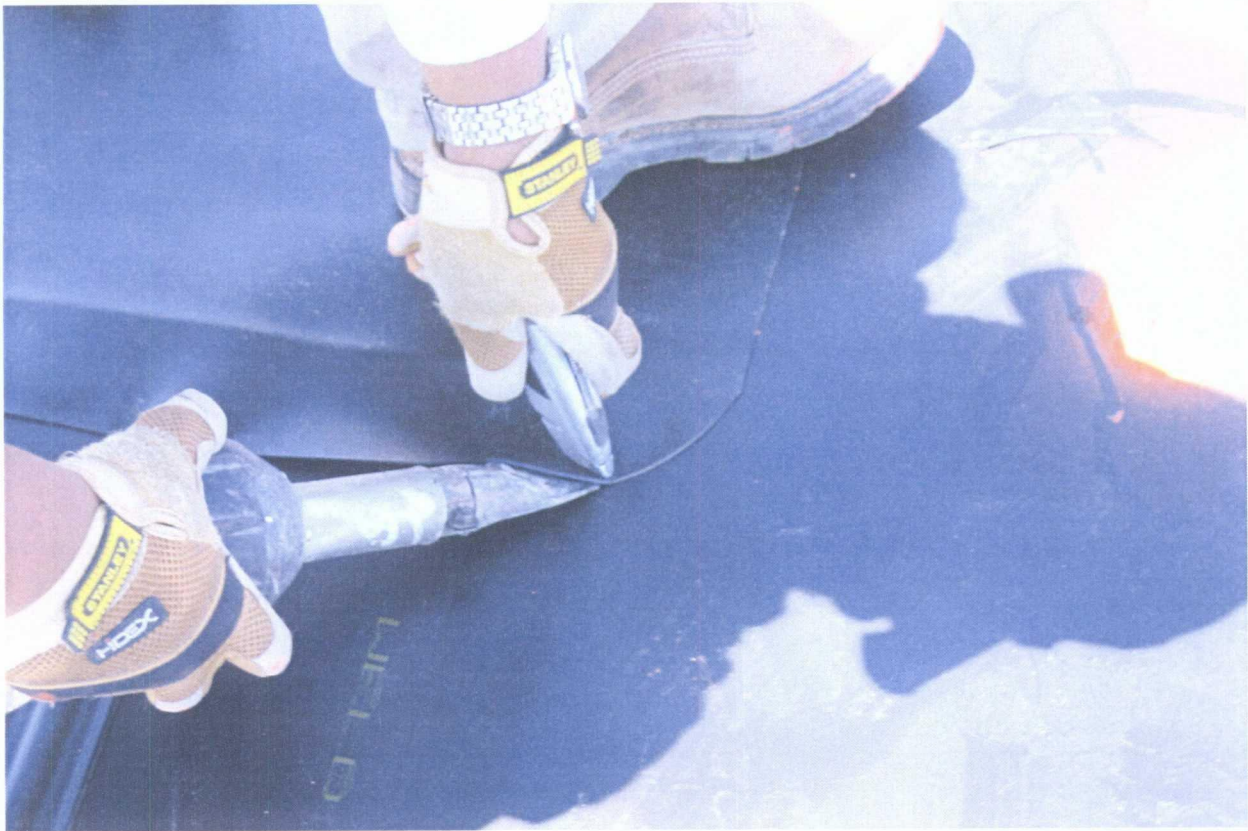
59. 6-22-09 Using Lyster to heat tack a patch prior to extrusion welding

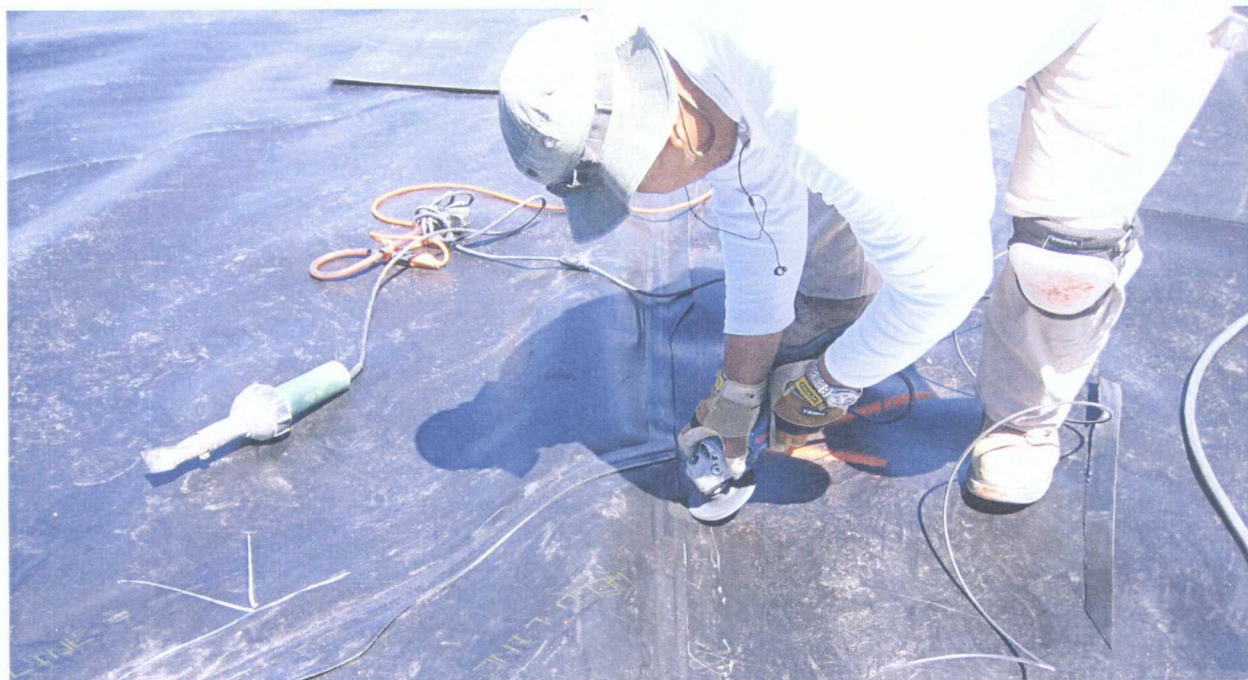
60. 6-22-09 Grinding a seam prior to extrusion welding

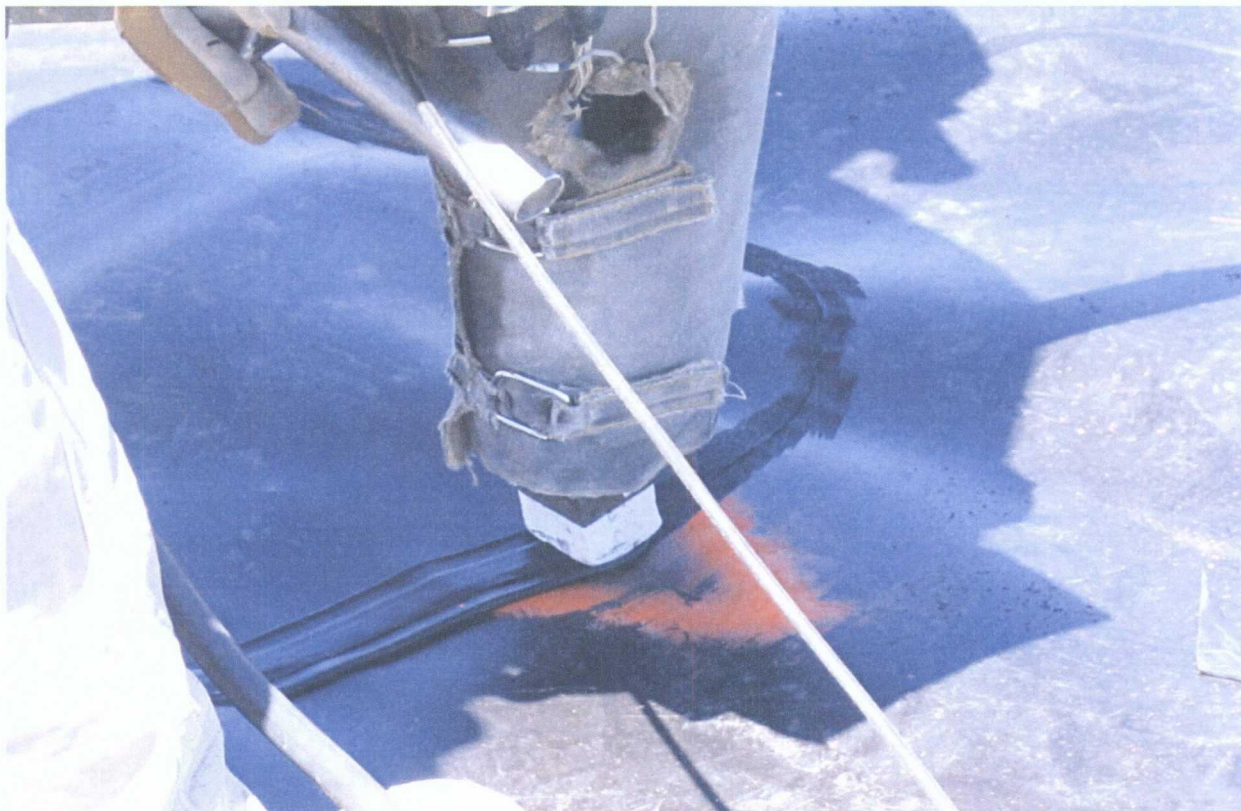
61. 6-22-09 Extrusion welding

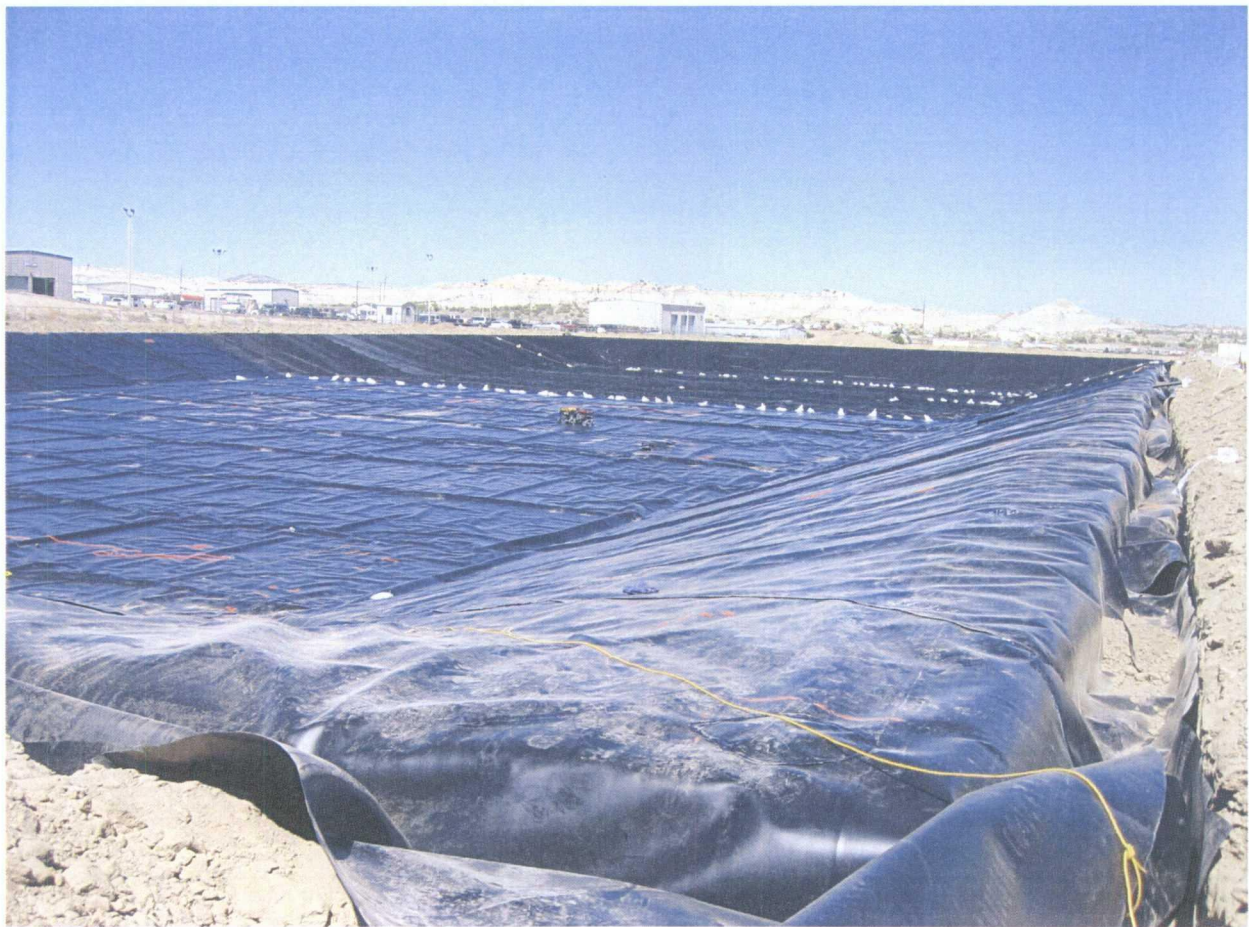
64. 6-22-09 End of day progress – Primary liner placement

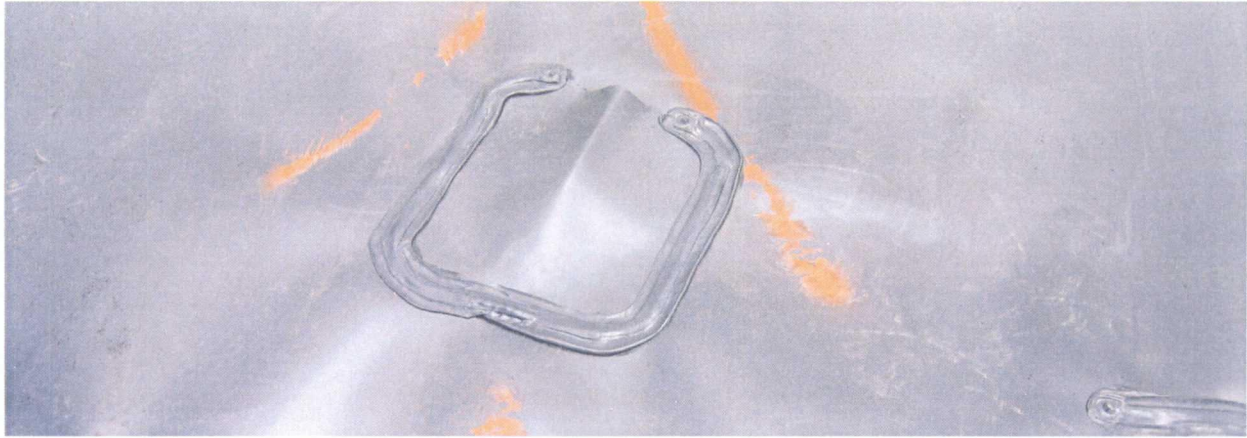
65. 6-23-09 Installed vent

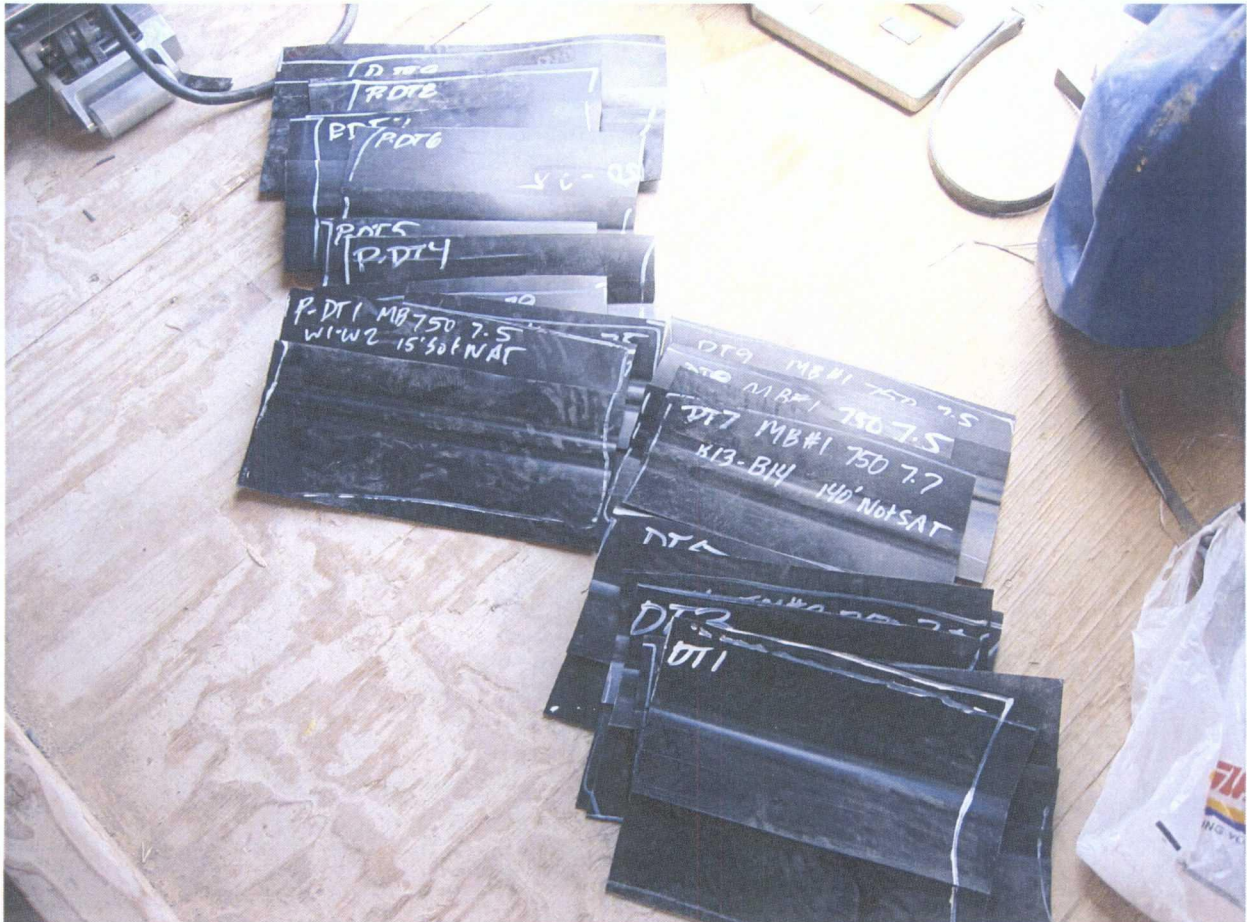
66. 6-23-09 Owners DT samples, both secondary (noted as DT) and primary (noted as PDT) HDPE liners

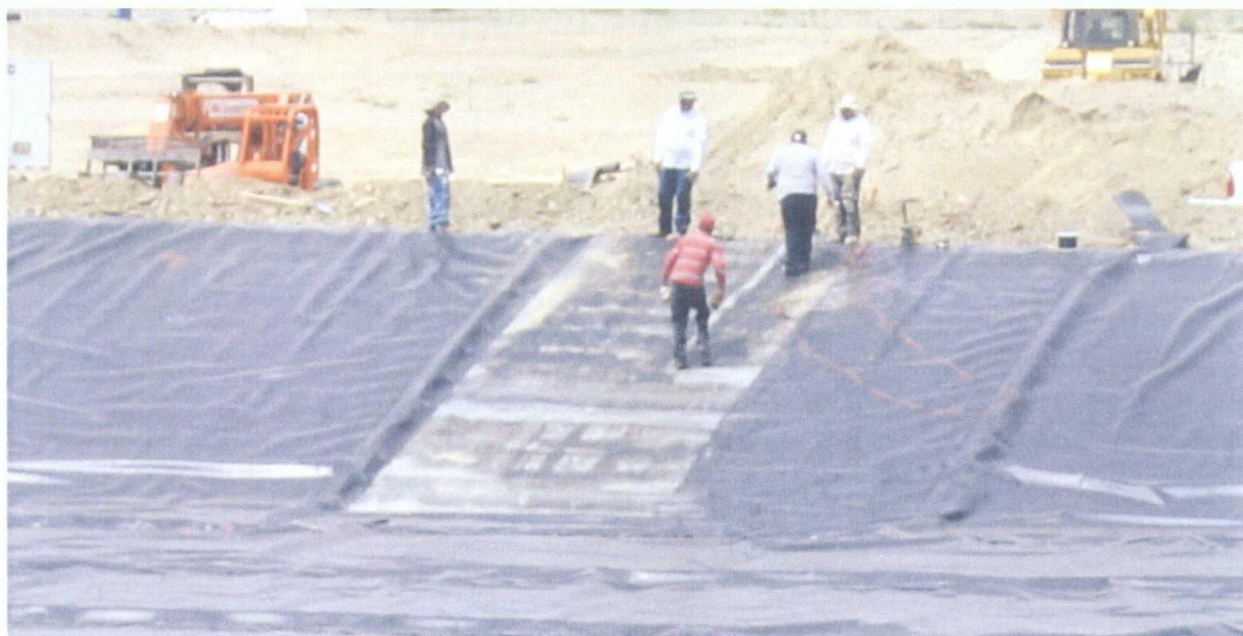
67. 6-23-09 Installation of textured liner on top of the primary liner on west slope for pond ingress and egress

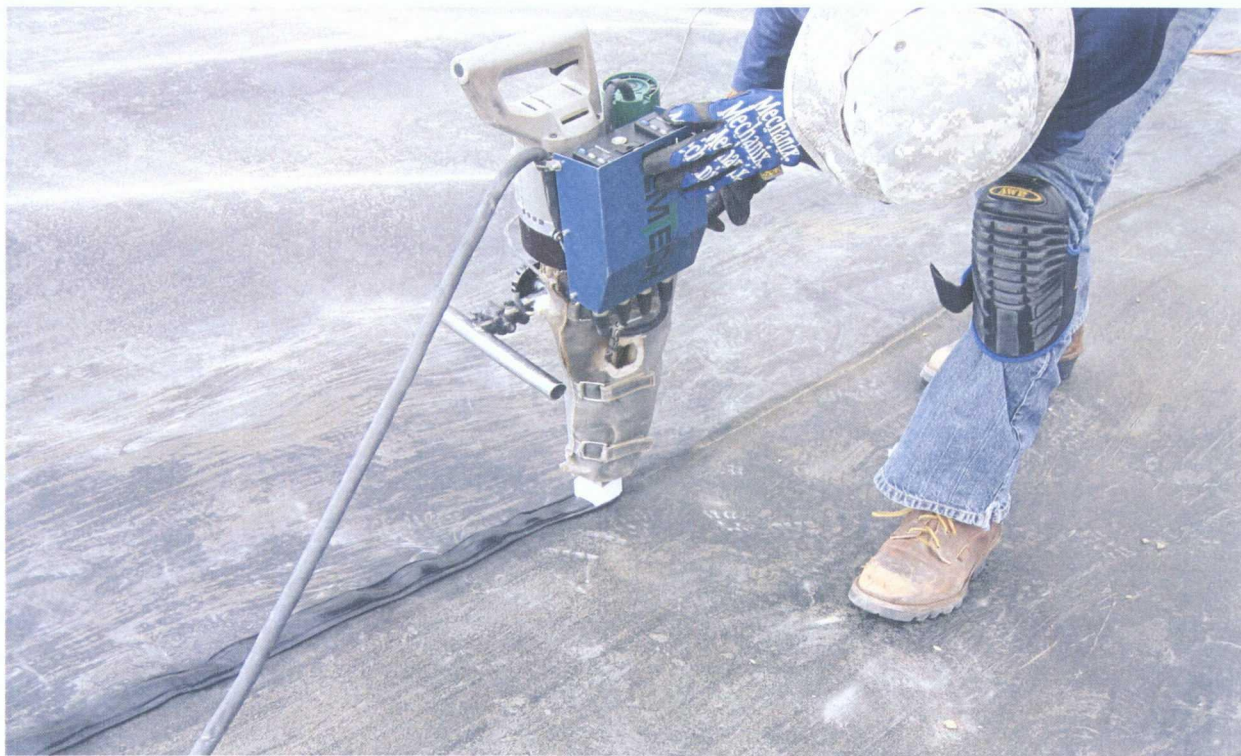
68. 6-23-09 Extrusion welding of textured liner to primary liner

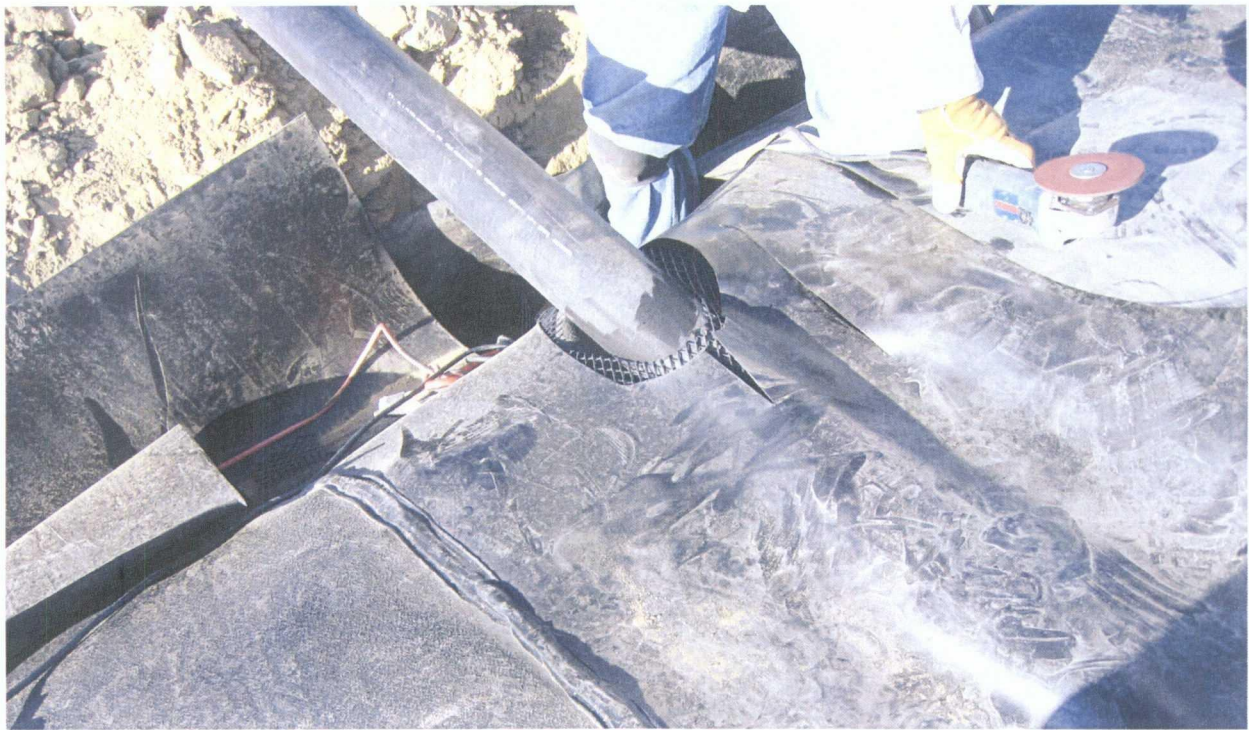
70. 6-24-09 Leak detection riser pipe extending outward from primary liner

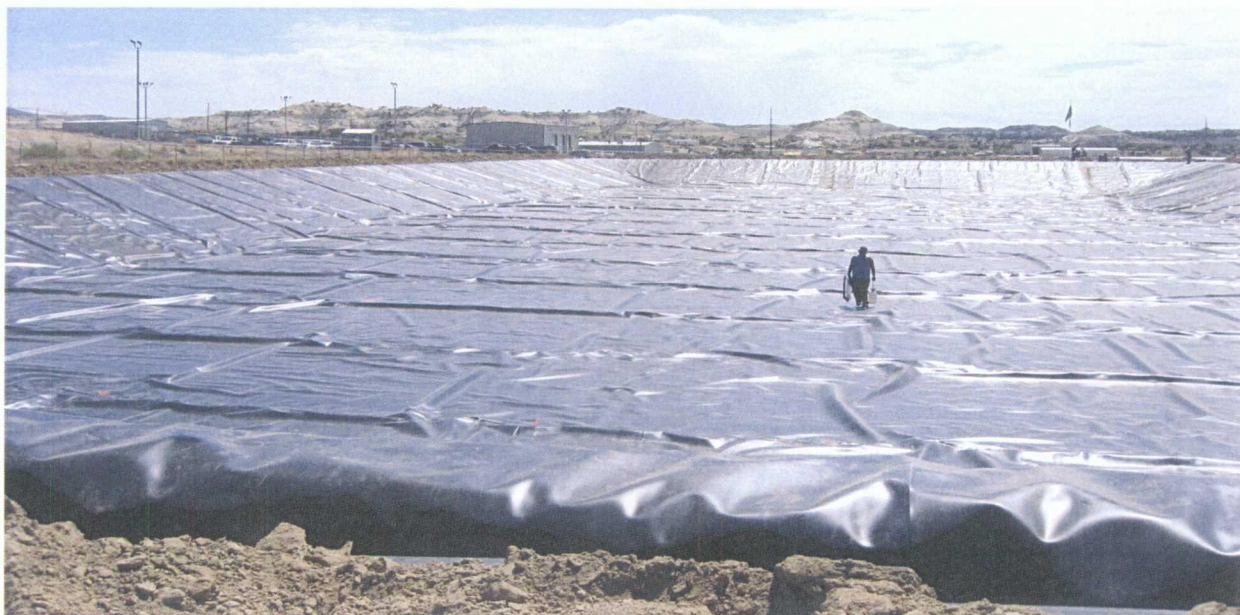
72. 6-24-09 Lining activities completed
