**CQA / CQC
REPORT**

**ENGINEERING CERTIFICATION REPORT
FOR
EVAPORATION POND 3 CONSTRUCTION**

**BASIN DISPOSAL, INC.
BLOOMFIELD, NEW MEXICO**

**Re: Basin Disposal Inc: [OCD Permit No. 1-0005]
Engineering Certification Report: Evaporation Pond 3 Construction [520.01.01]**

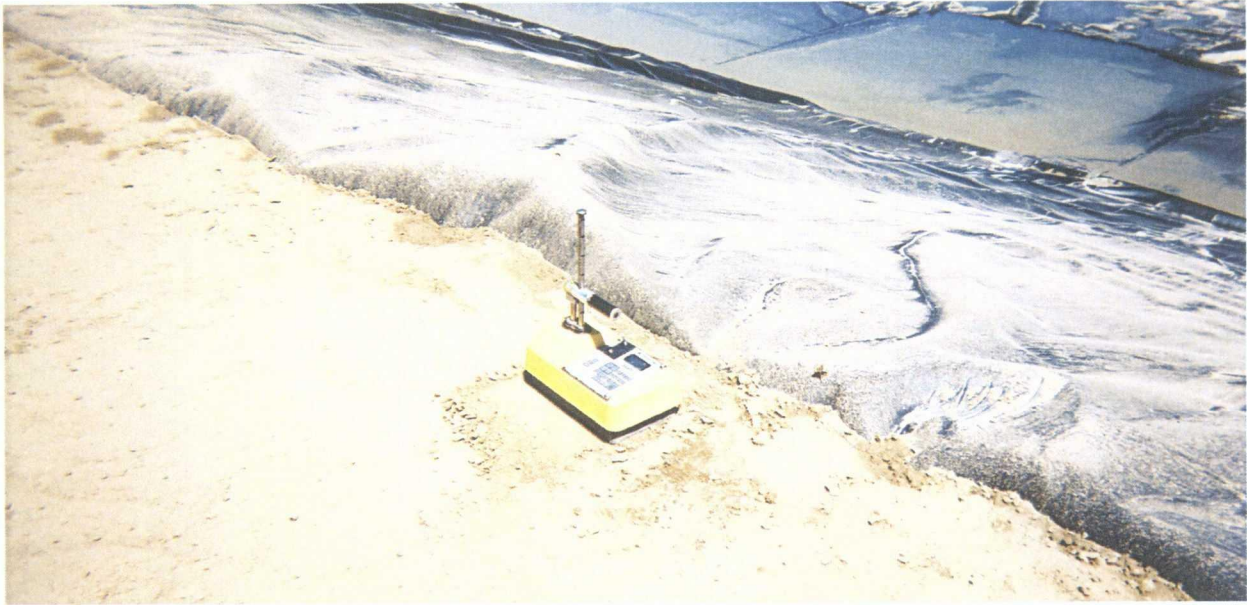
73. 6-29-09 Density testing of anchor trenches

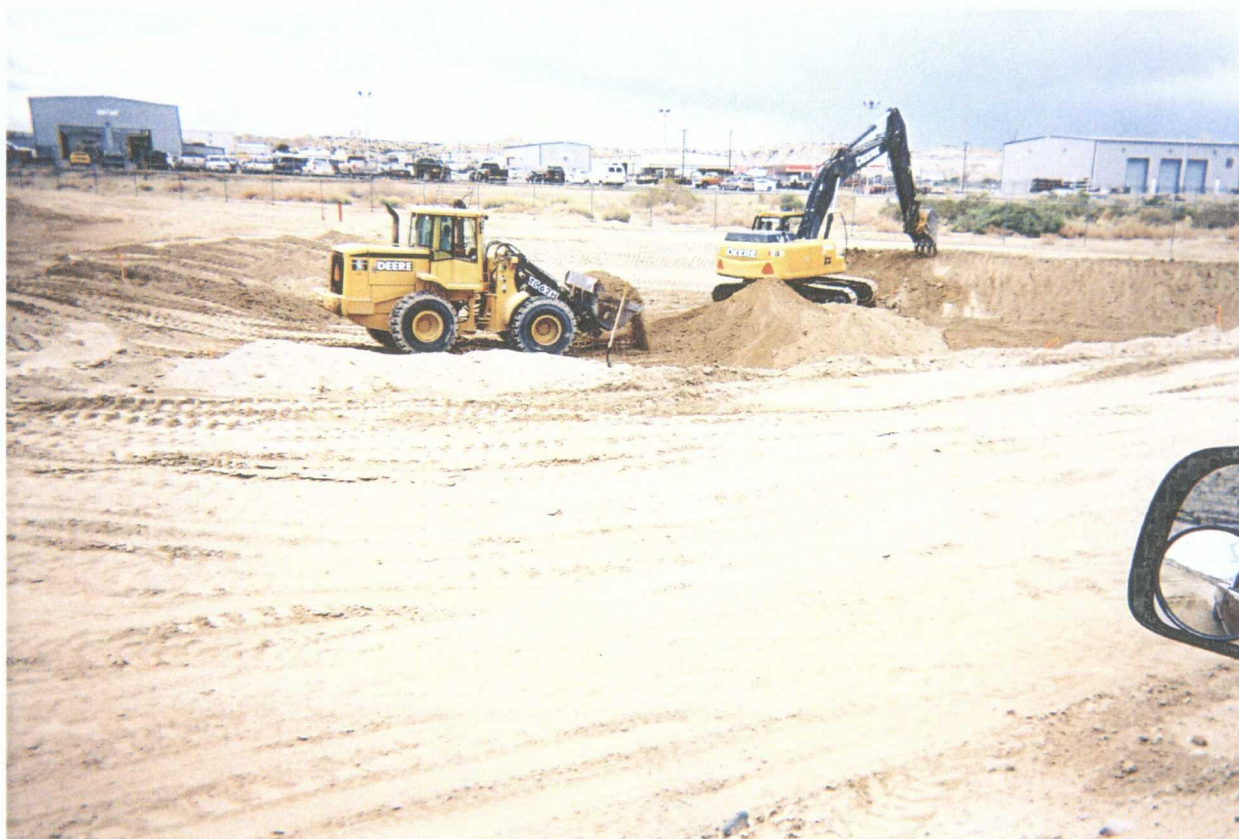
75. 6-29-09 Excavation for east stormwater detention pond

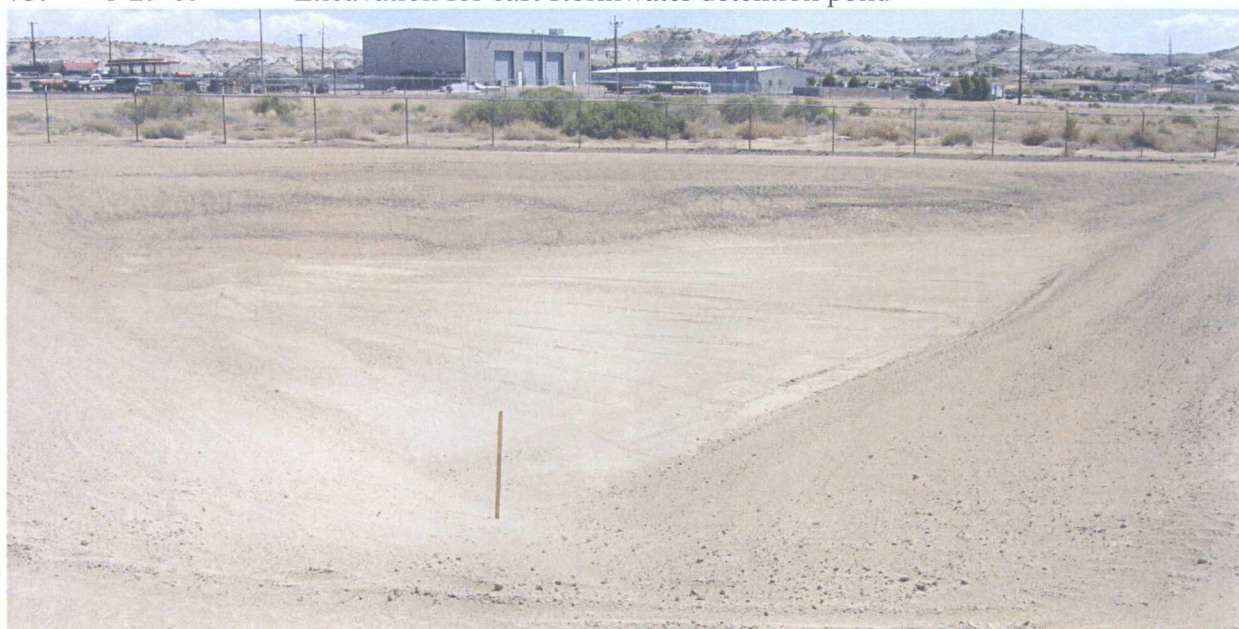
76. 7.28-09 Completed Stormwater Detention Pond
