Evaporation Pond
Repairs
(2 of 2)

REVISED SUMMARY REPORT EVAPORATION POND REPAIRS

Gallup Refinery

Revision 1 Date: February 15, 2017

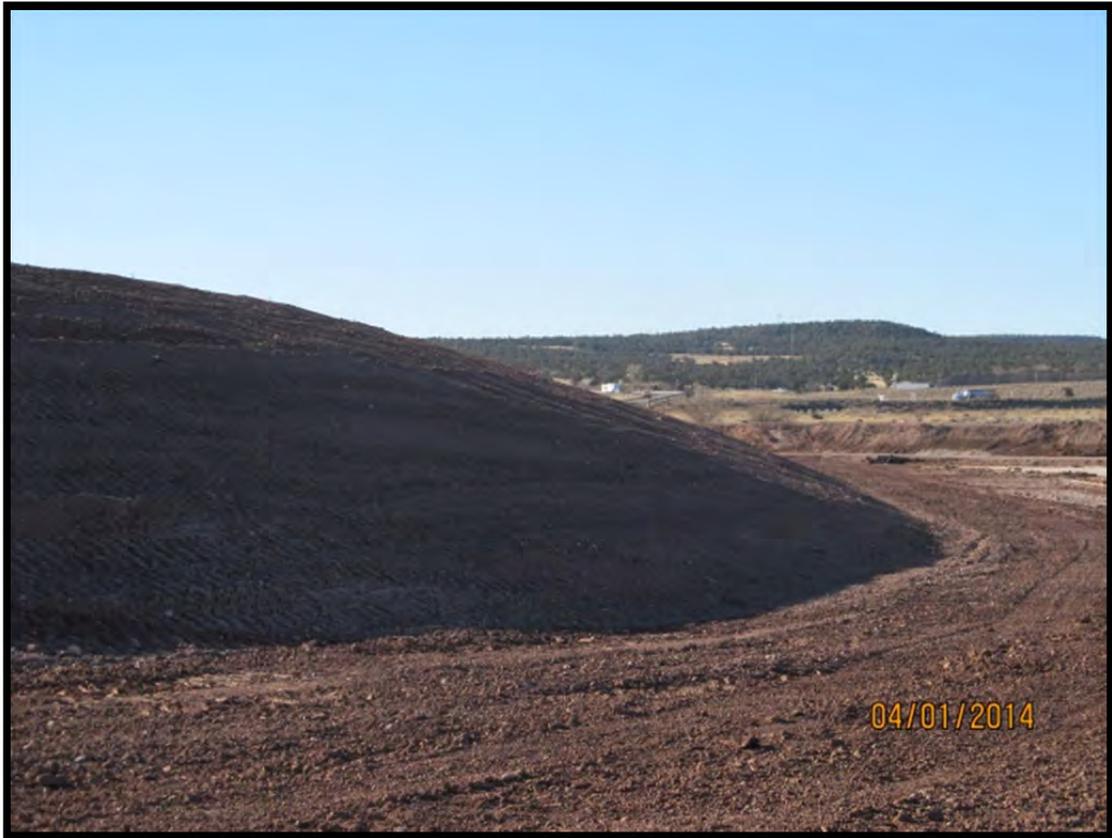
Photo #1: Pond 6 Northwest Corner After Fill Placement - Looking South

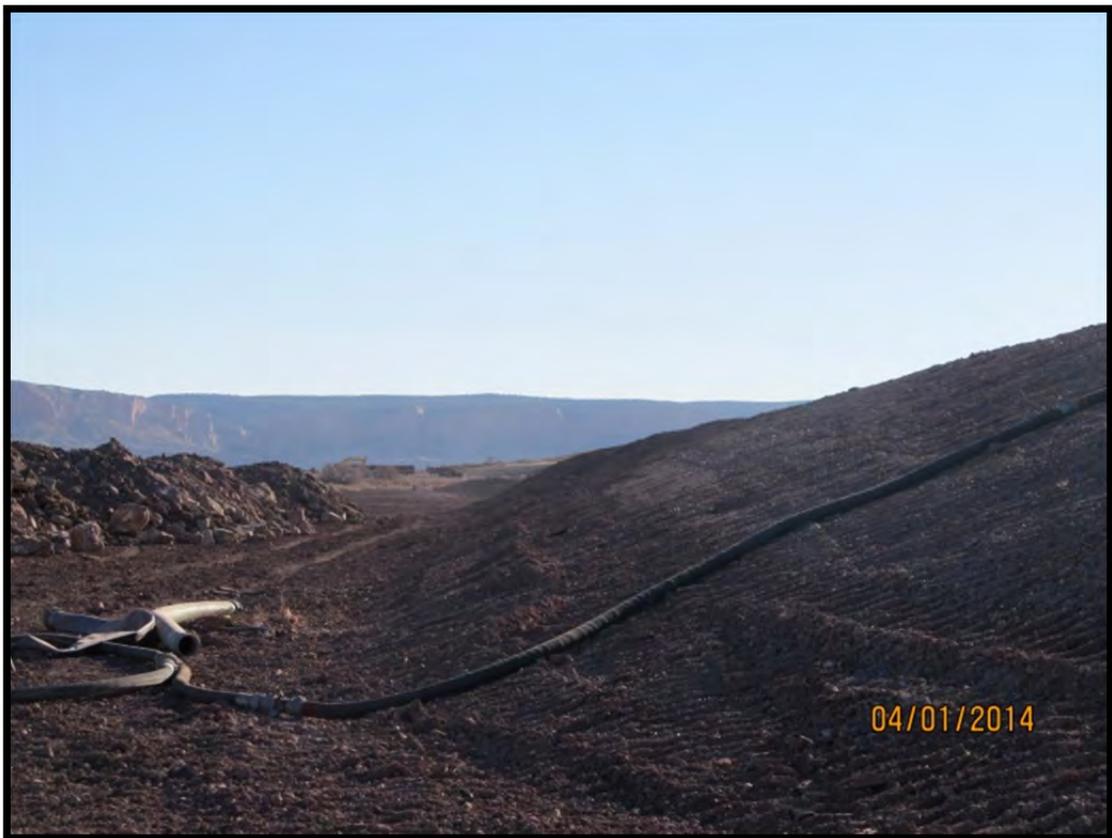
Photo #2: Pond 6 Northwest Corner After Fill Placement - Looking North

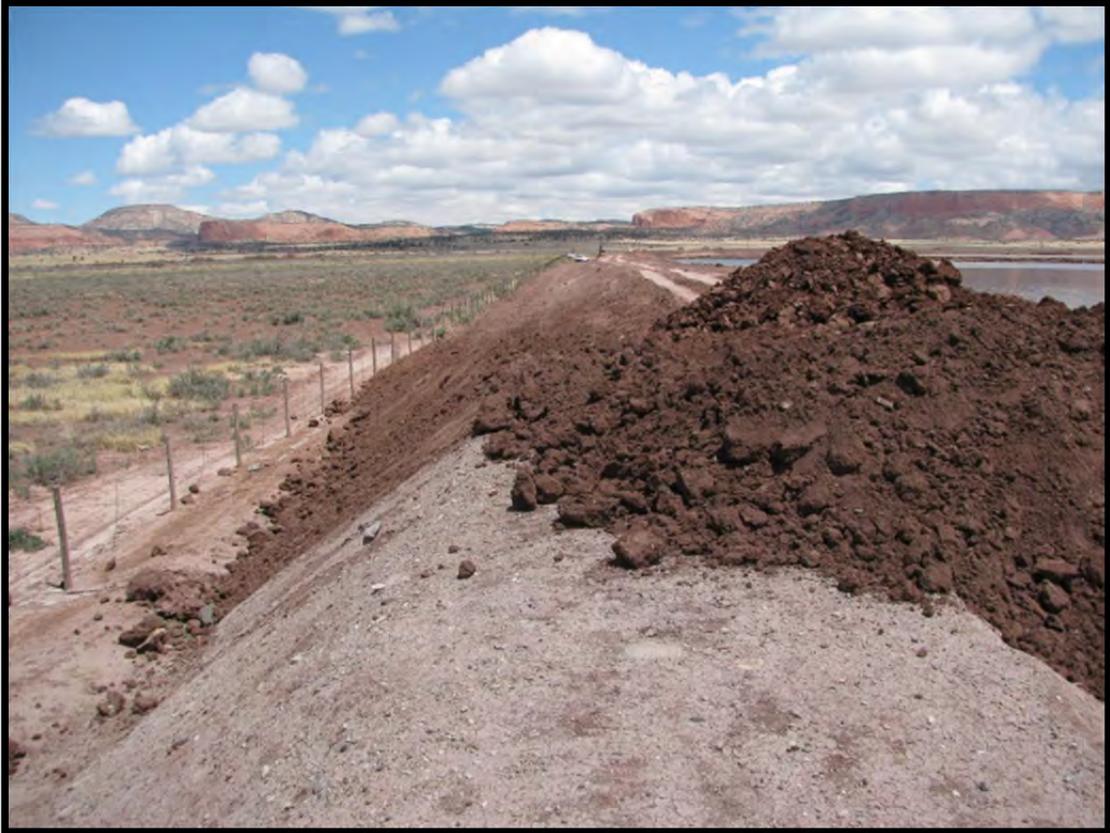
Photo #3: Pond 7/8 West Berm Under Construction - Looking North
(Note how the new crest alignment is shifted to the east)

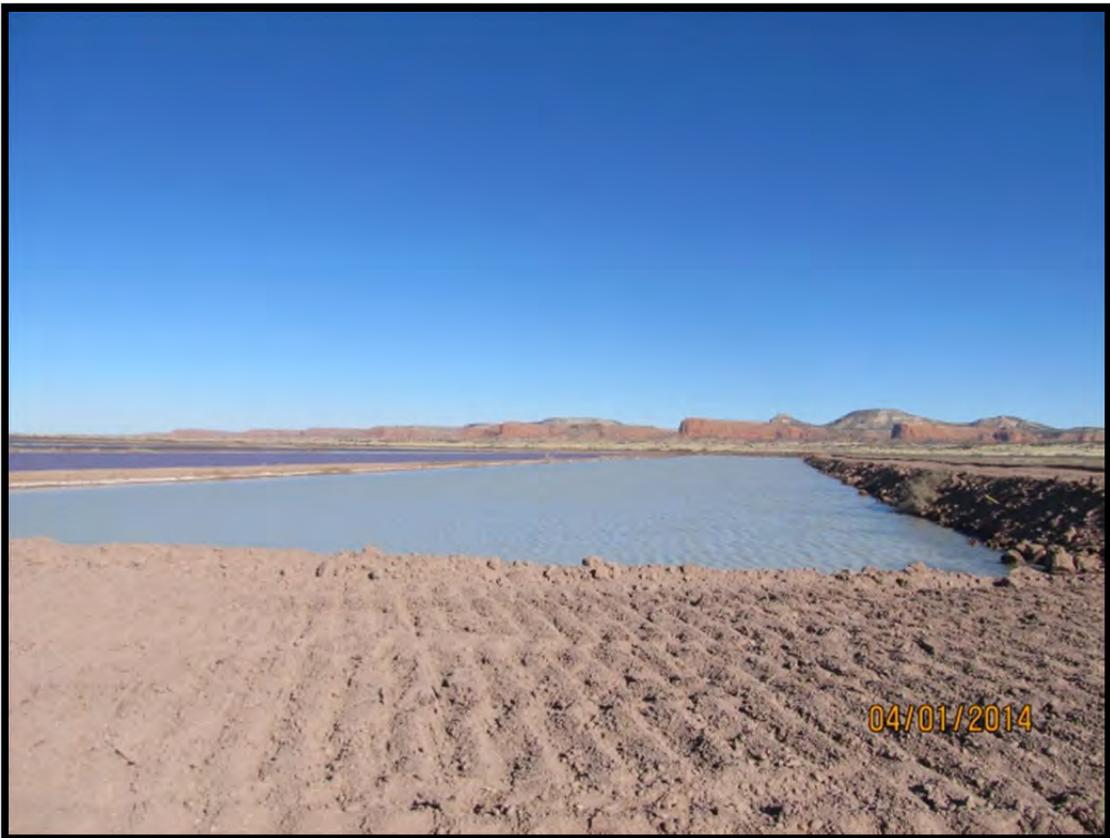
Photo #4: Pond 11 South Berm Construction Complete - Looking North

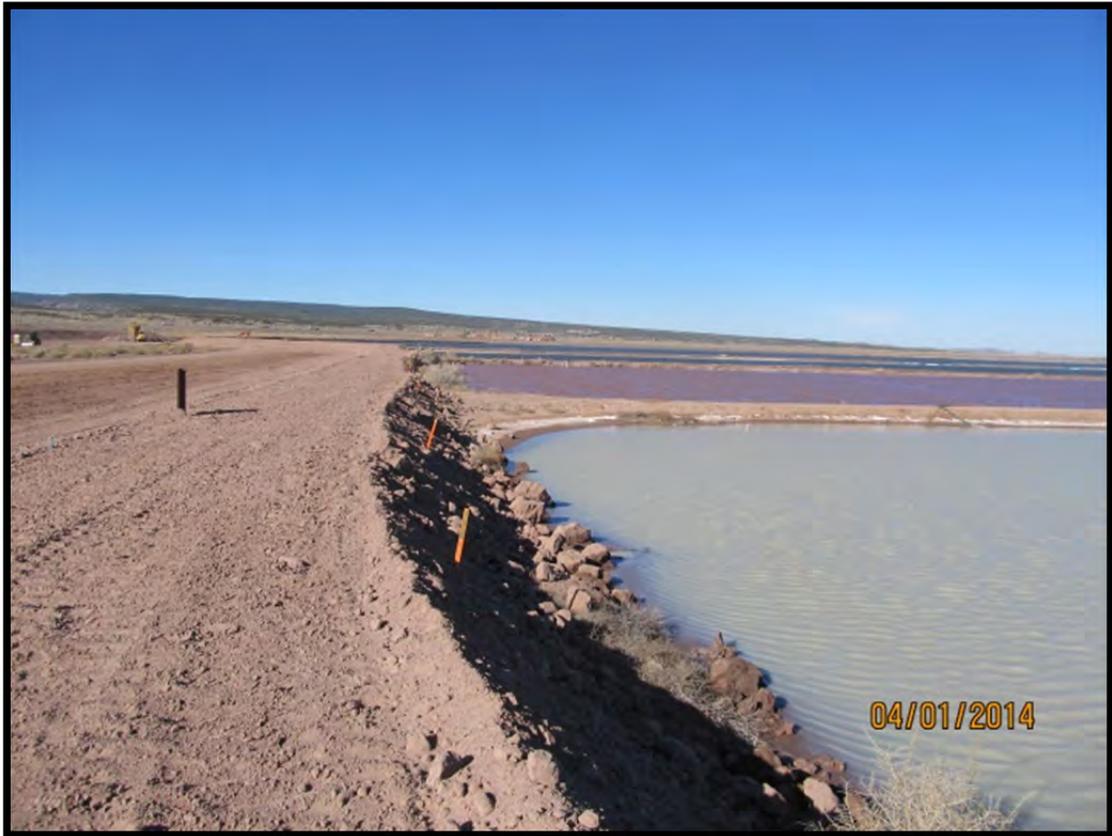
Photo #5: Pond 12A South Berm Construction Complete - Looking West

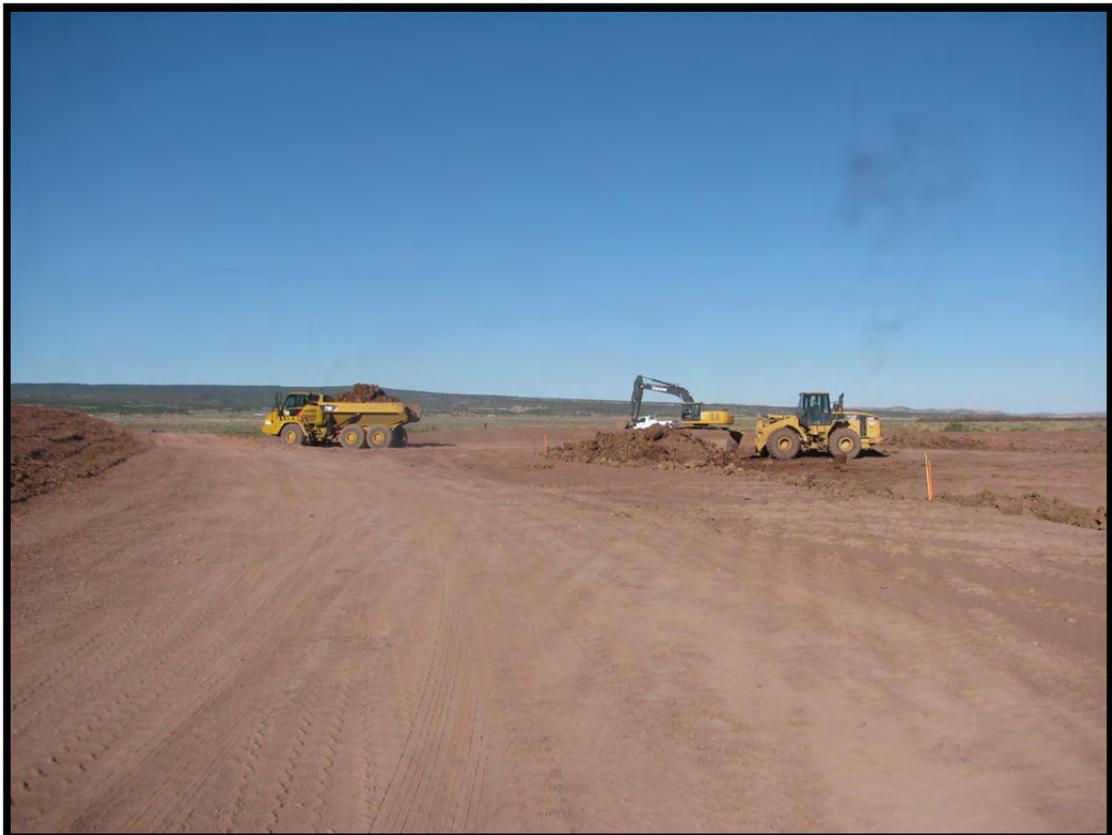
Photo #6: Borrow area north of Pond 11 – Looking West

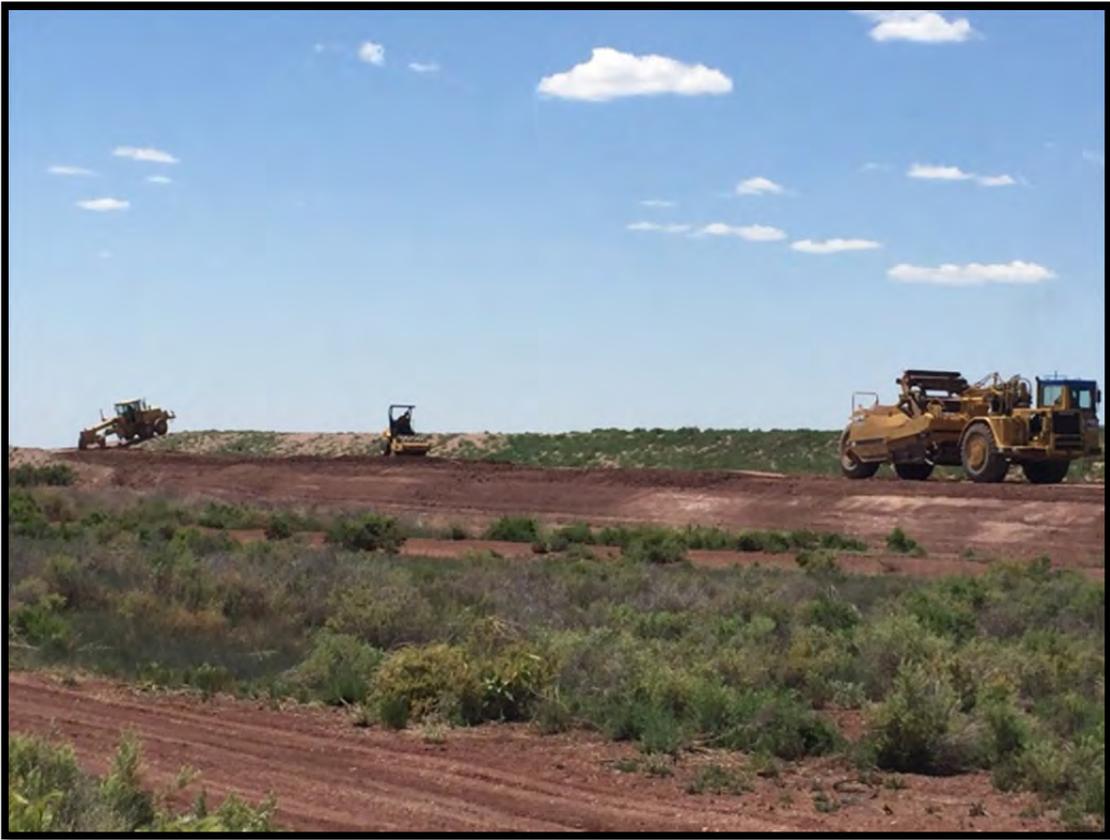
Photo #7: Pond 5 North Berm Under Construction, Nearly Complete - Looking East

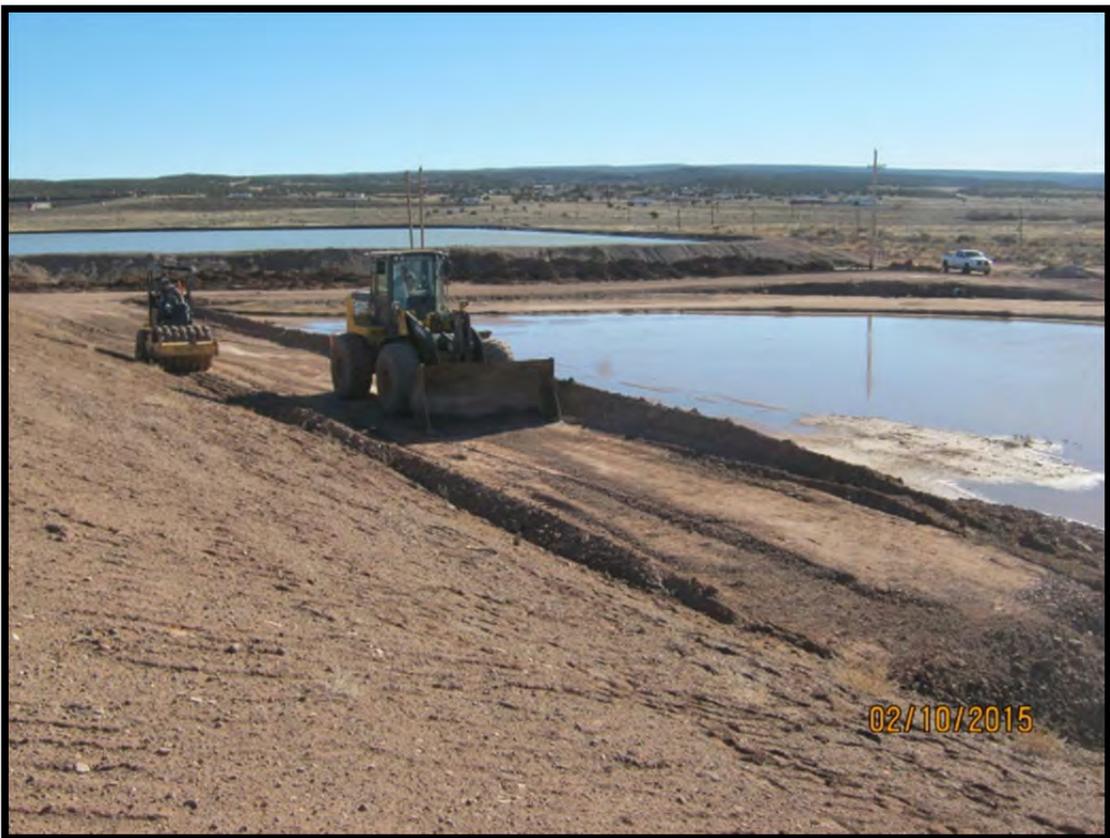
Photo #8: Pond 6 West Berm Under Construction - Looking South

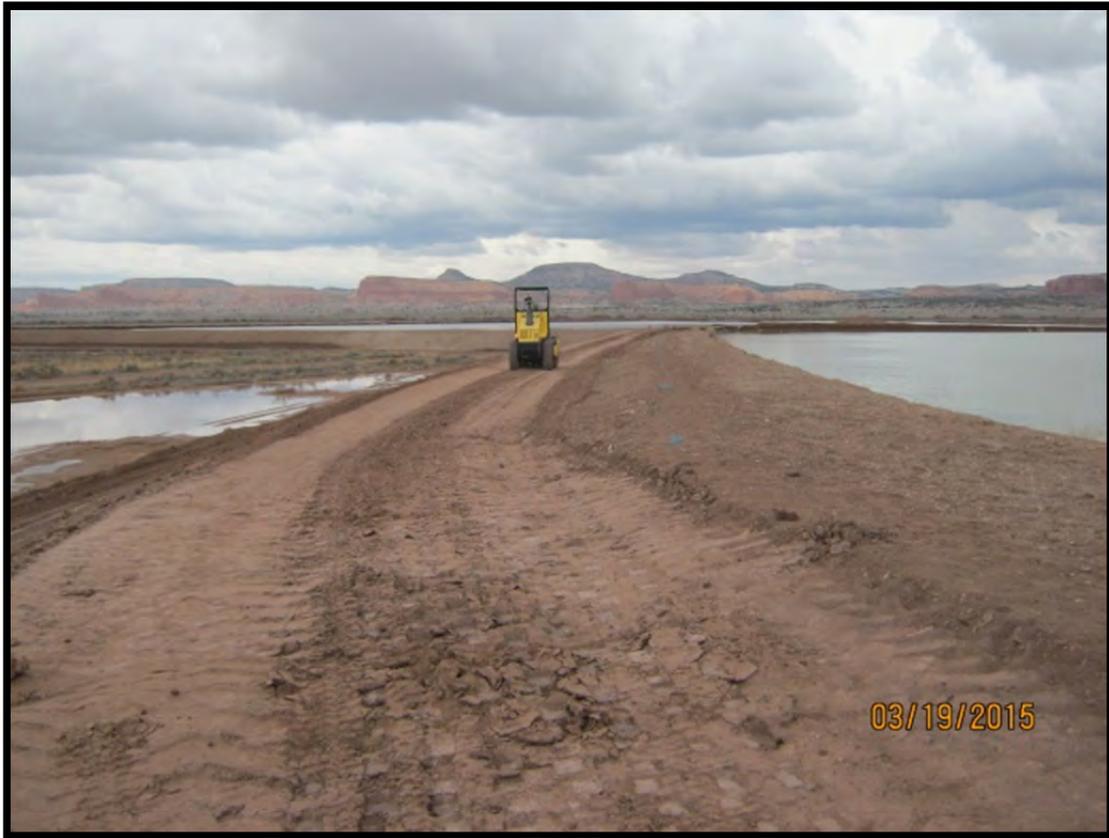
Photo #9: Pond 6 West Berm Under Construction, Nearly Complete - Looking North

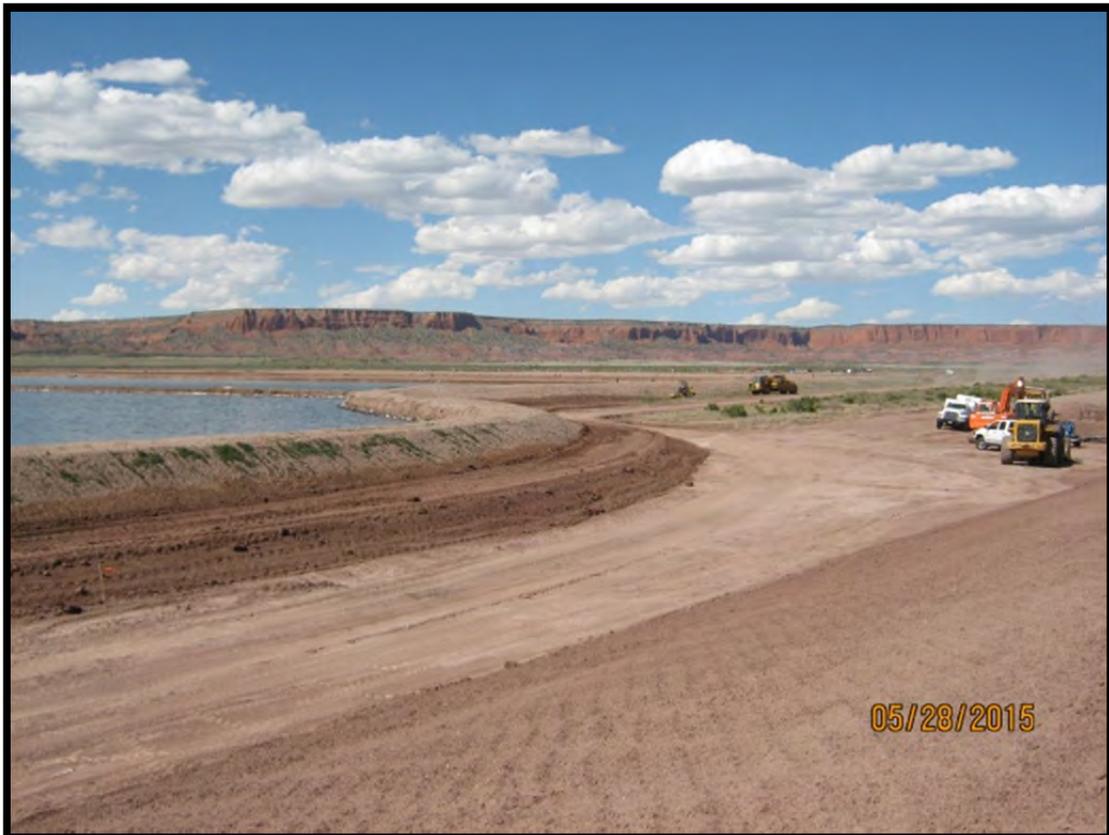
Photo #10: Pond 7/8 and Pond 11 South Berms Under Construction - Looking Northeast

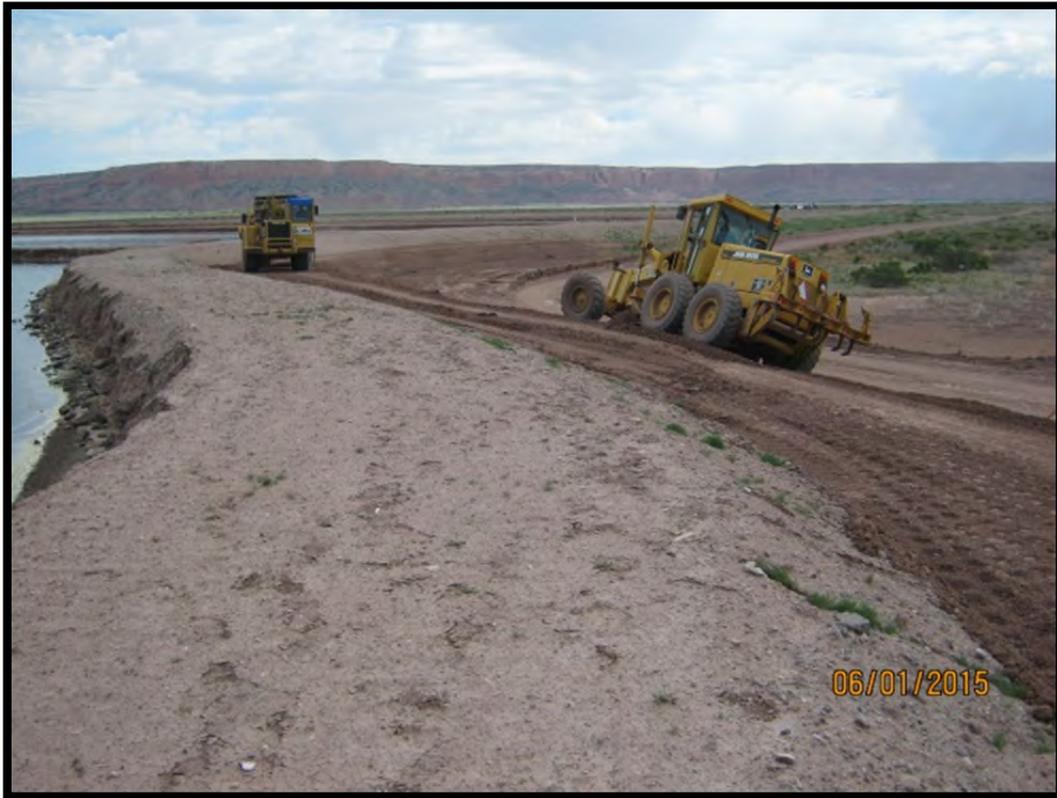
Photo #11: Pond 7/8 and Pond 11 South Berms Under Construction, Nearly Complete - Looking Northeast

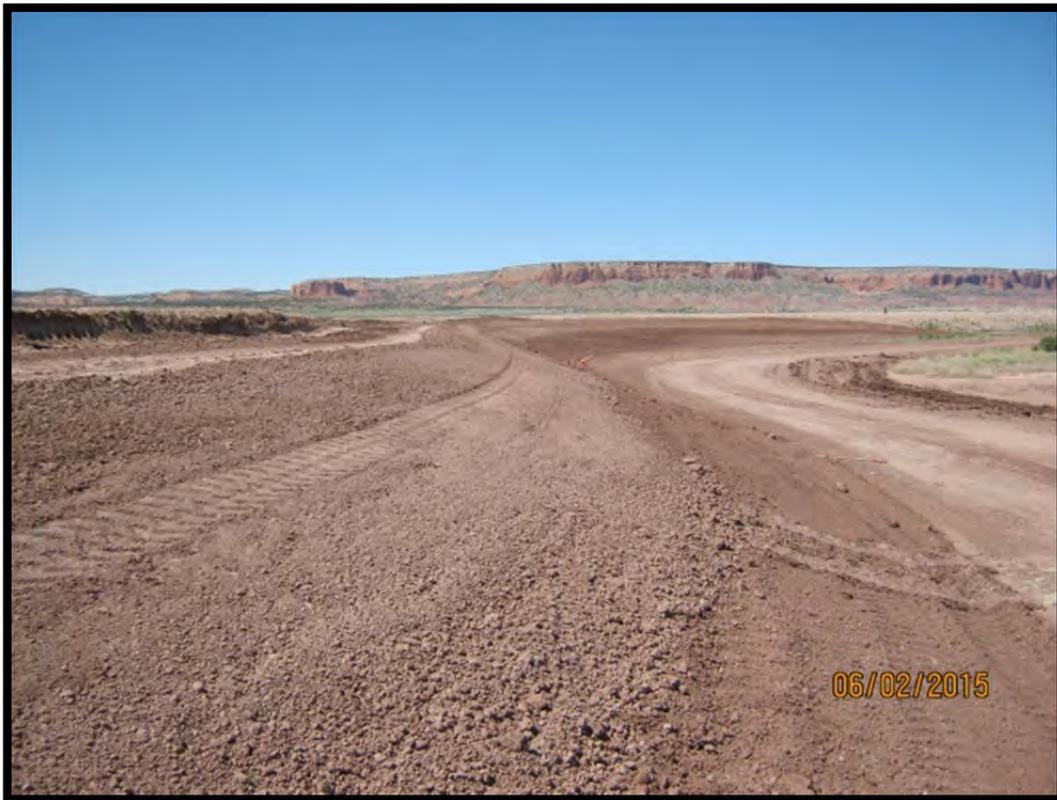
Photo #12: Pond 7/8 and Pond 11 South Berms Under Construction, Nearly Complete - Looking Northeast

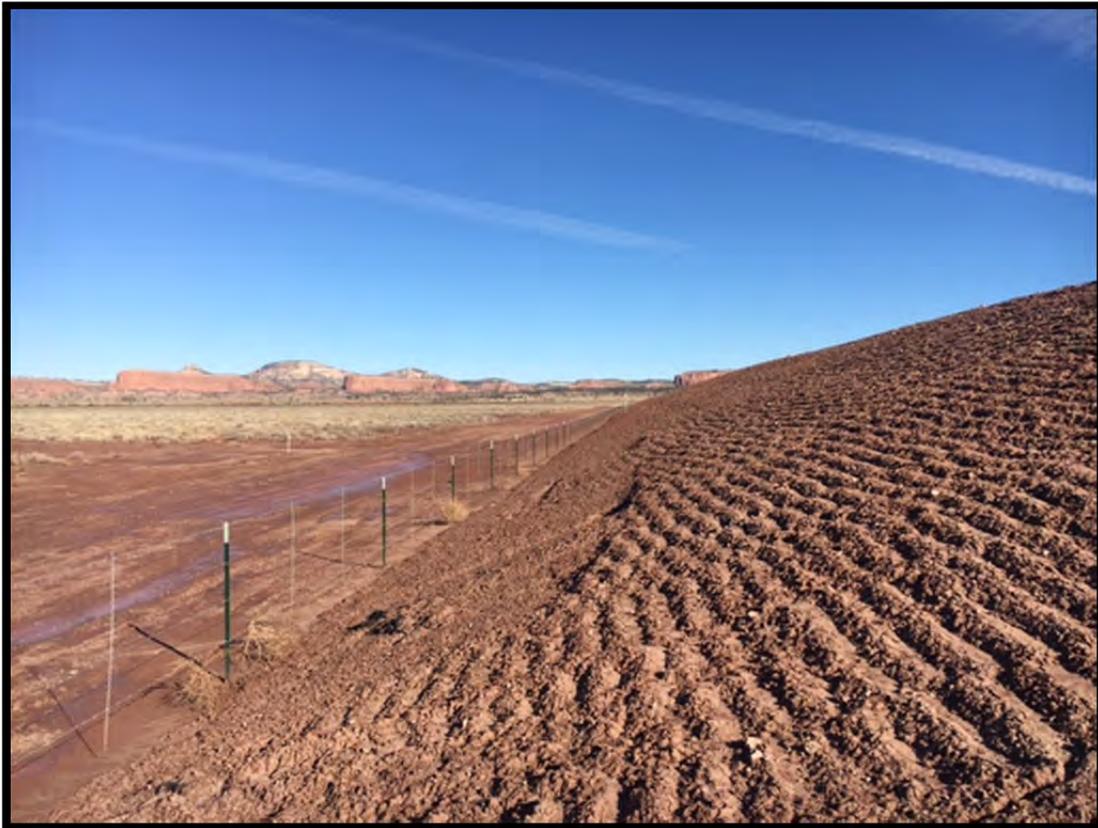
Photo #14: Pond 7/8 West Berm Completed Fill.

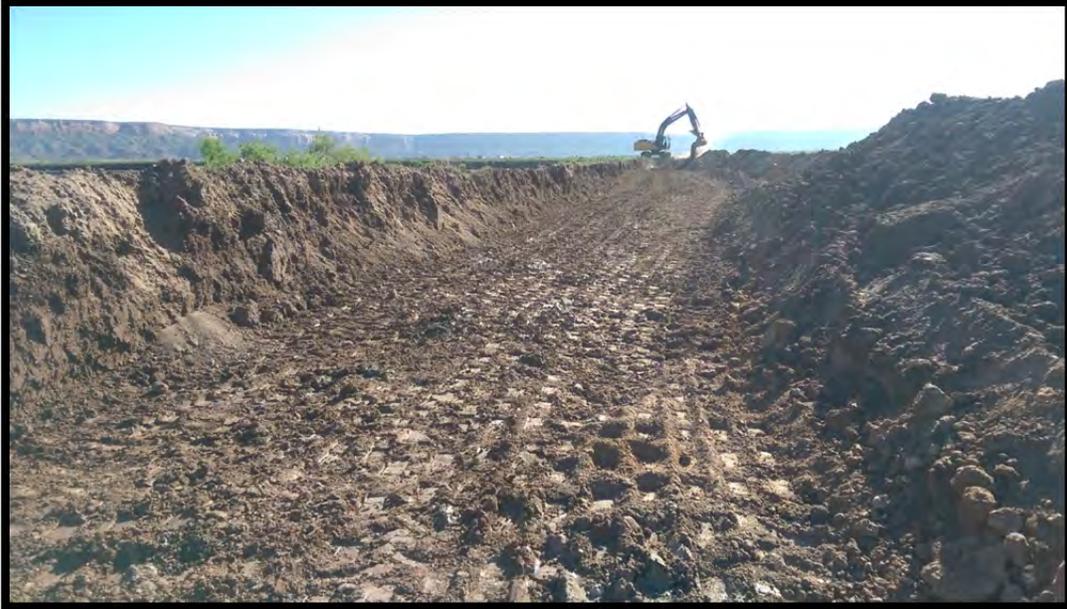
Photo #17: Pond 11-12 Berm Being Removed and Reworked

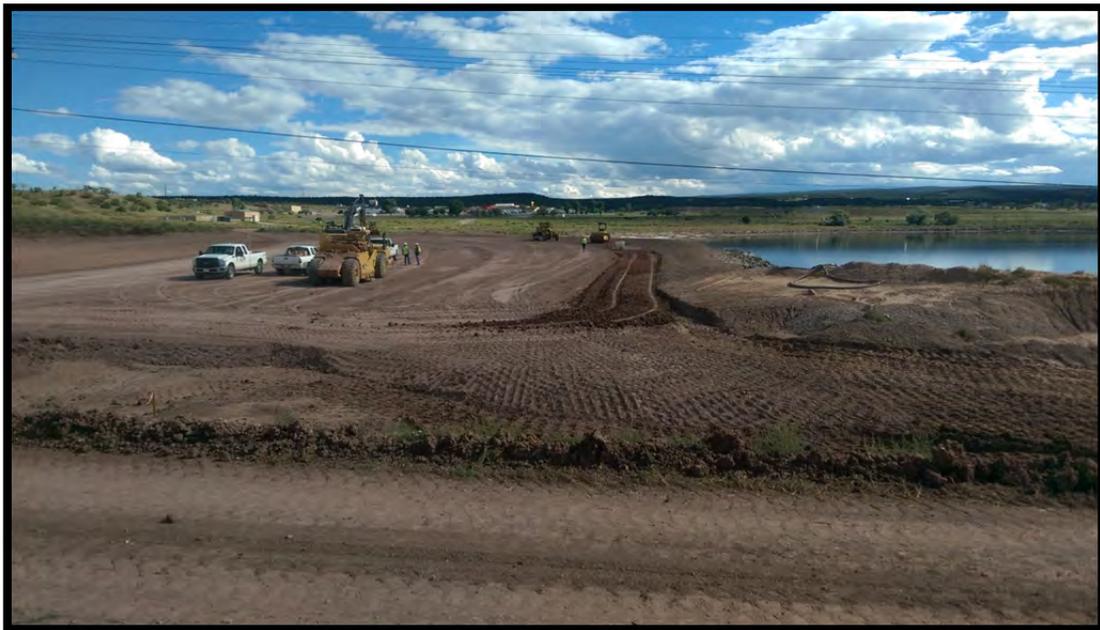
Photo #20: Pond 9 East End Completed.

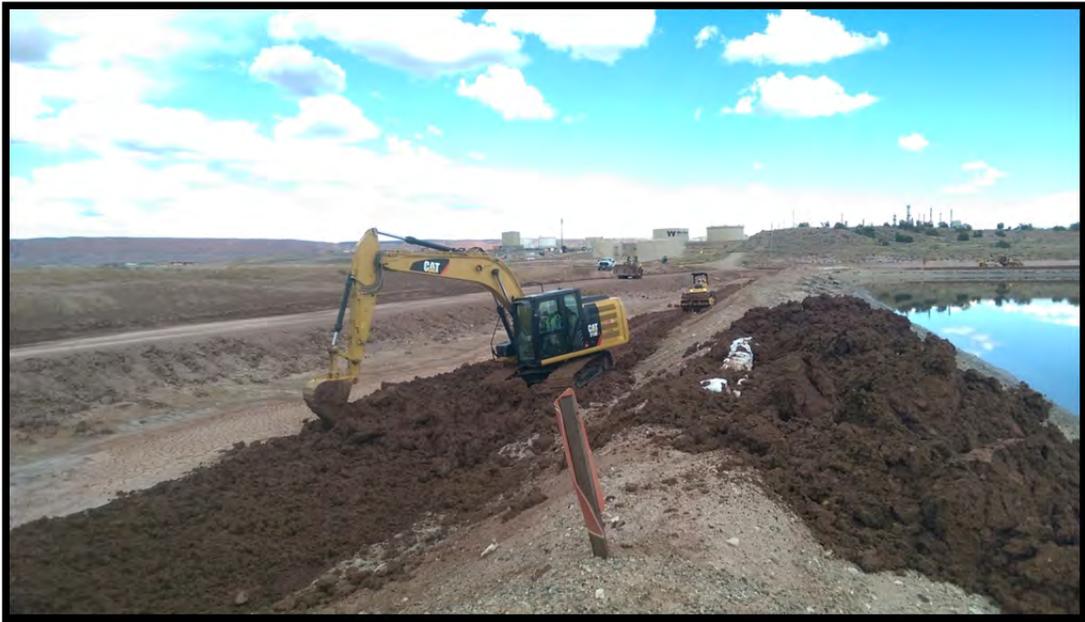
Photo #21: Pond 9 Start of Fill Placement on North Berm
Removing Base Material and Placing it on the Interior

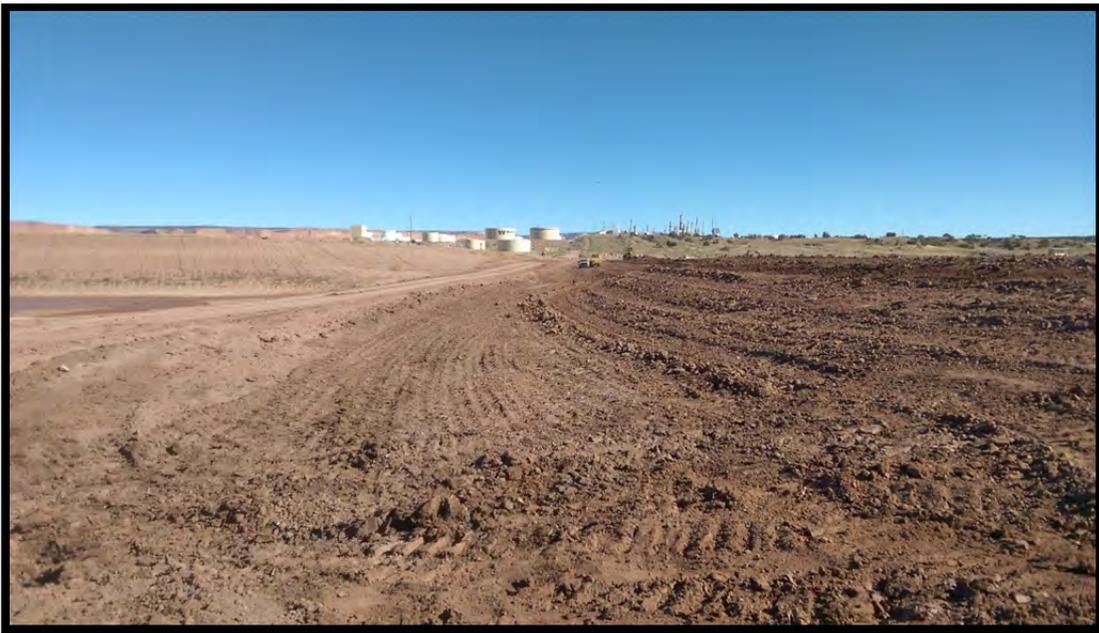
Photo #22: Pond 9 North Berm Completed.

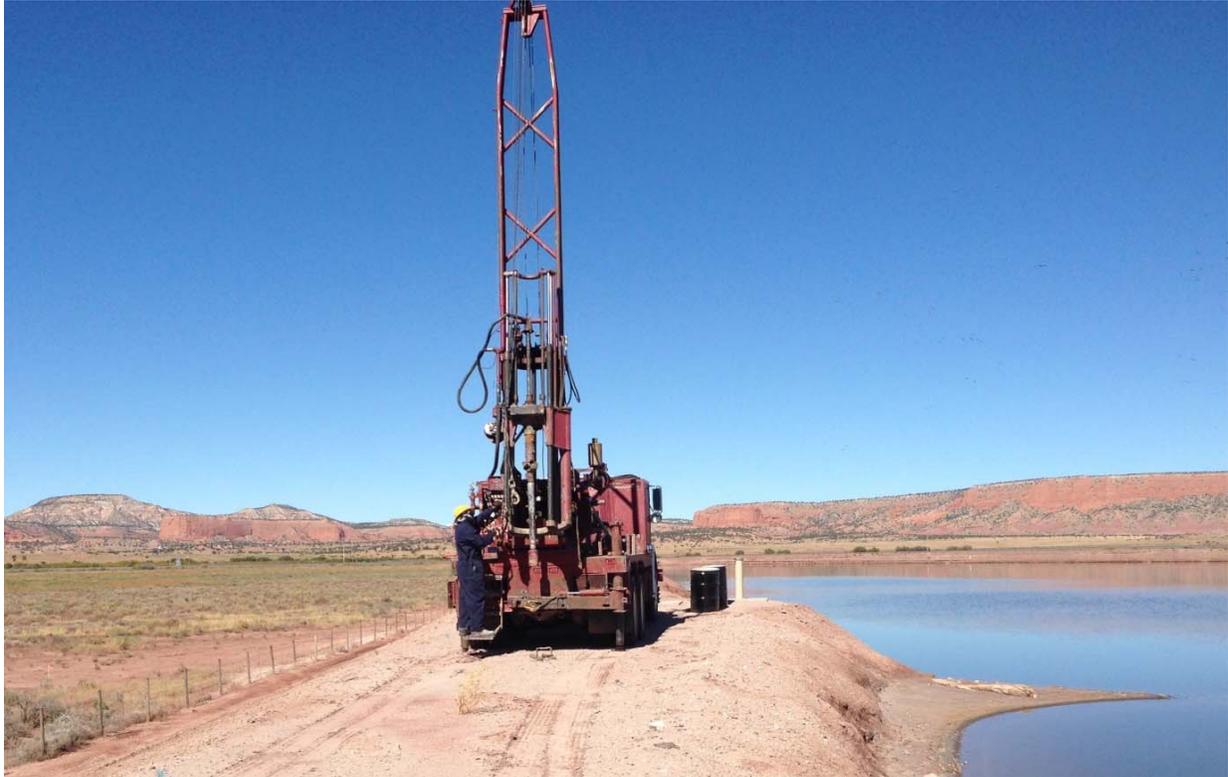
Set Up on Soil Boring SB-8N - Looking North

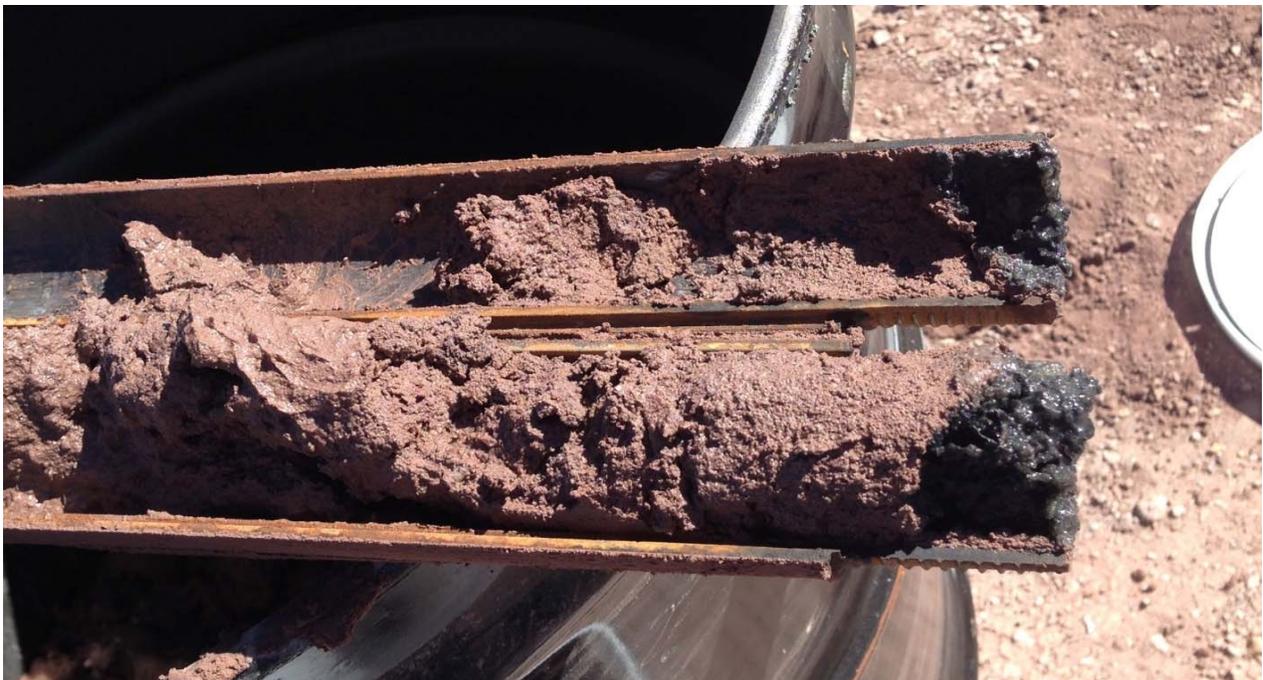
Bottom of Split Spoon Sample from 10 to 12 Feet Deep

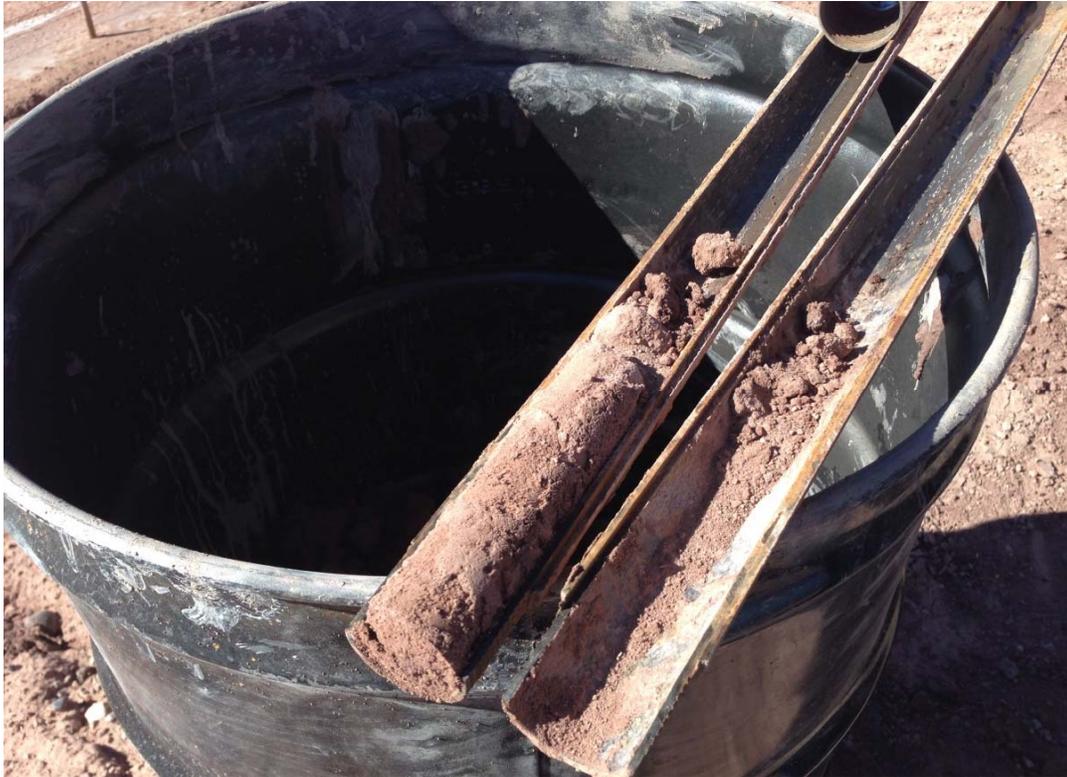
Bottom of Split Spoon Sample from 0 to 2 Feet Deep

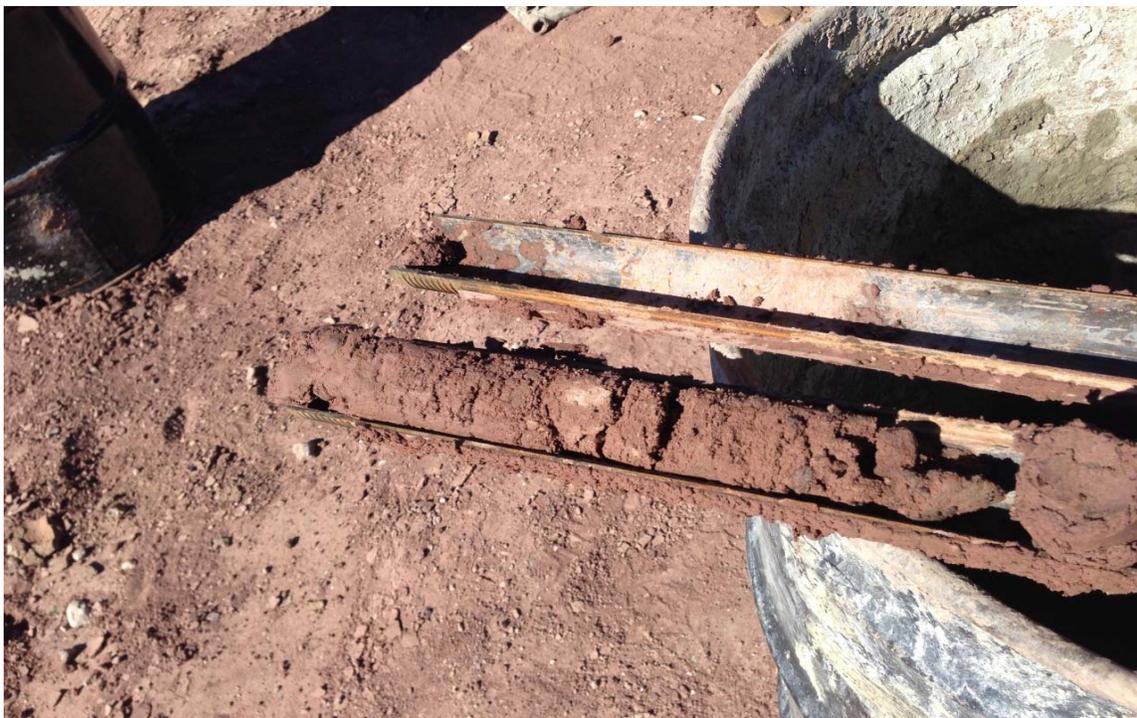
Bottom of Split Spoon Sample from 4 to 6 Feet Deep

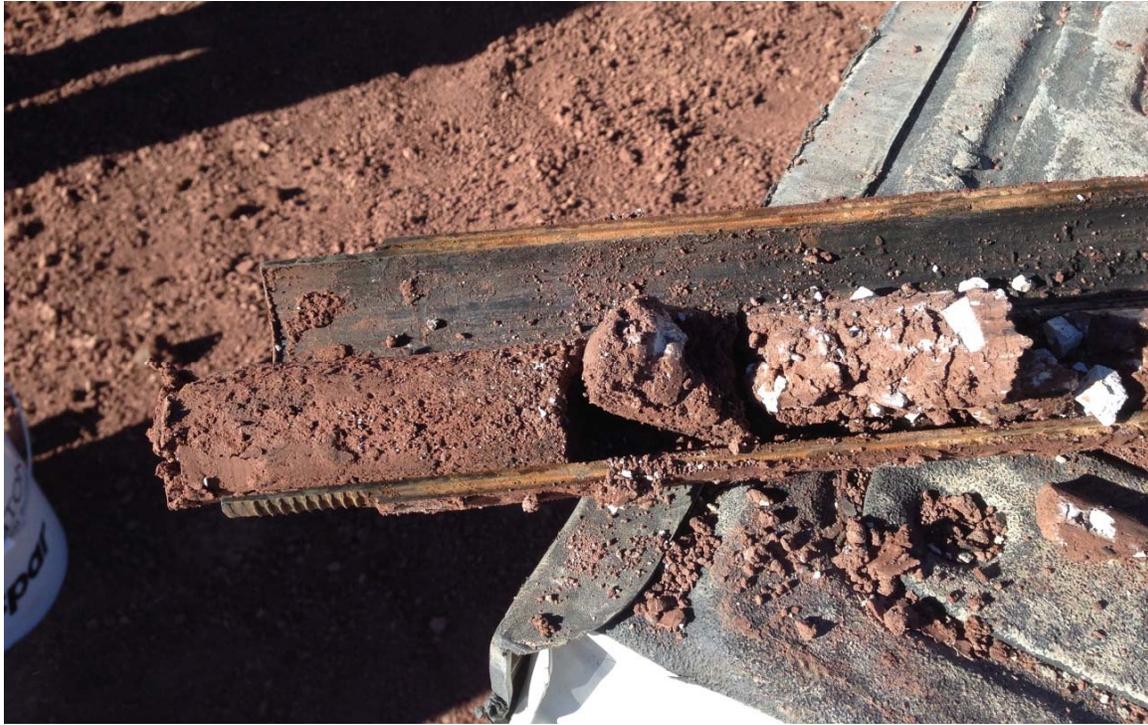
Bottom of Split Spoon Sample from 8 to 10 Feet Deep

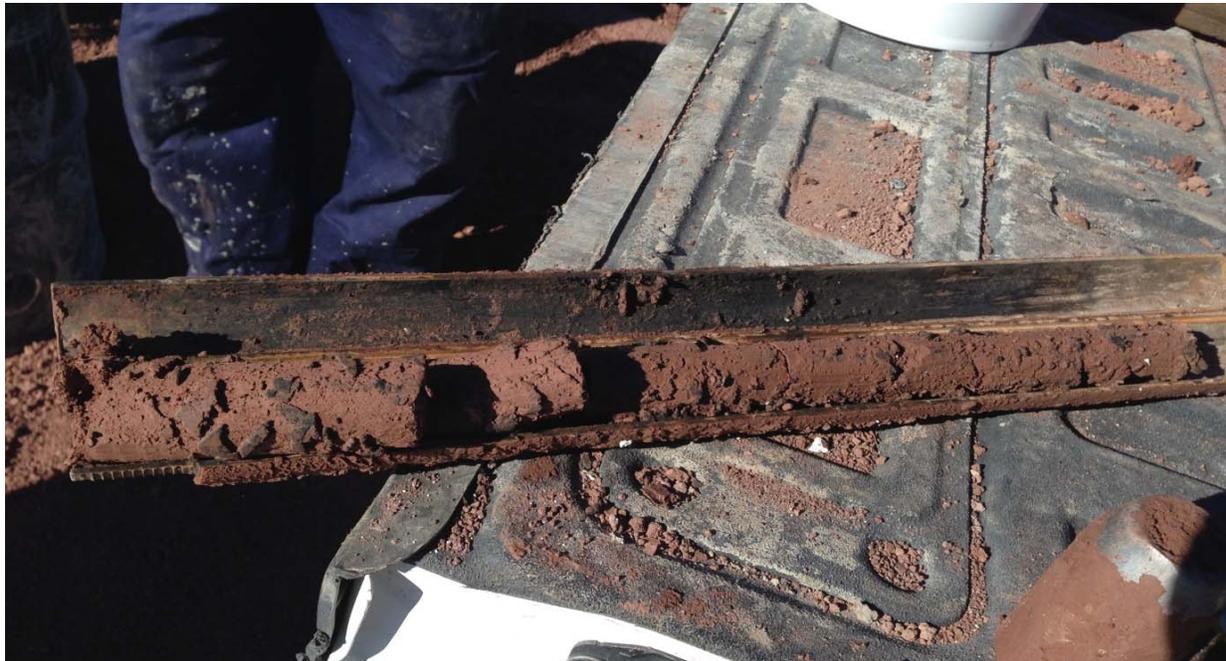
Bottom of Split Spoon Sample from 12 to 14 Feet Deep
