Liberty Lift was in the process of pumping out of the jet nozzle when the jet pump pressured up causing the PRV to relieve. The operation was shut down and fluid was immediately removed. 15 bbls. of fluid was released to the lined secondary containment.

# Daily Site Visit Report

Client:	<u>BTA Oil Producers LLC</u>	Inspection Date:	<u>11/22/2023</u>
Site Location Name:	<u>Chiso State 14 Battery</u>	Report Run Date:	<u>11/27/2023 10:19 AM</u>
Client Contact Name:	<u>Kelton Baird</u>	API #:	<u></u>
Client Contact Phone #:	<u>432-312-2203</u>		
Unique Project ID	<u></u>	Project Owner:	<u></u>
Project Reference #	<u></u>	Project Manager:	<u></u>

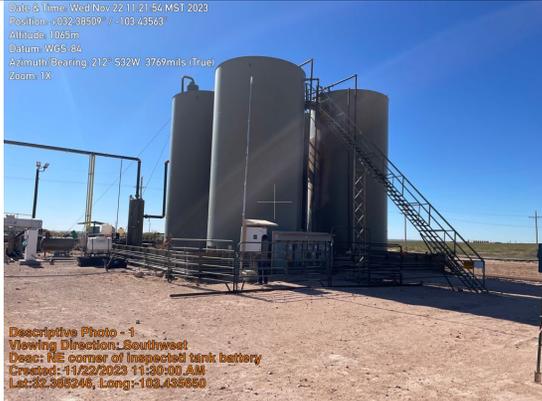
NE corner of inspected tank battery

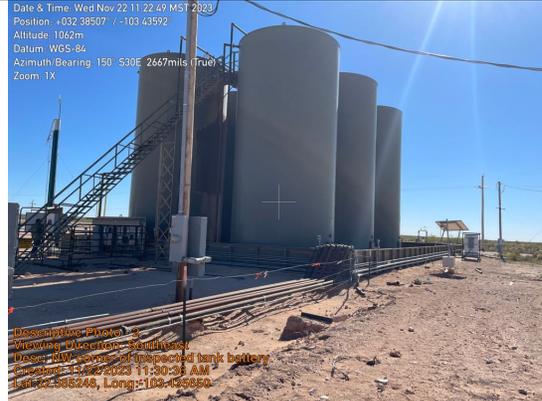
NW corner of inspected tank battery

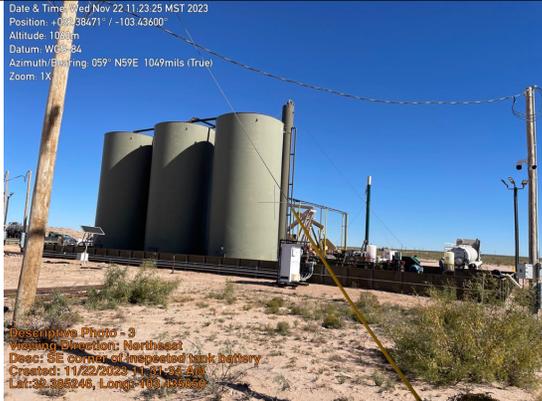
SE corner of inspected tank battery

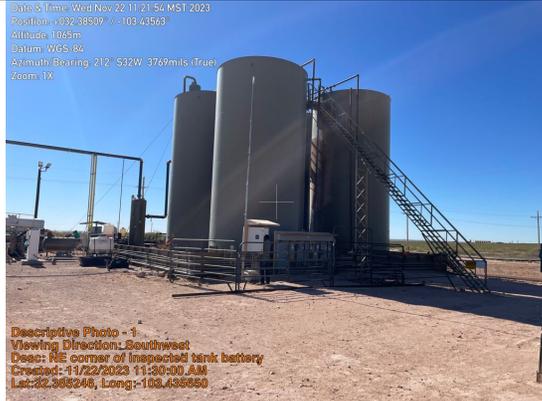
NE corner of inspected tank battery

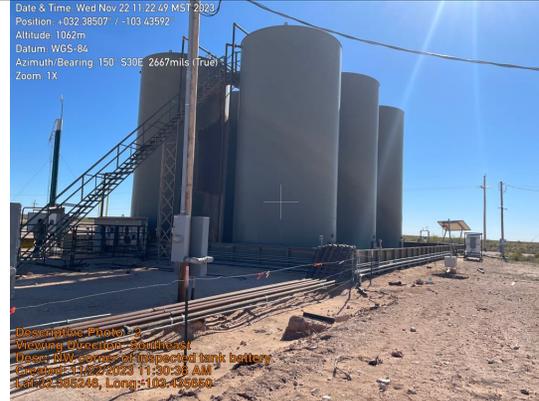
NW corner of inspected tank battery

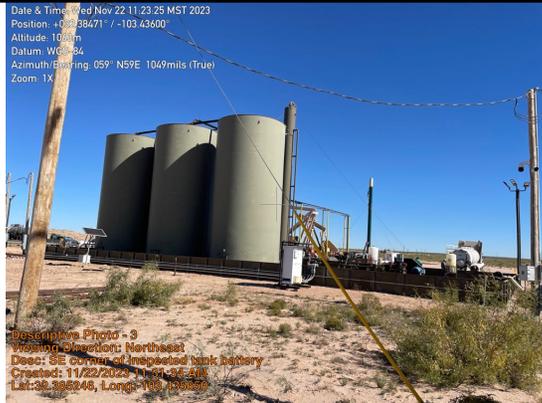
SE corner of inspected tank battery

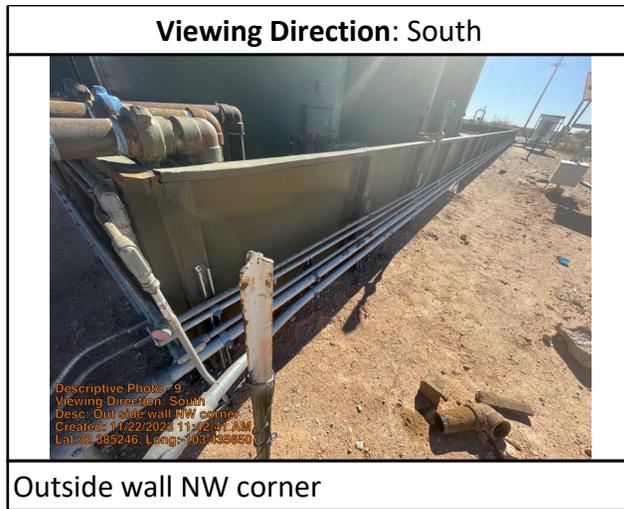
Outside wall NW corner

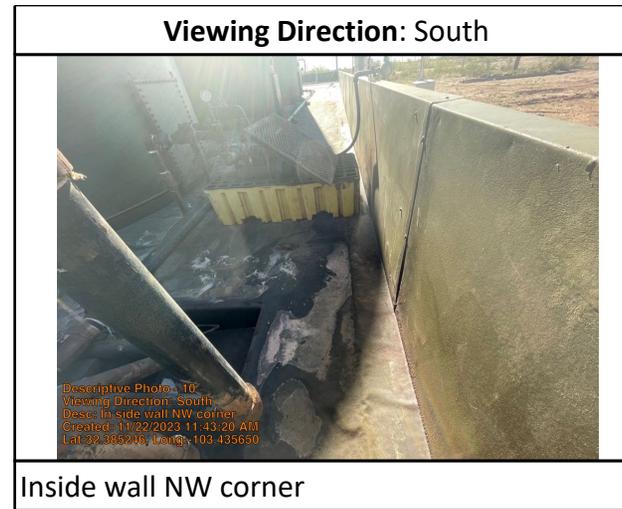
Inside wall NW corner

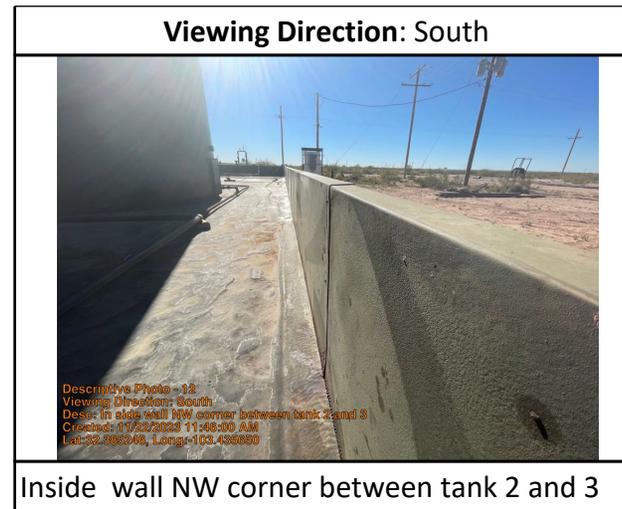
Inside wall NW corner between tank 2 and 3

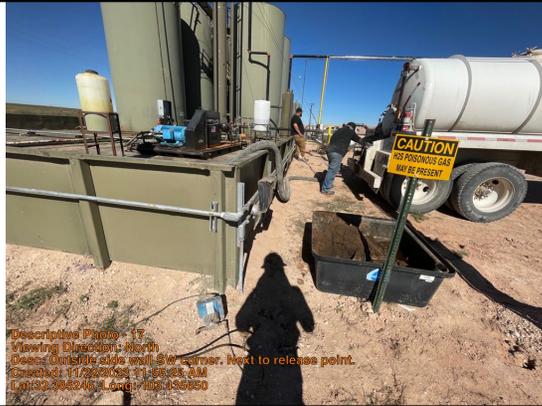
Descriptive Photo - 17  
Viewing Direction: North  
Desc: Outside side wall SW corner. Next to release point.  
Created: 11/22/2023 11:55:31 AM  
Lat:32.385246, Long:-103.435650

Outside side wall SW corner. Next to release point.

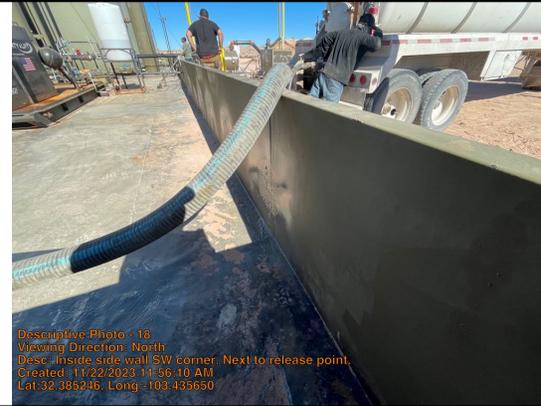
Descriptive Photo - 18  
Viewing Direction: North  
Desc: Inside side wall SW corner. Next to release point.  
Created: 11/22/2023 11:56:10 AM  
Lat:32.385246, Long:-103.435650

Inside side wall SW corner. Next to release point.

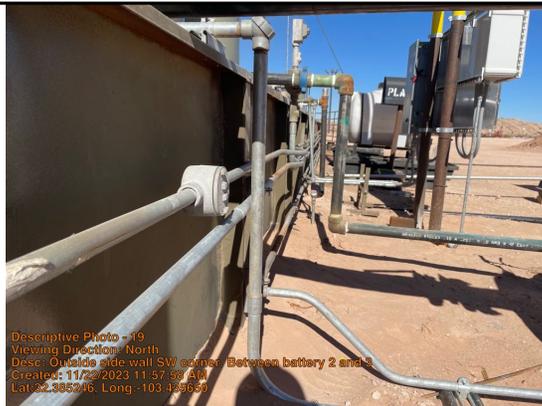
Descriptive Photo - 19  
Viewing Direction: North  
Desc: Outside side wall SW corner. Between battery 2 and 3.  
Created: 11/22/2023 11:57:57 AM  
Lat:32.385246, Long:-103.435650

Outside side wall SW corner. Between battery 2 and 3

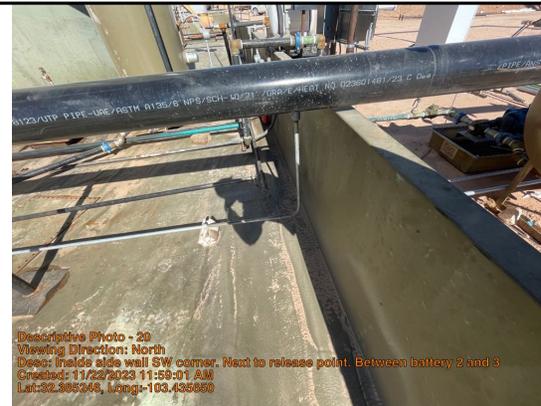
Descriptive Photo - 20  
Viewing Direction: North  
Desc: Inside side wall SW corner. Next to release point. Between battery 2 and 3.  
Created: 11/22/2023 11:59:01 AM  
Lat:32.385246, Long:-103.435650

Inside side wall SW corner. Next to release point. Between battery 2 and 3

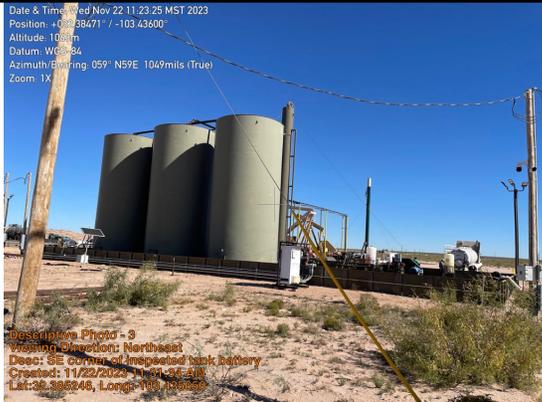
SE corner of inspected tank battery

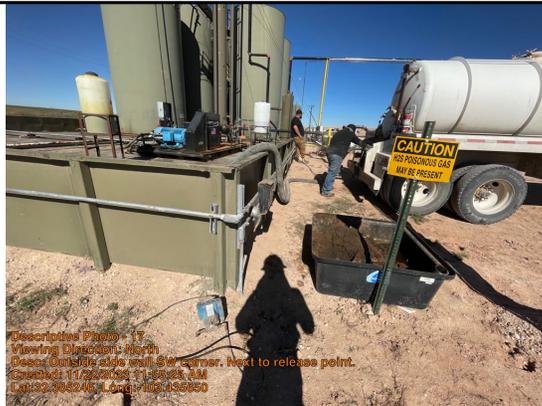
Descriptive Photo - 17  
Viewing Direction: North  
Desc: Outside side wall SW corner. Next to release point.  
Created: 11/22/2023 11:55:31 AM  
Lat:32.385246, Long:-103.433650

Outside side wall SW corner. Next to release point.

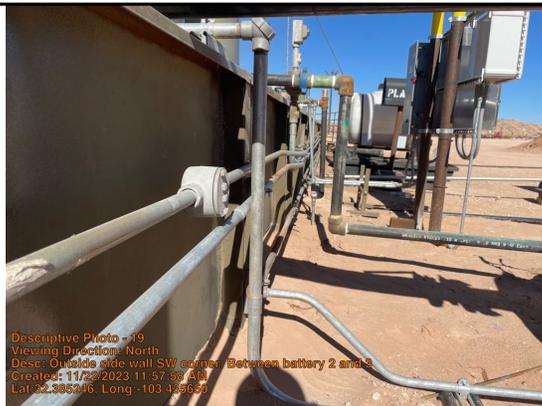
Descriptive Photo - 19  
Viewing Direction: North  
Desc: Outside side wall SW corner. Between battery 2 and 3.  
Created: 11/22/2023 11:57:57 AM  
Lat:32.385246, Long:-103.433650

Outside side wall SW corner. Between battery 2 and 3
