Closure Report

API# 30025 305920000

2RP-1035

Saber Resources
F M Hollyway S W D # 1

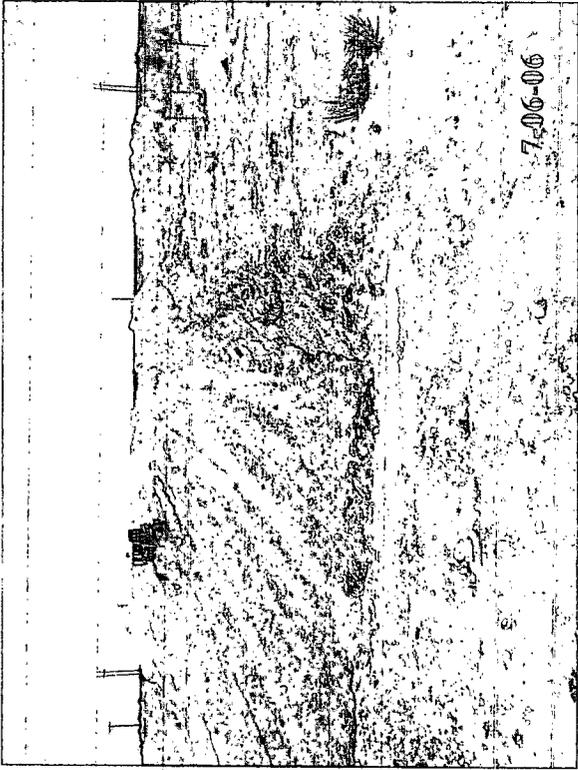
Blending Spoil Pile

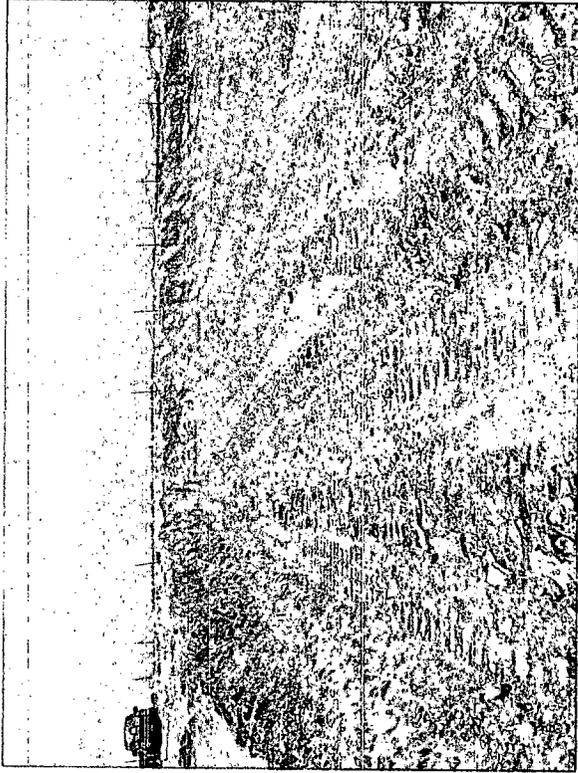
East to West Backfilled prior to Liner

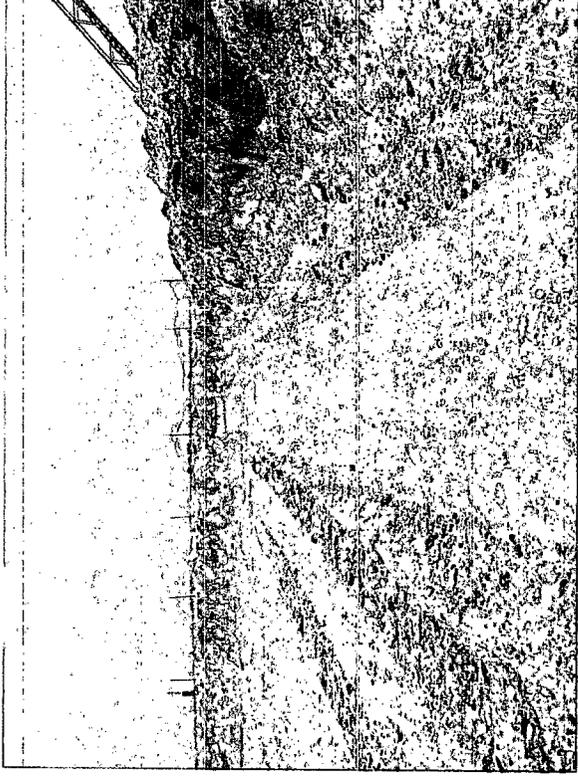
North to South Backfilled prior to Liner

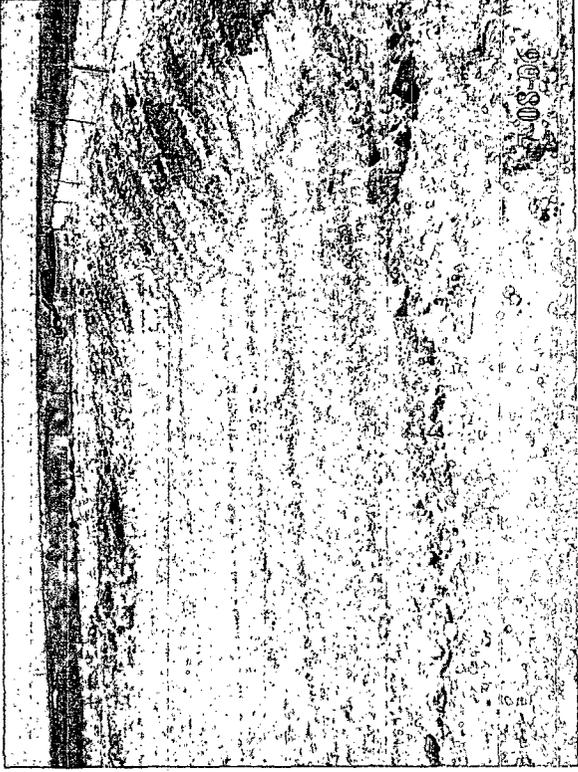
North to South Backfilled prior to Liner

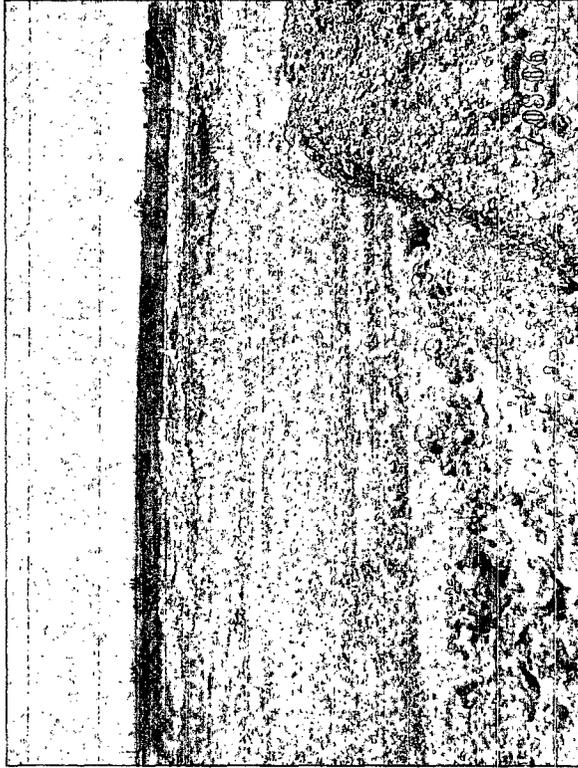
West to East Backfilled prior to Liner

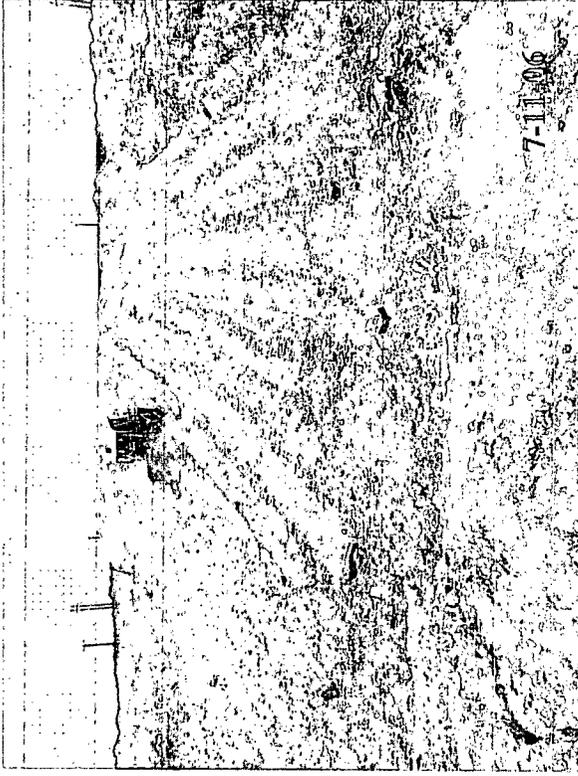
Backfilling to put in Liner South to North

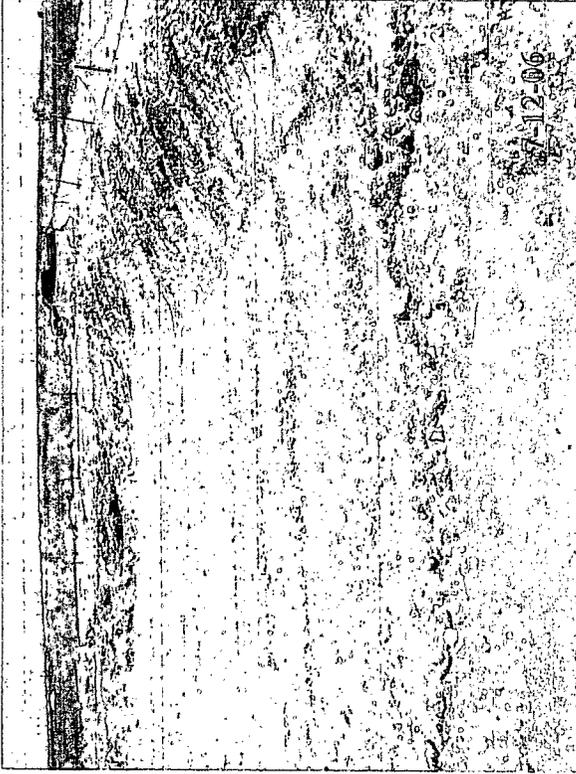
North to South Backfilled prior to Liner

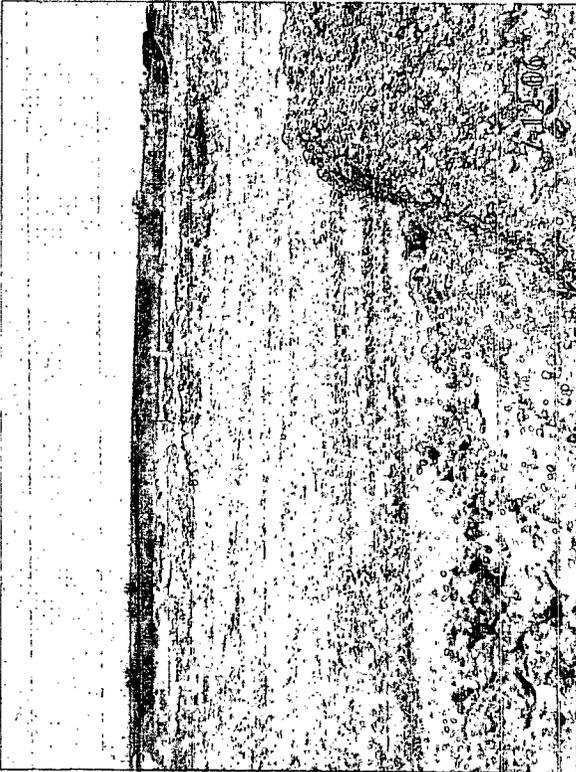
West to East Backfilled prior to Liner

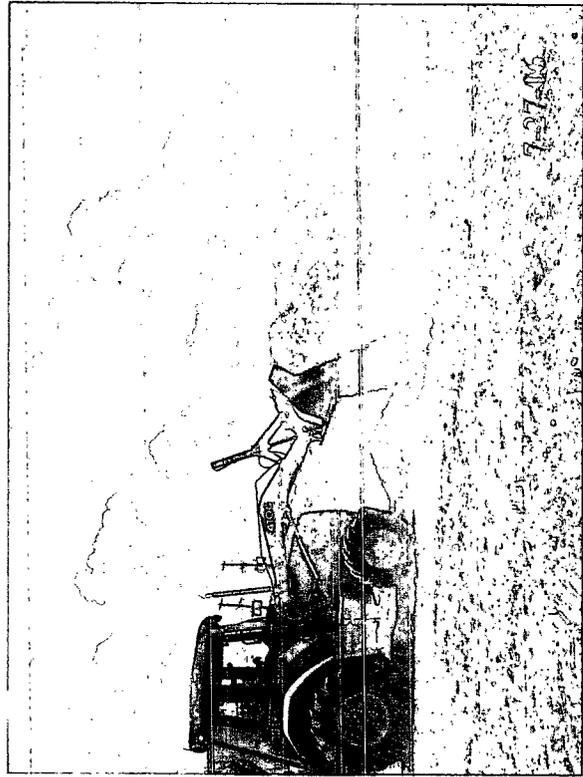
Blending Spoil Piles

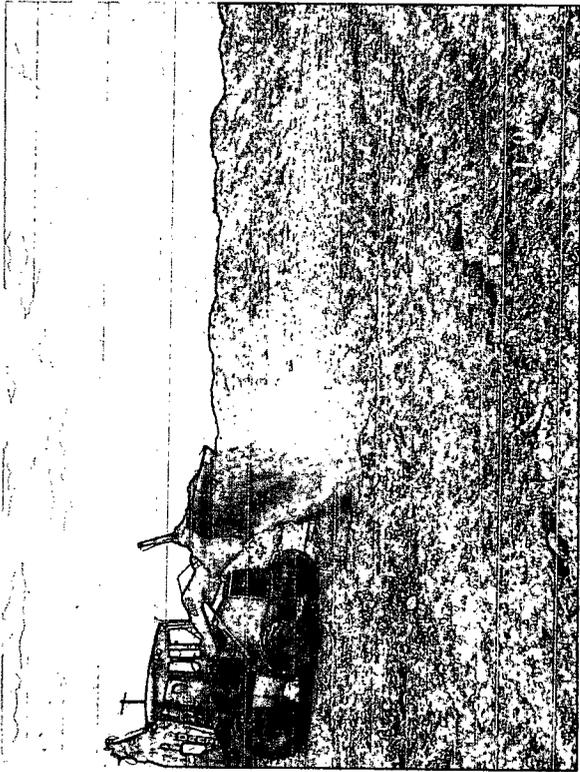
Backfilling with Backhoe
