**RE: Phase I and II Remediation, Former Enersource Facility, Monument, Lea County,
New Mexico**

Phase I and II Remediation, Former Enersource Facility Monument, Lea County, New Mexico

June 29, 2007

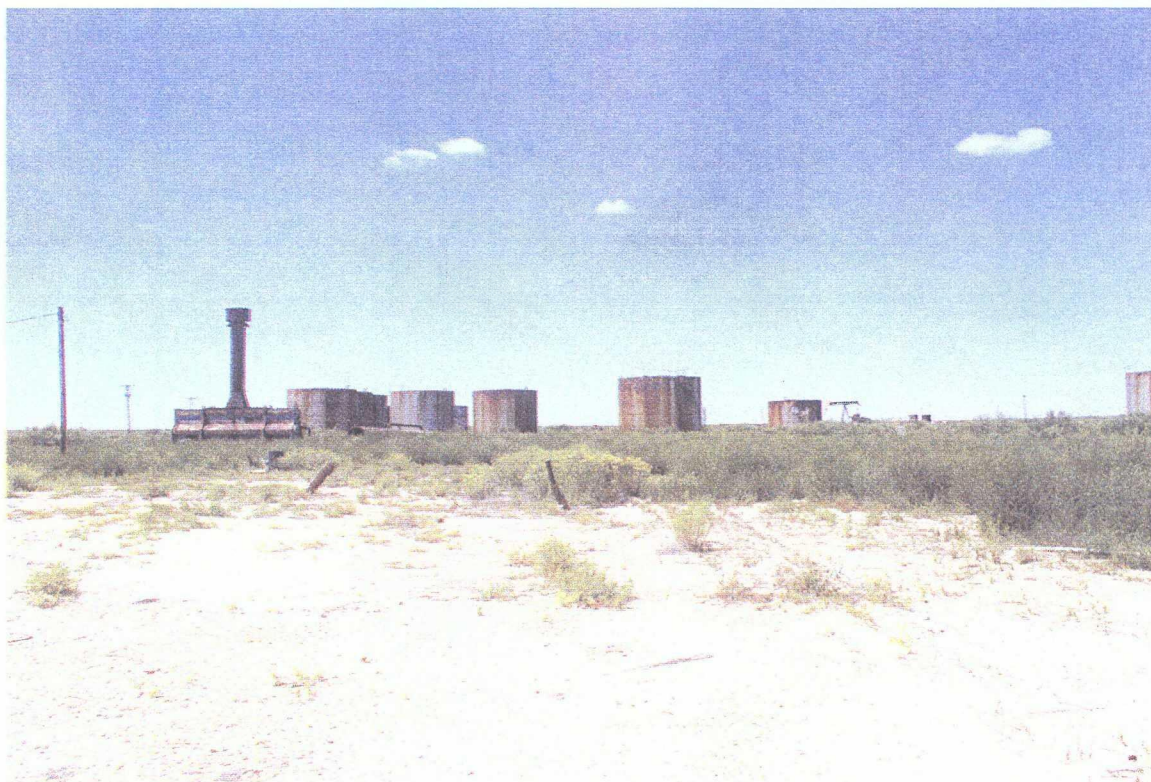
No. 1 – A view of some of the above ground storage tanks that were pumped out and removed from site.

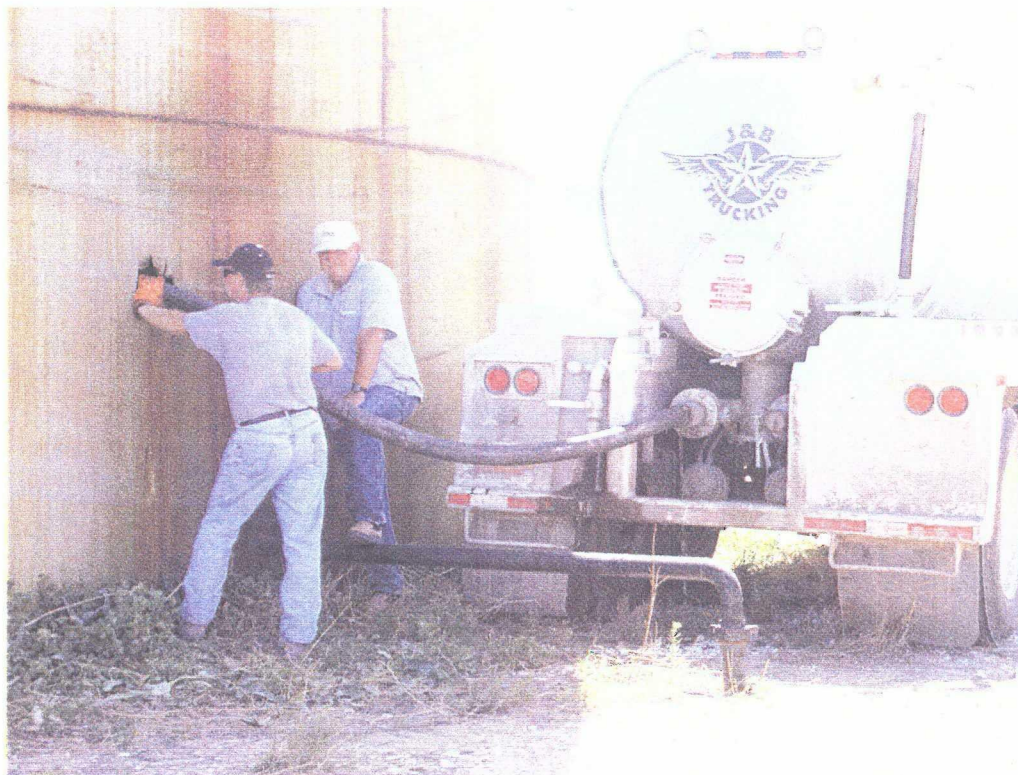
No. 5 – Vacuum trucks were used to remove flowable fluid from within the tanks.

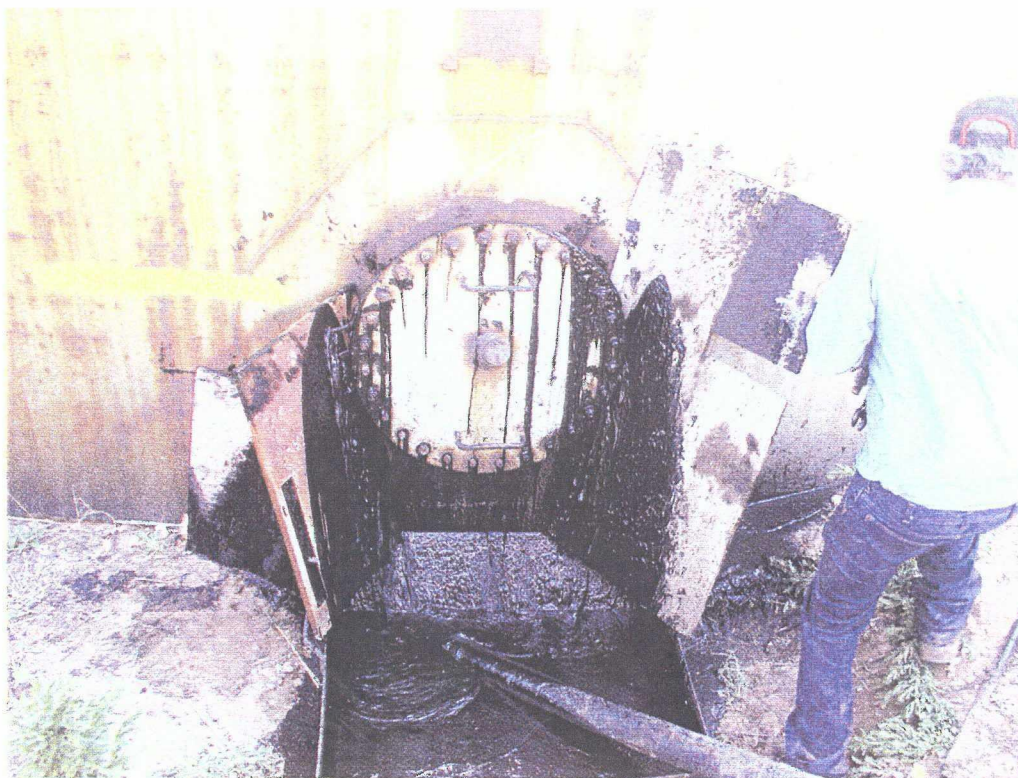
No. 6 – The man ways were carefully cracked open to access fluid when the valves on the tanks did not work. The vacuum truck pulled the fluid collected in the capture vessel.

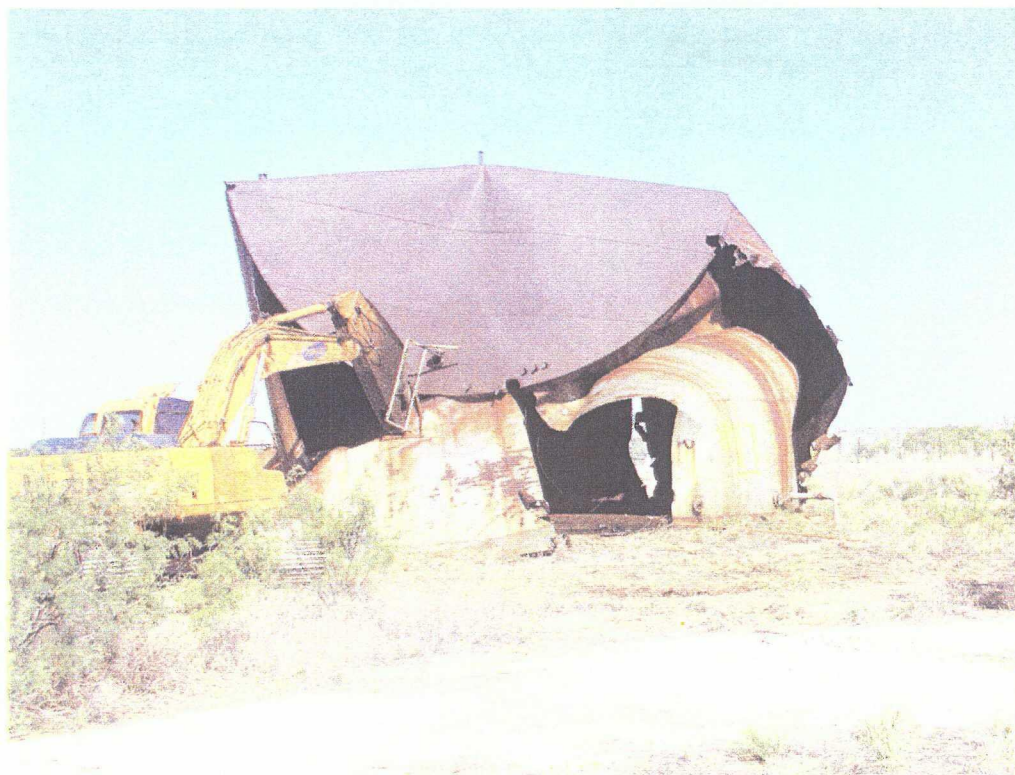
No. 7 – A hydraulic shear dismantled the tanks for recycling.

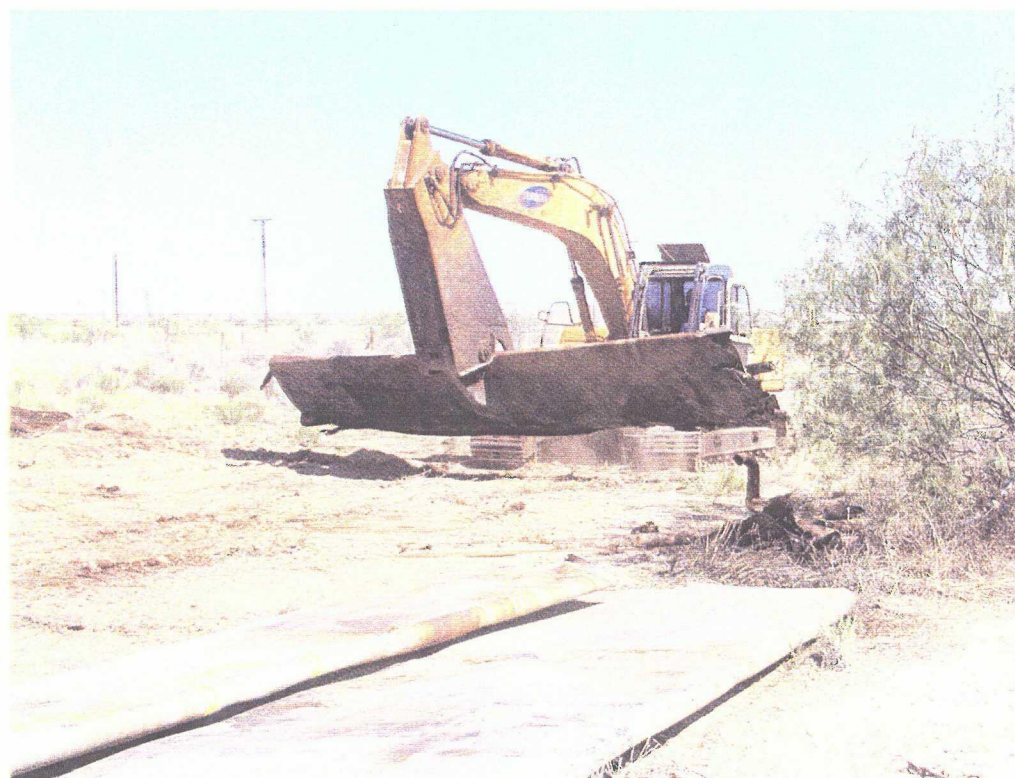
No. 8 – The sheared tanks were folded up for transport offsite.

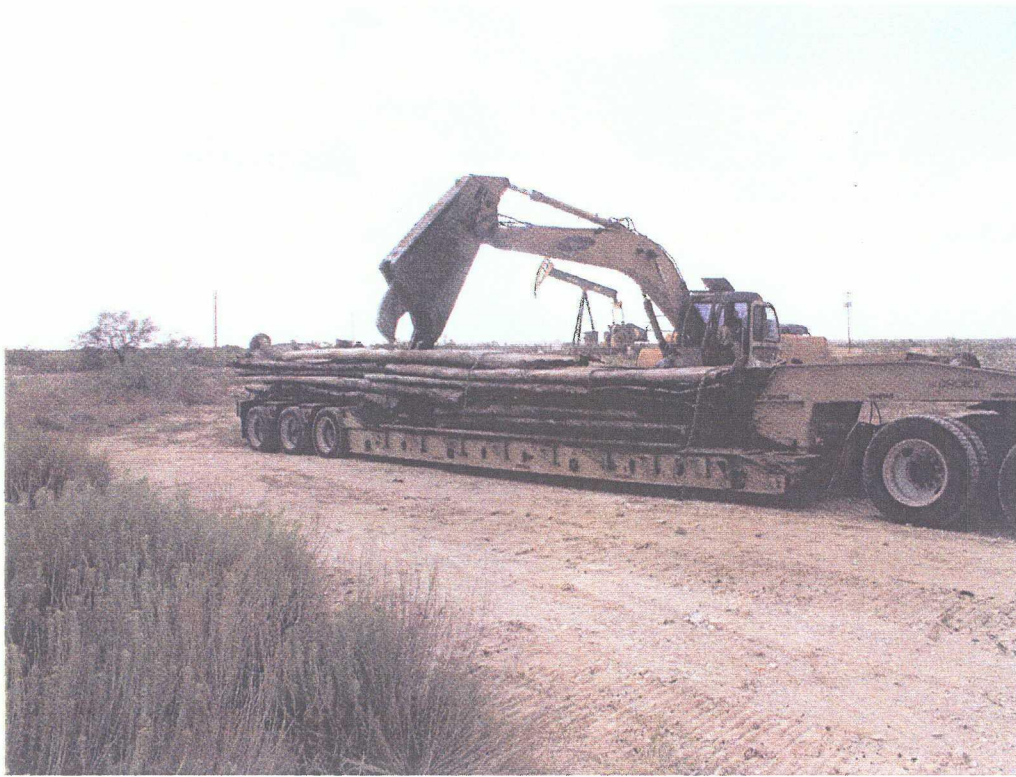
No. 9 – The folded up steel loaded on trucks for transport offsite.

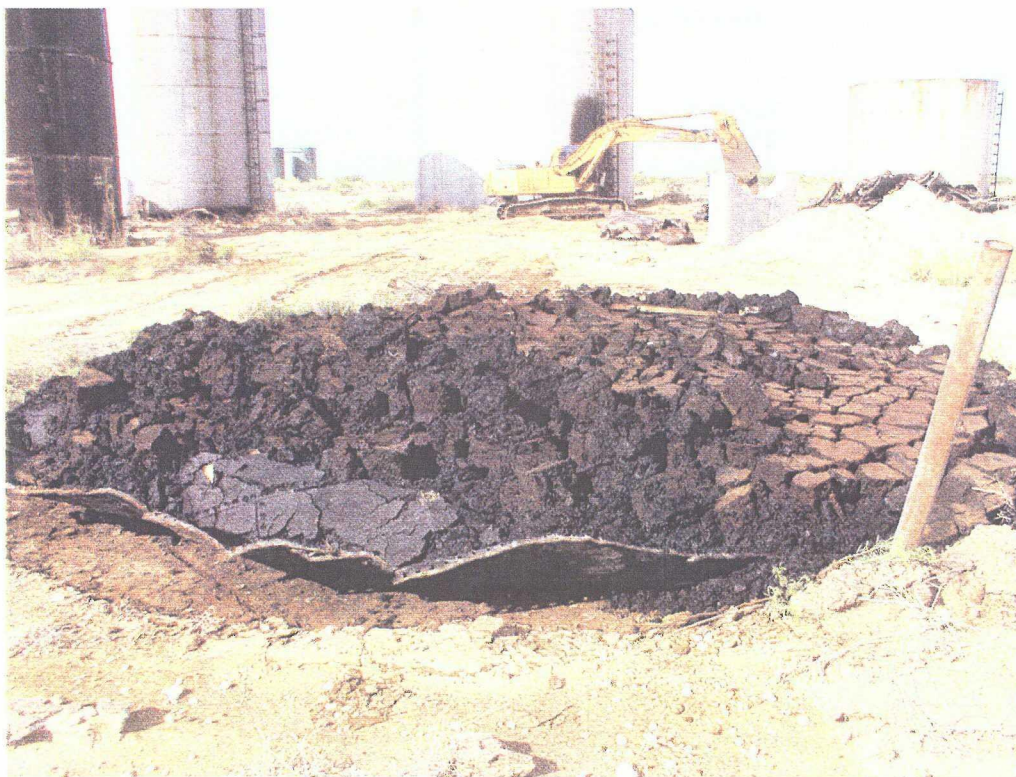
No. 10 – Non flowable sludge was loaded into covered roll offs for disposal.

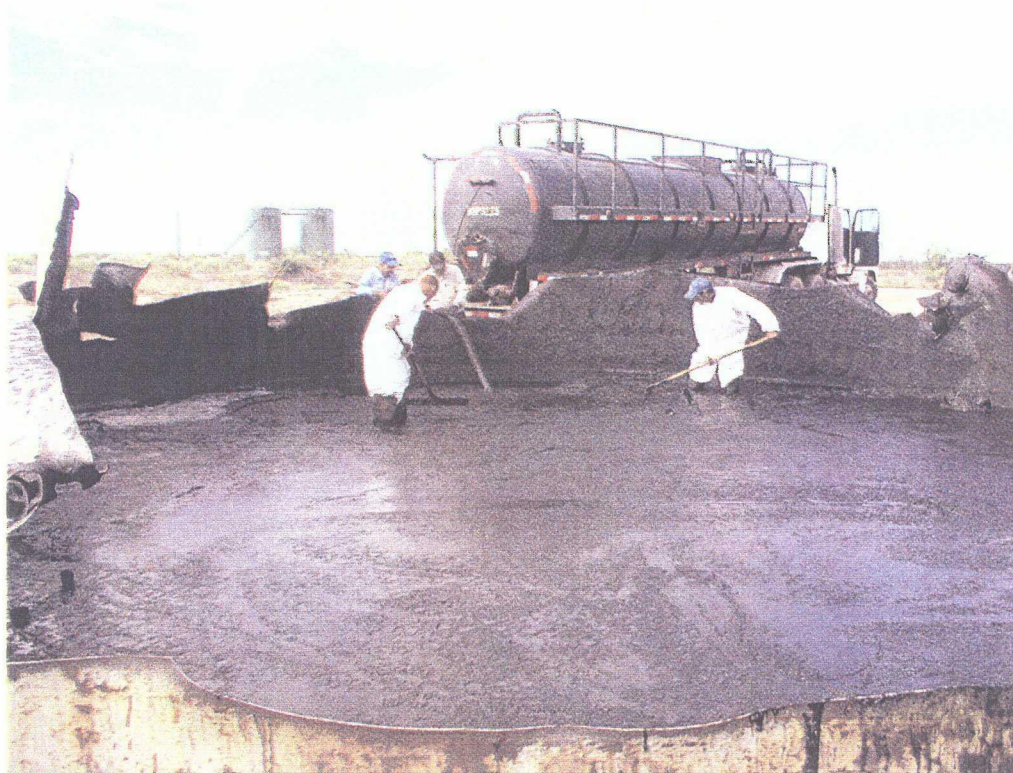
No. 11 – The tank bottom after all flowable material was removed from a tank, the shear tore the top of tank off so roustabouts could then push the thicker material to the vacuum truck for removal from tank.

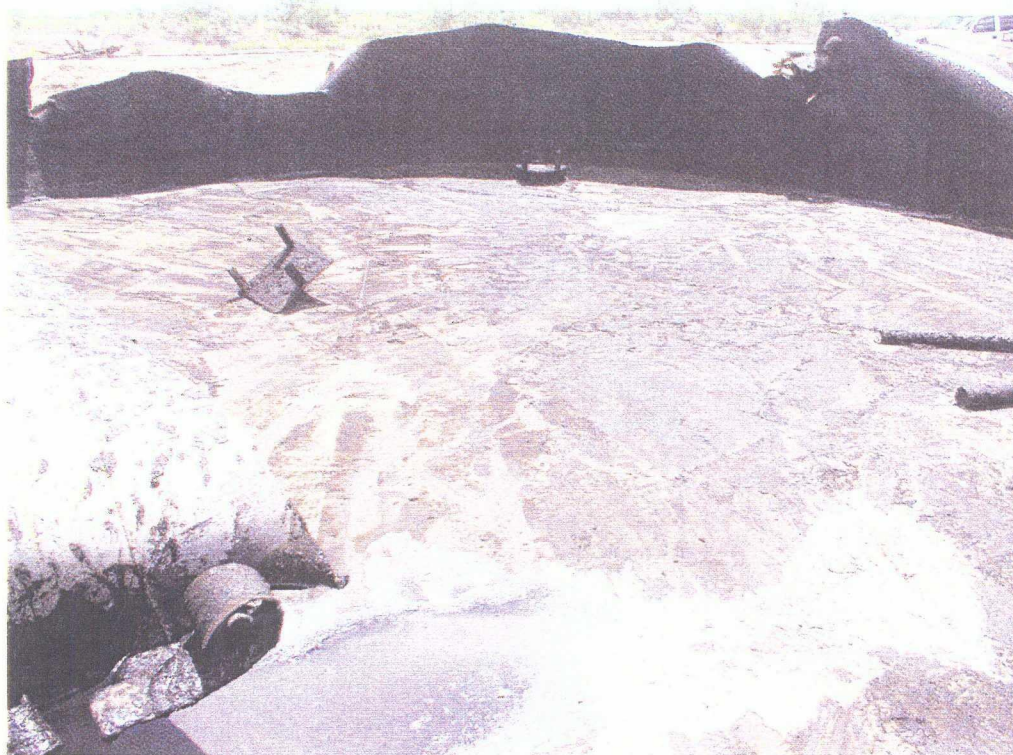
No. 12 – The tank bottom after the roustabouts finished cleaning out fluid.

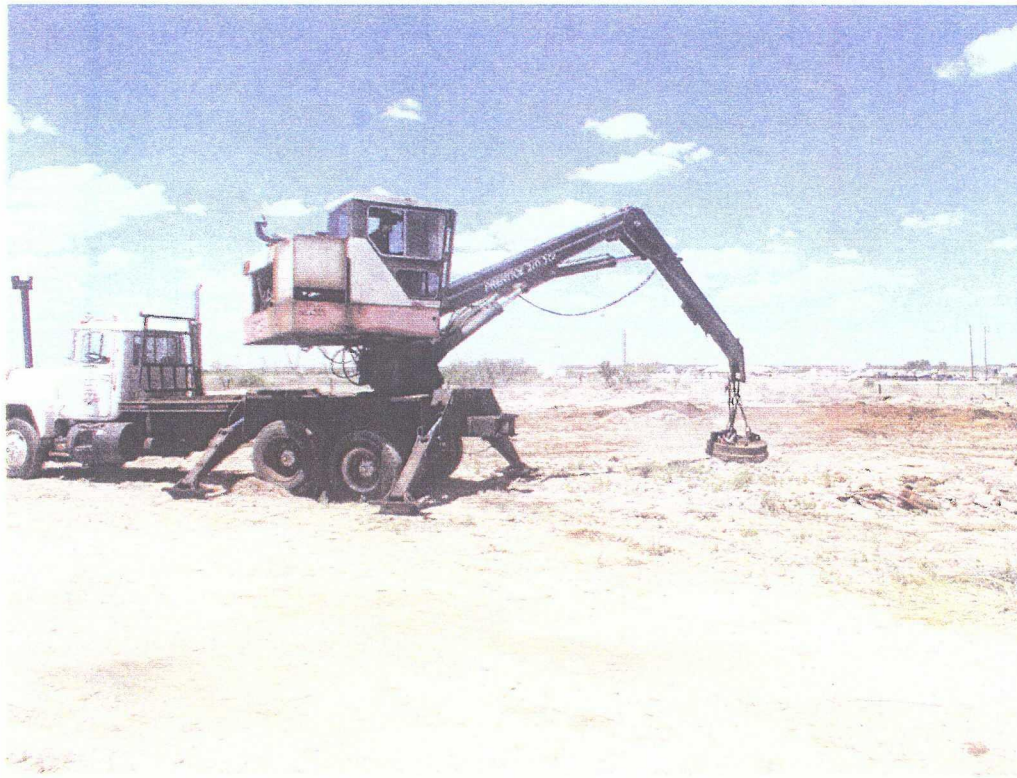
No. 13 – After completing the tank demolition and loading, an electric magnet went over the area to pick up the smaller pieces of steel for disposal.

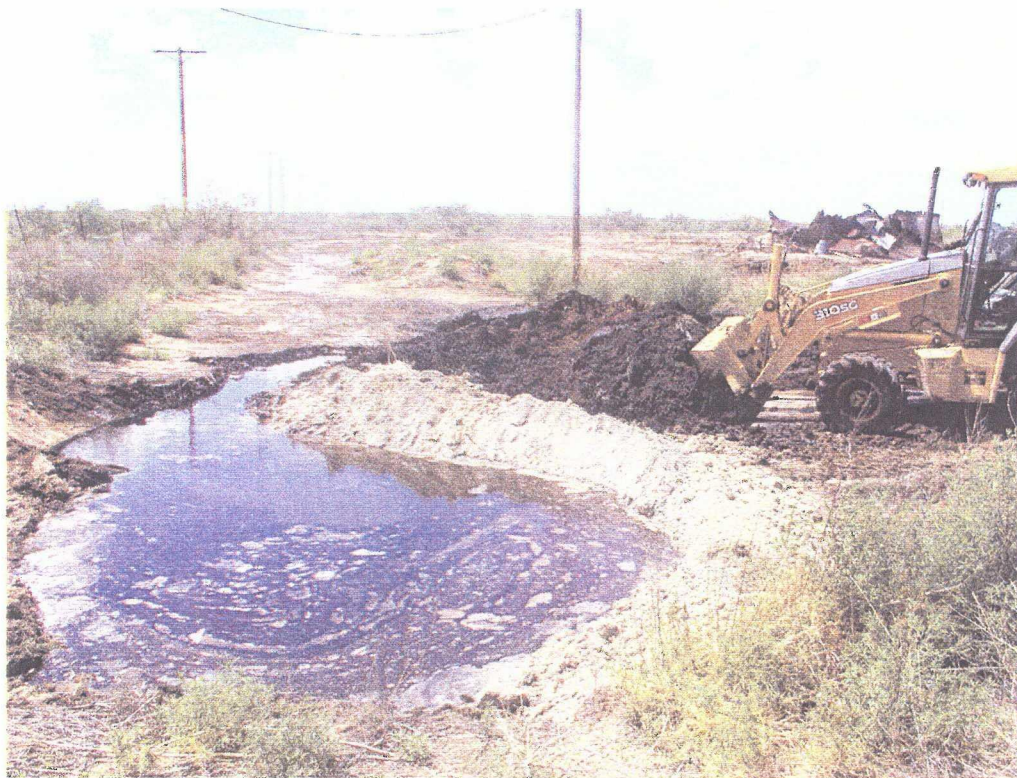
No. 14 – The sludge pile shown on Photo 2 was dug up and disposed of in the covered roll offs.

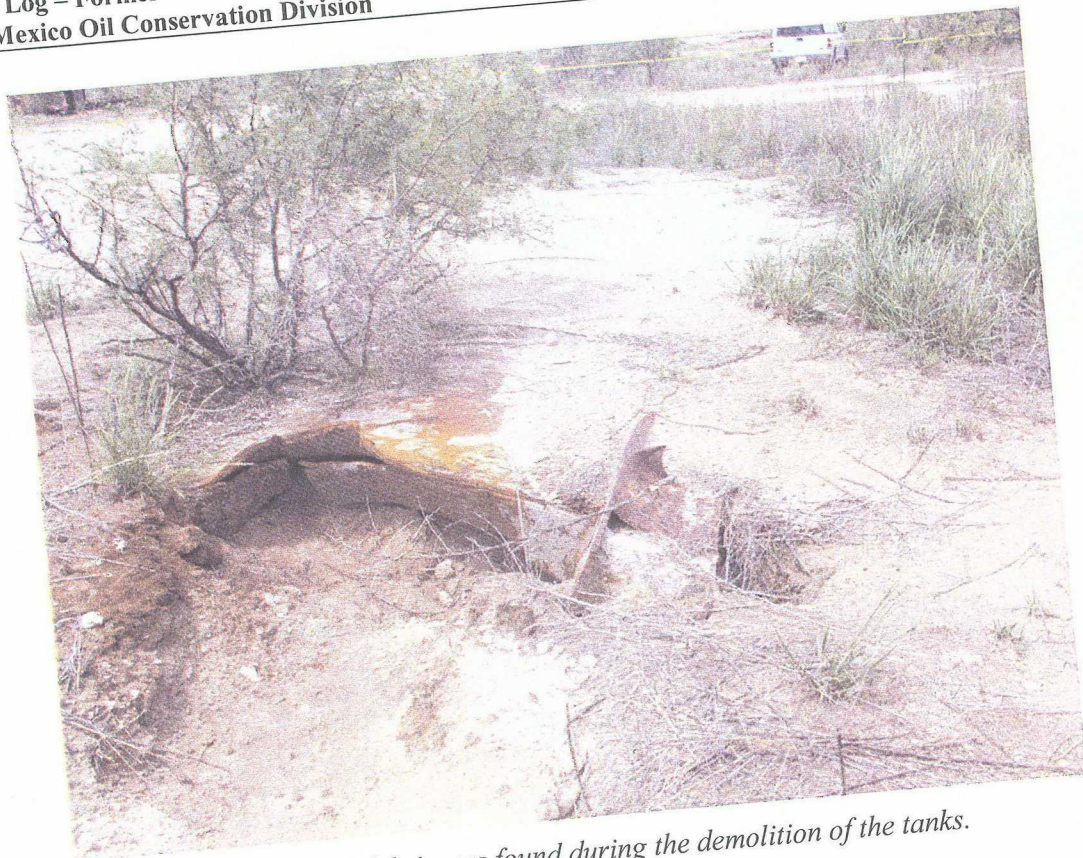
No. 15 – Some buried metal debris was found during the demolition of the tanks.

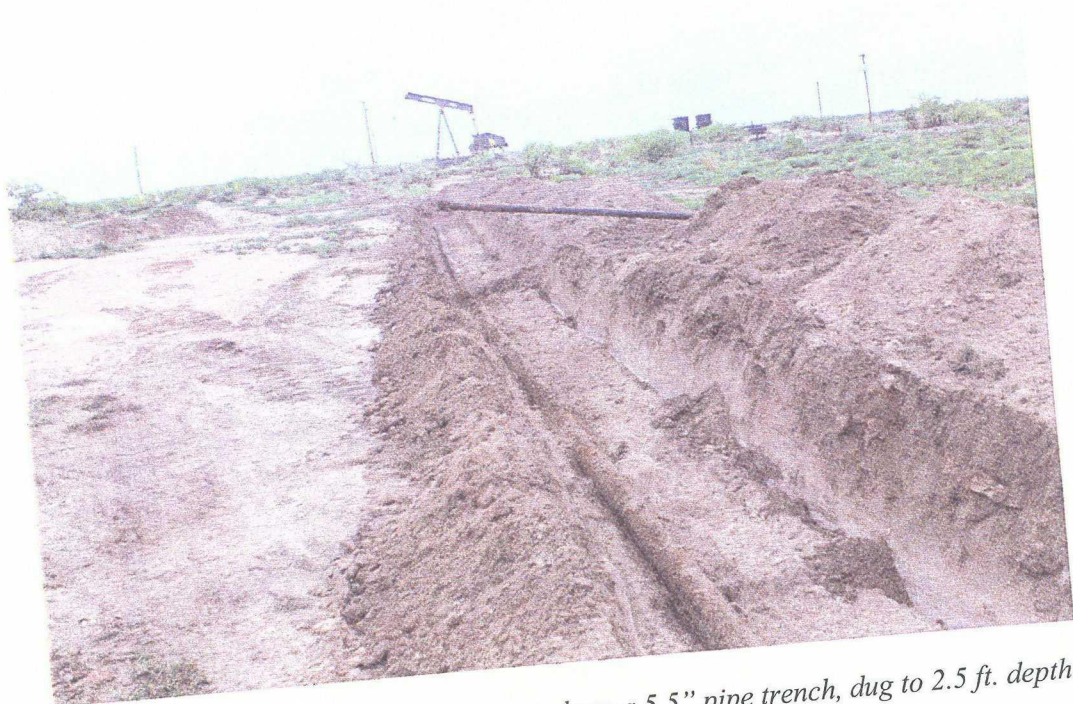
Grid Cells A and B. Phase II removal activities started in grid cells A and B (i.e., the western portion of the property) (Figure 8). Buried metal pipes removed from this area ranged in inside diameter from 2- to 5-inches and were buried at depths ranging from 2- to 3-feet bgs (Photo #s 16 and 17). In addition to the buried metal pipes removed in grid cells A and B, several PVC

Dark, discolored soils containing a petroleum hydrocarbon odor were noted in excavated soils and along trench walls throughout grid cells A and B. Soils in grid cell A and the south portion of grid cell B appeared to be more significantly impacted than the soils in the northern part of grid cell B.

No 16 - This is in Section A, looking west along a 5.5" pipe trench, dug to 2.5 ft. depth.

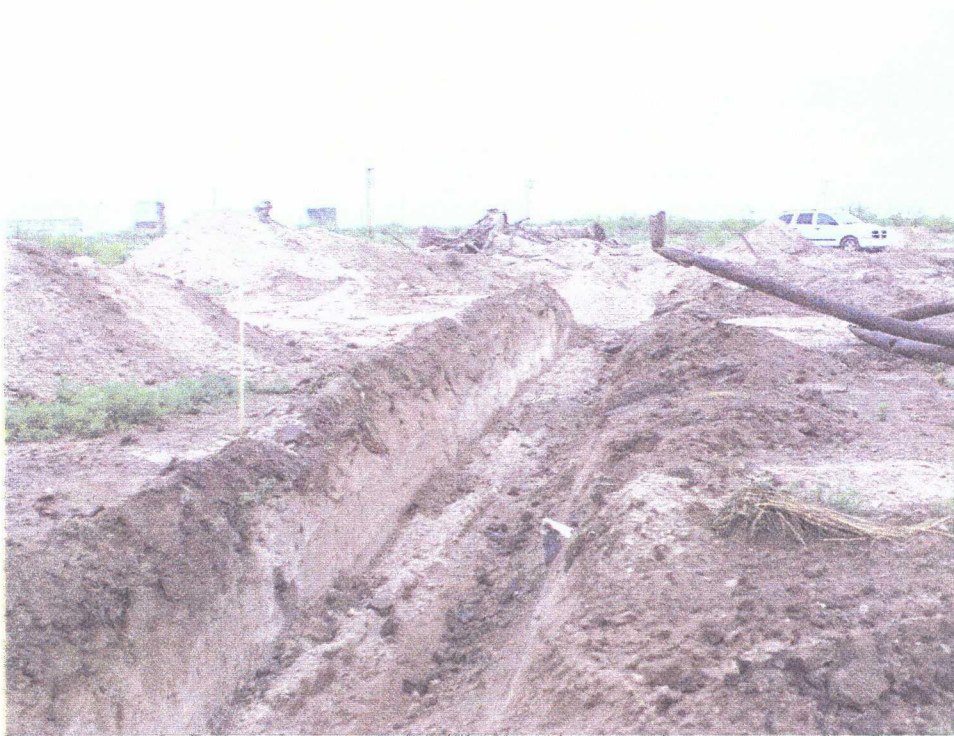
No 17 - This is in northeast Section B, looking southeast along a 5.5" pipe trench, with a 4" PVC pipe running across it. The trench runs toward Section D where a pit has been filled with vessels and pipe.

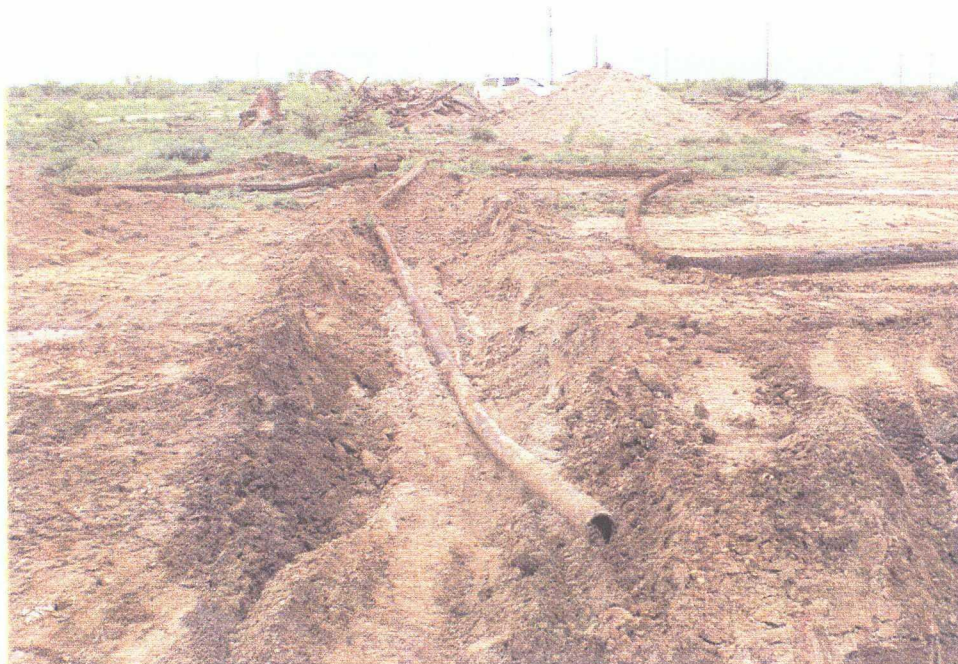
No 18 - This is Section C, looking south along a 5.5" pipe trench toward the pit of section D. The 7" pipe crosses the 5.5" at the bottom of the photo and is seen where it was pushed aside in the upper part of the photo.

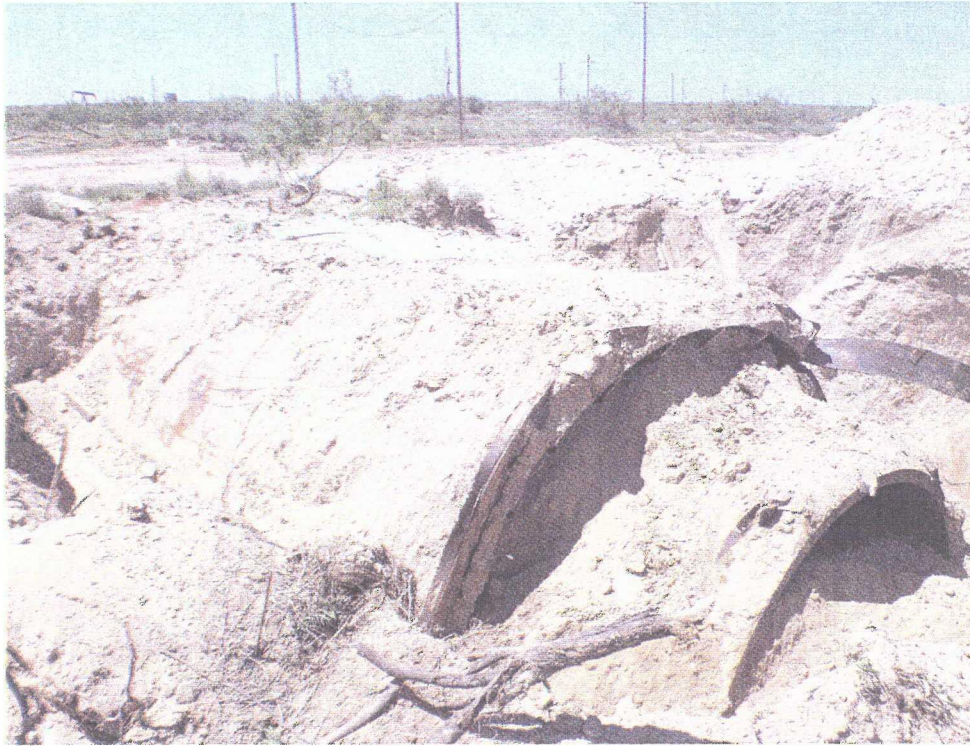
No 19 - This is D Section, looking north at the start of an excavation to pull up a large vessel. The vessel was buried in a pit that contained several smaller vessels as well as scrap metal and numerous pipe sizes and lengths. The pit took up a considerable portion of Section D.

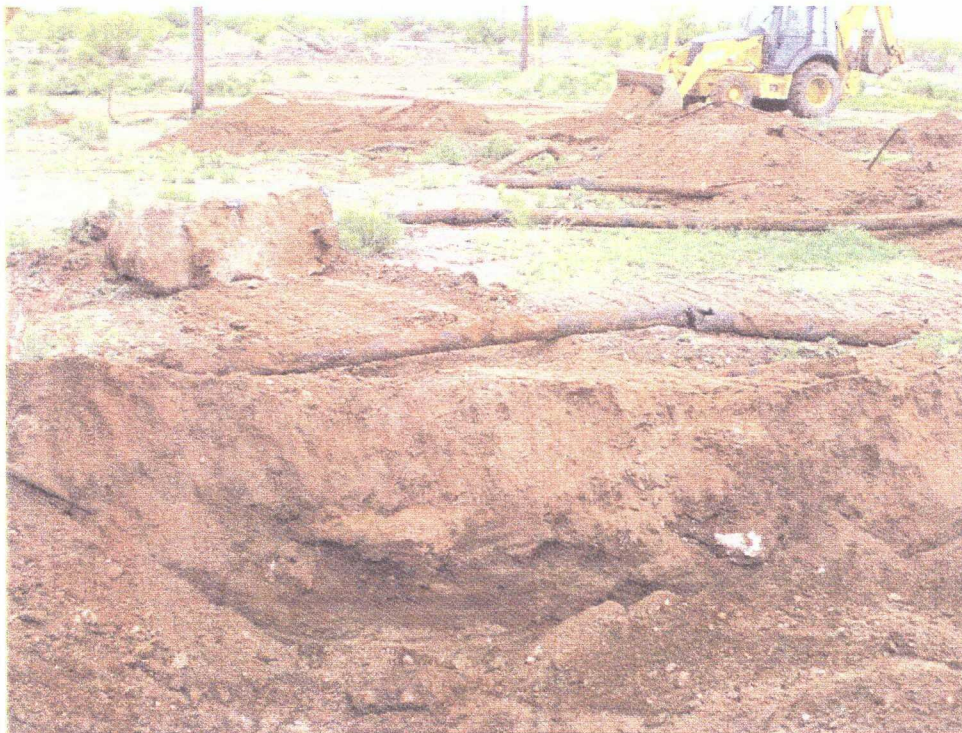
No 20 - This is east-central, Section E. The view is looking southeast to where 4" pipe was pulled from trenches excavated between concrete footings.

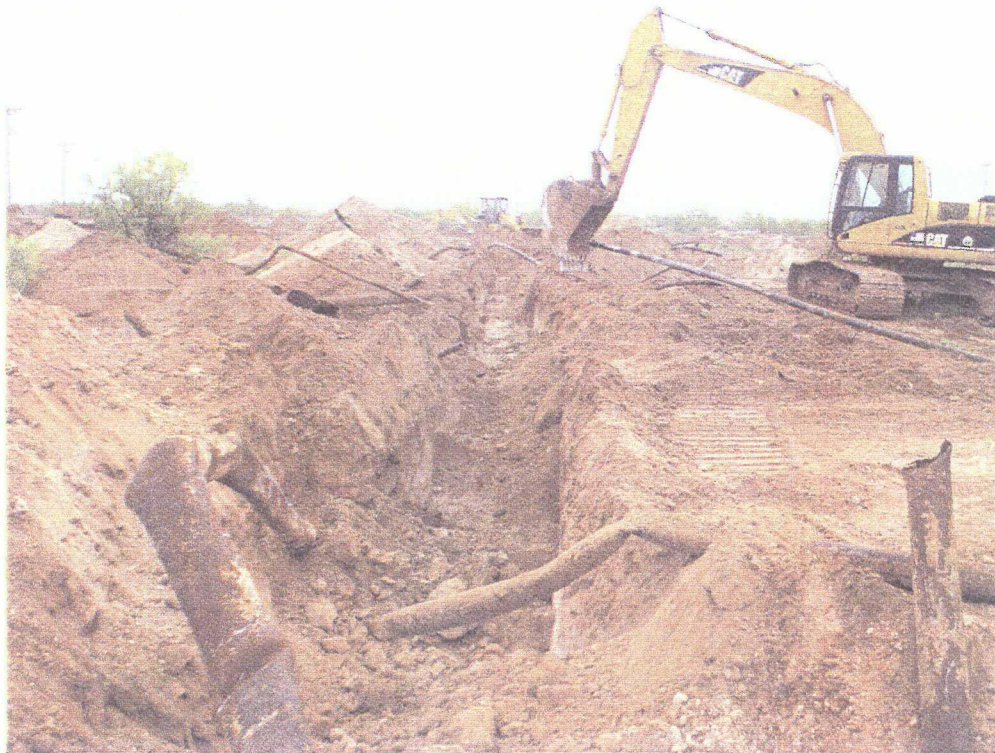
No 21- This is Section F, looking south into a trench containing 5.5", 4", and 3" pipe.

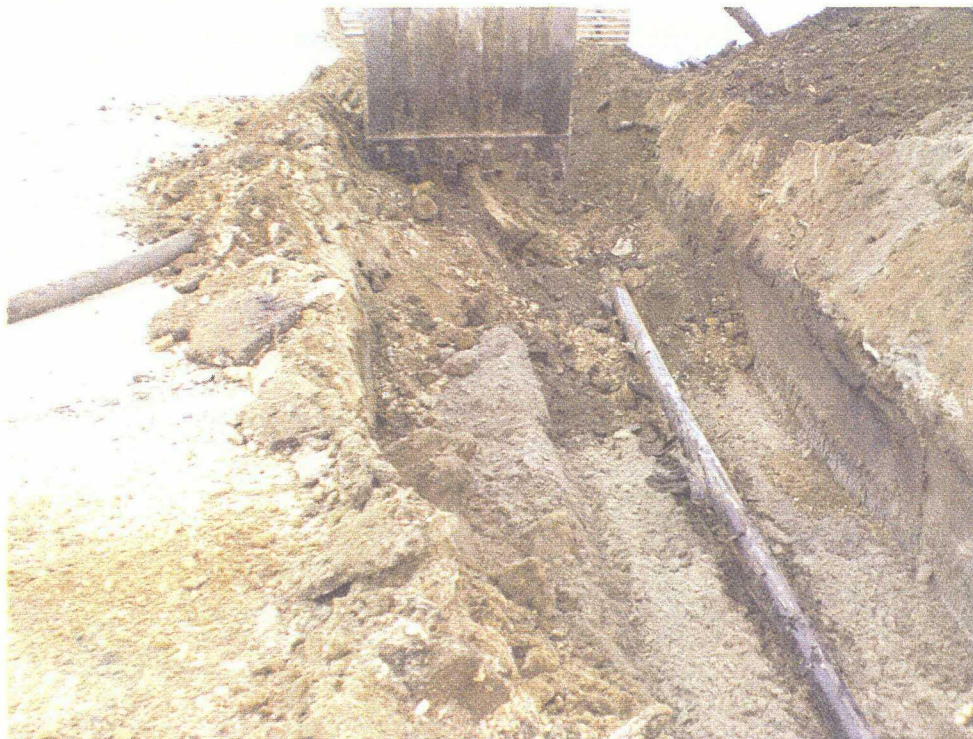
No. 26 – This is just north of central Section K, looking east along a trench where 3" pipe is being excavated at 3 ft.

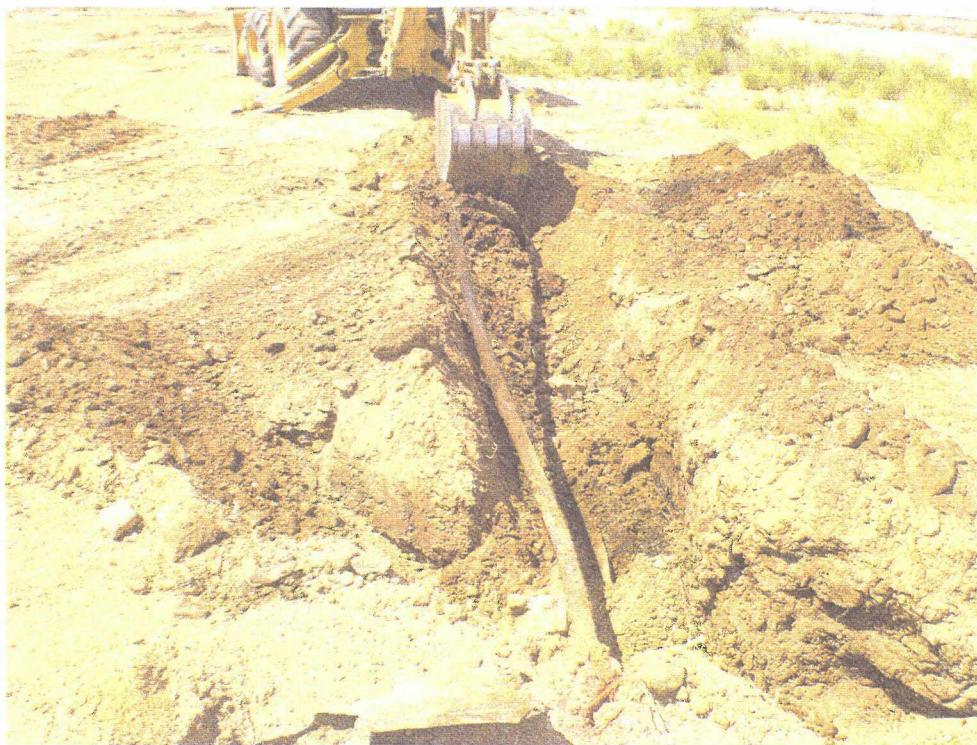
No 27 - This is looking northwest along a 2" pipe, crossing the southwest corner of L Section.

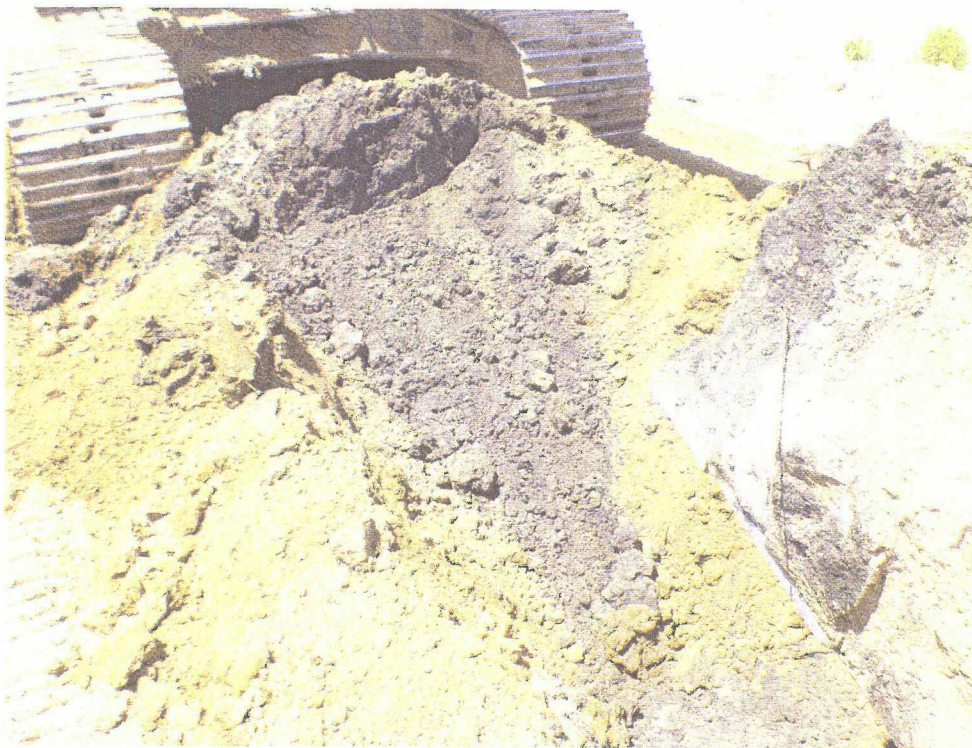
No 29- This is looking northeast at a metal plate which was pulled out of a shallow excavation in Section M.

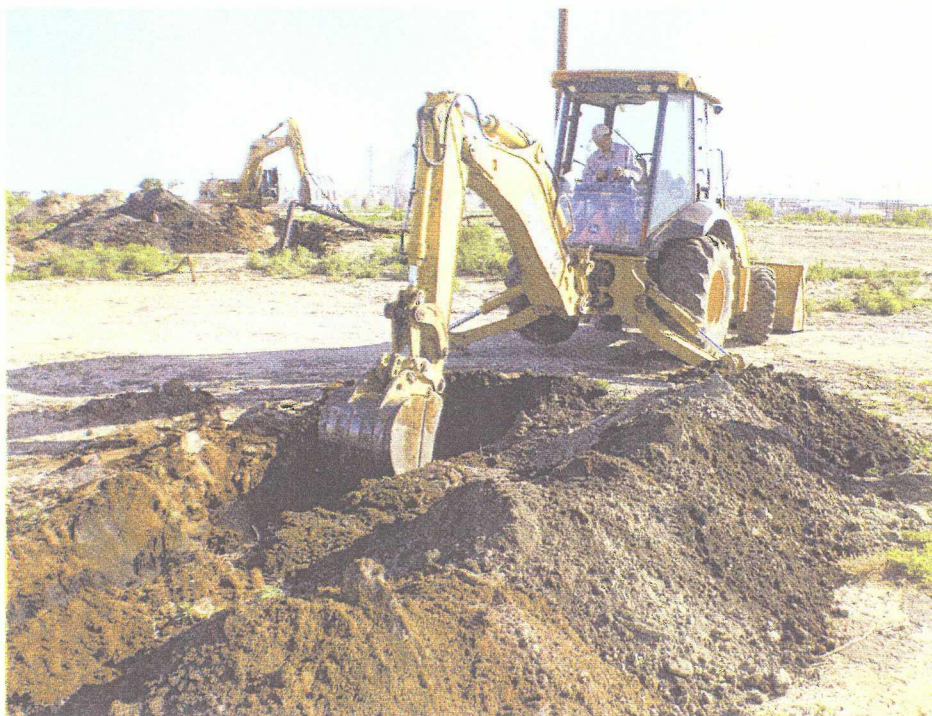
No 30 - This is the backhoe that was used to dig trenches, pull pipe, fill trenches, load bins, and level uneven areas. This photo was taken in the southwest corner of Section I, looking north.

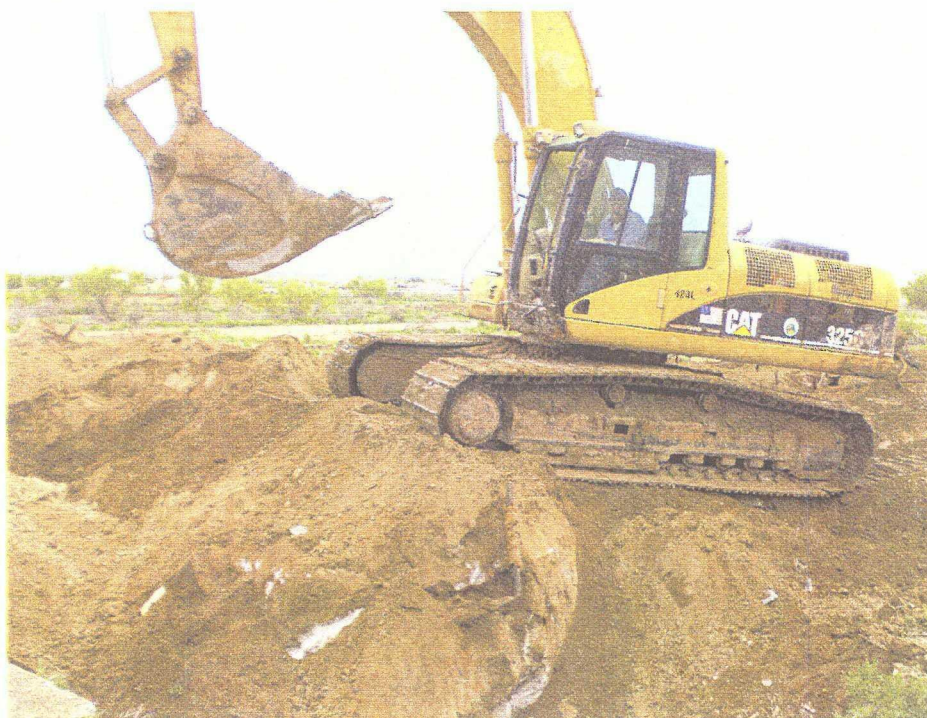
No 31 - This is the track hoe that was used to dig pipe, pull pipe, pull large objects from the pits, and to load trucks and bins. This photo was taken looking northwest from central Section E.

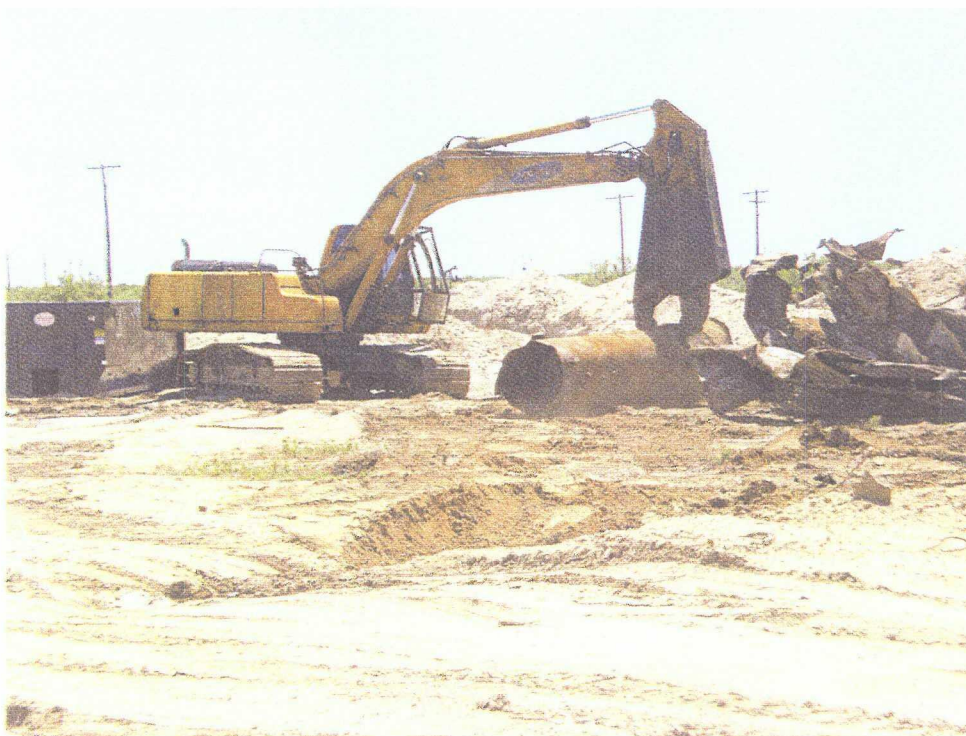
No 32 - This is in Section F, where the shears hoe was cutting pipe and large metal objects, such as vessels and pipe, into manageable lengths for loading into bins or onto flatbed trucks.

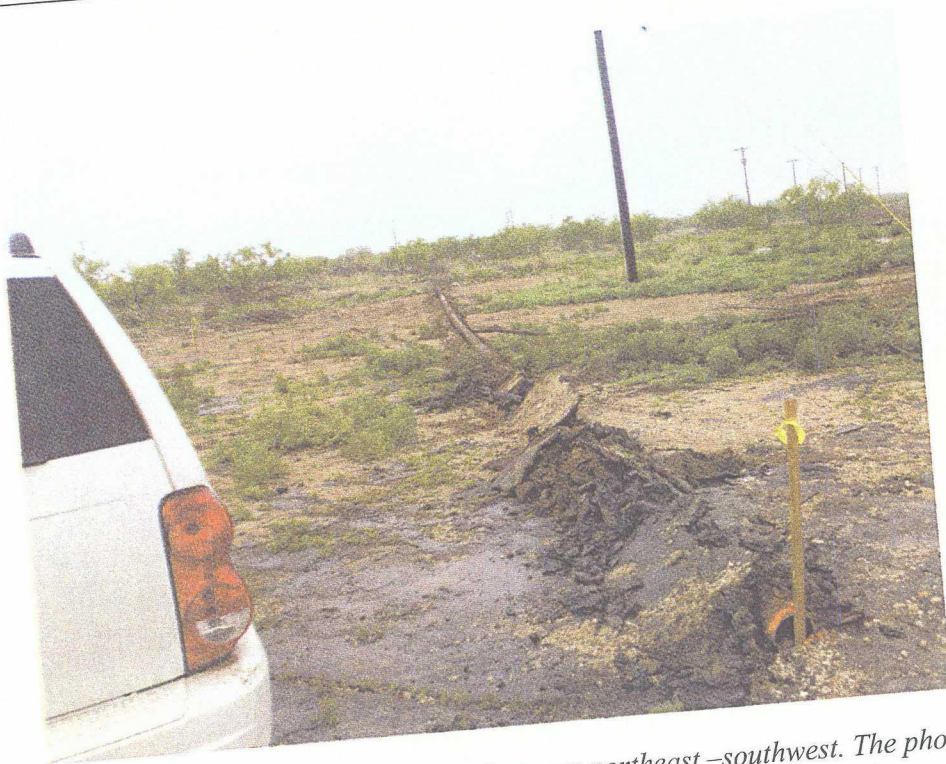
No 38 - This photo was taken of a 5.5" pipe that runs northeast-southwest. The photo is looking southwest along the shallow-buried pipe. The pipe was excavated to the property line and then it was cut off.

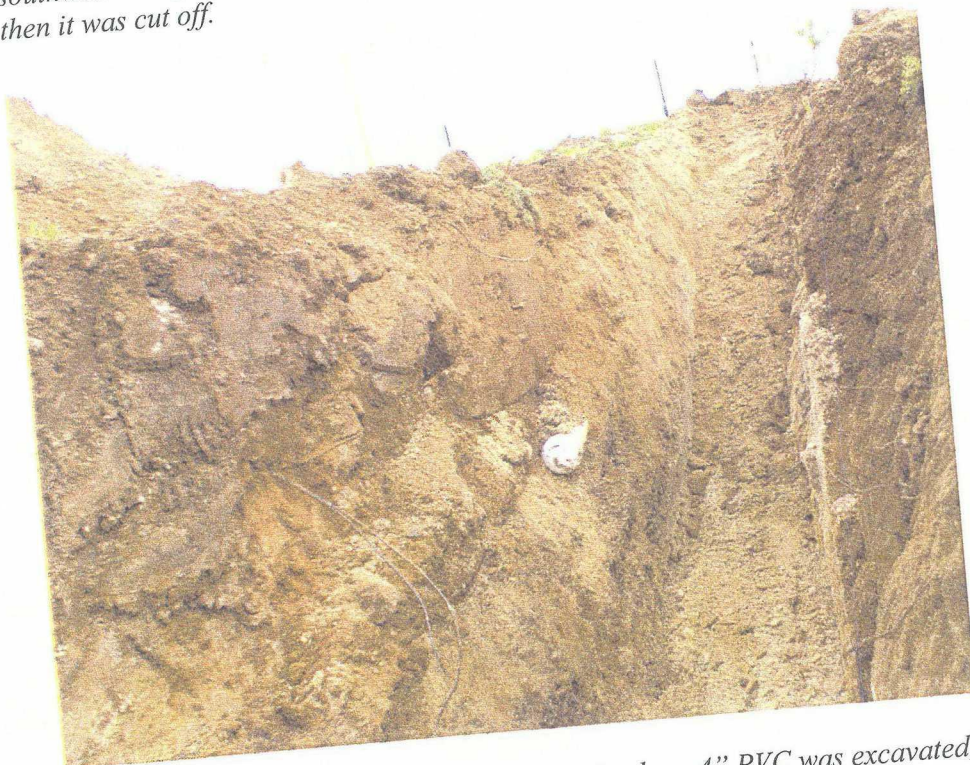
No 39 - This photo is looking northeast along a trench where 4" PVC was excavated, cut and capped at the property boundary, just 25' north of central Section C.

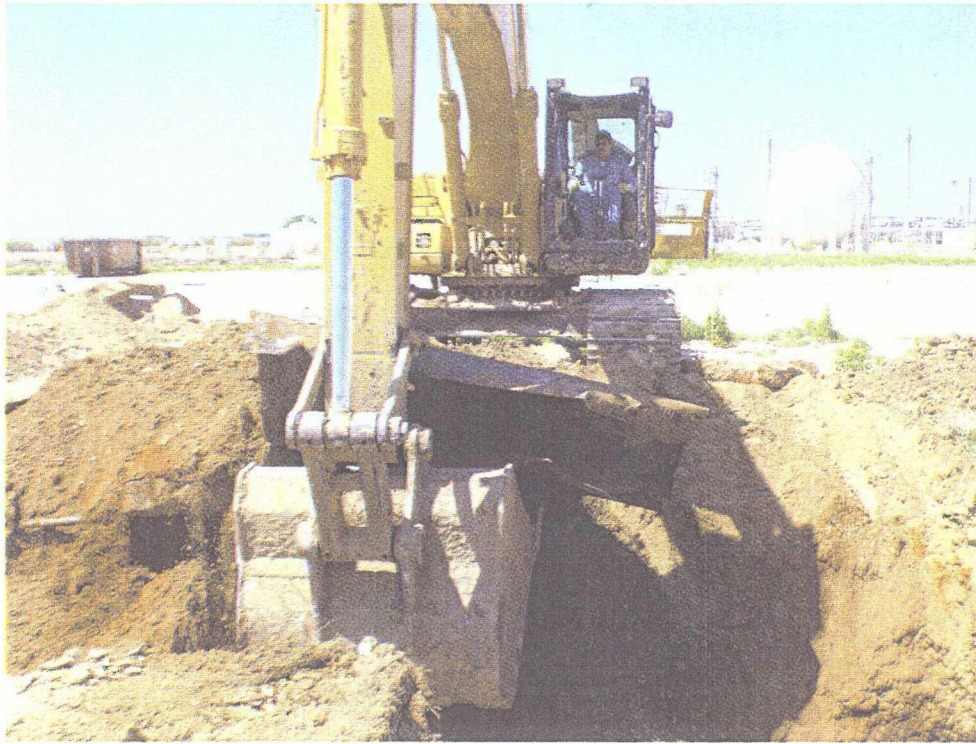
No 40 - This photo shows the removal of 1 of 2 septic tanks from the central area of Section H.

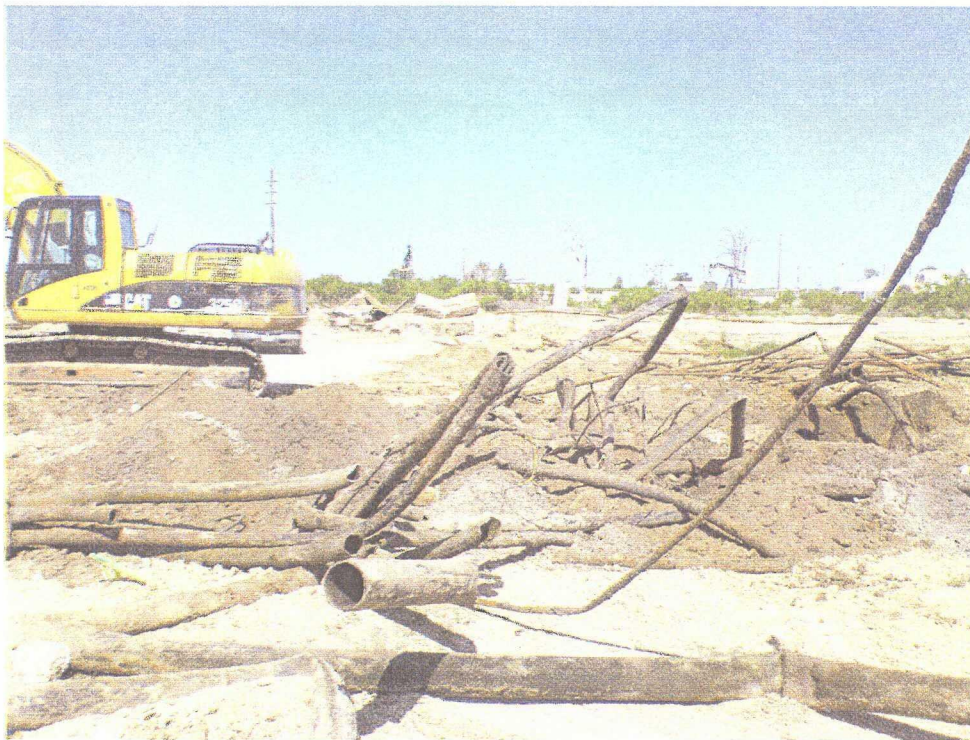
No 41 - This photo shows a congestion of pipe that was dug up from a concrete basin area in the northwest corner of Section K.

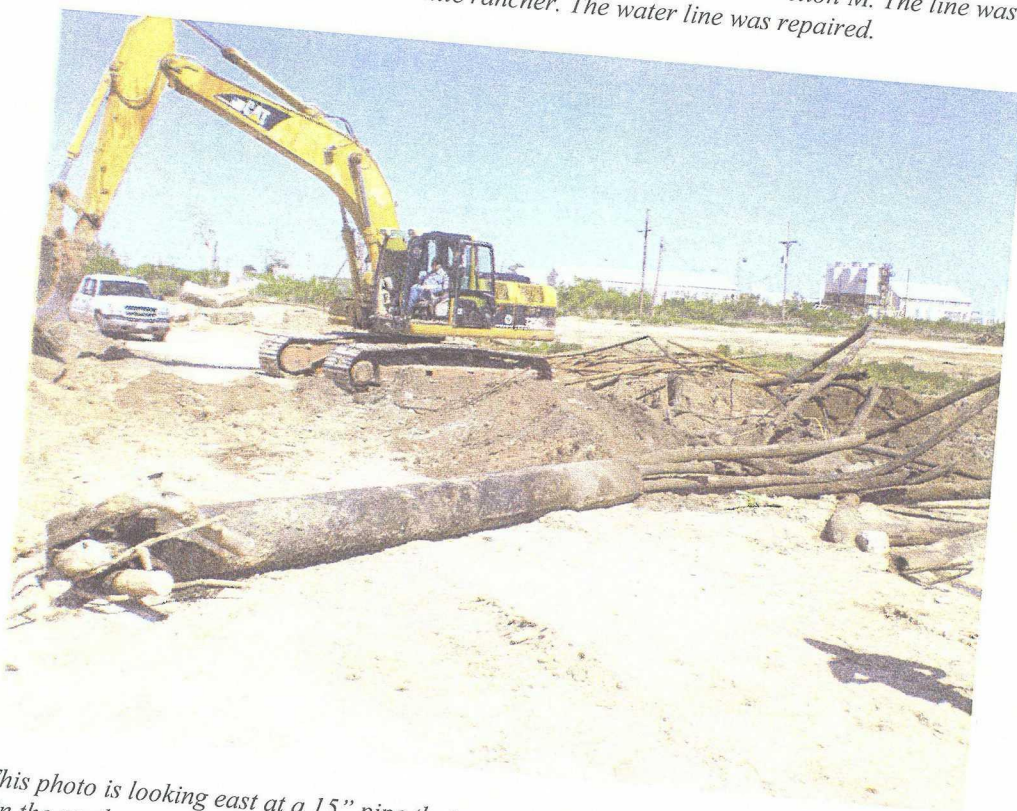
No 42 - This photo is looking east at the location where a 2" poly water line was broken by excavating 2-3" pipes located along the east perimeter of the site boundary in Section M. The line was under pressure and utilized by a local cattle rancher. The water line was repaired.
