**RE: Phase I and II Remediation, Former Enersource Facility, Monument, Lea County,
New Mexico**

Phase I and II Remediation, Former Enersource Facility Monument, Lea County, New Mexico

June 29, 2007

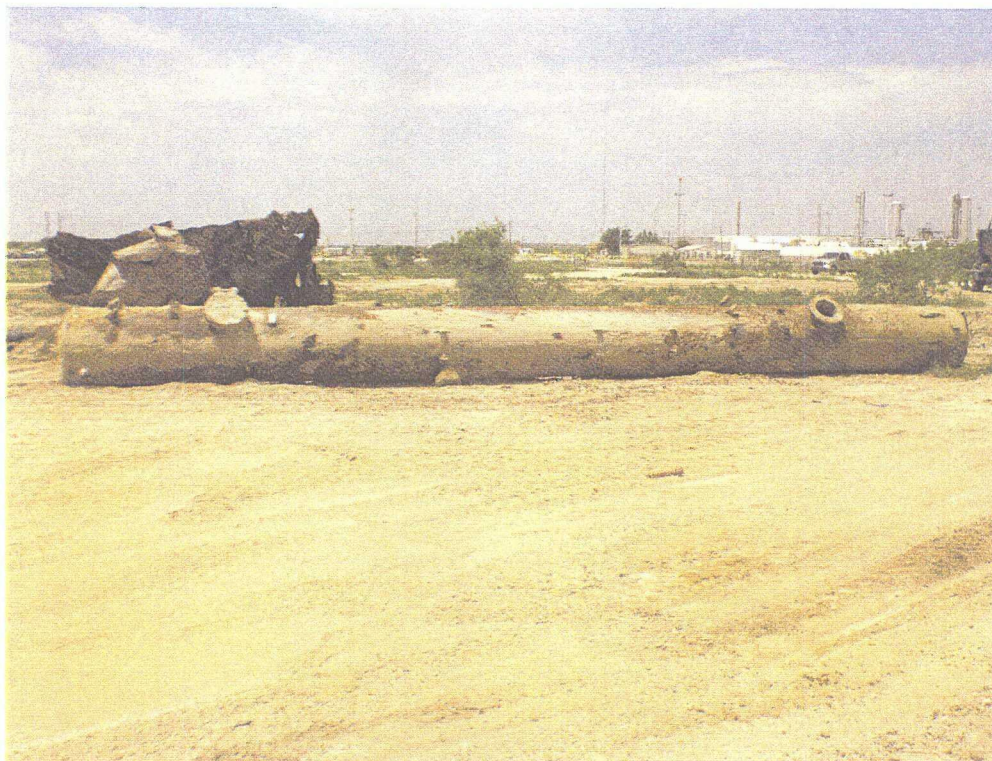
No 43 - This photo is looking east at a 15" pipe that was pulled up from under the concrete basin located in the northwest corner of Section K. This large diameter pipe was a shroud for 3-4", 2-3", and 2-1" pipes.

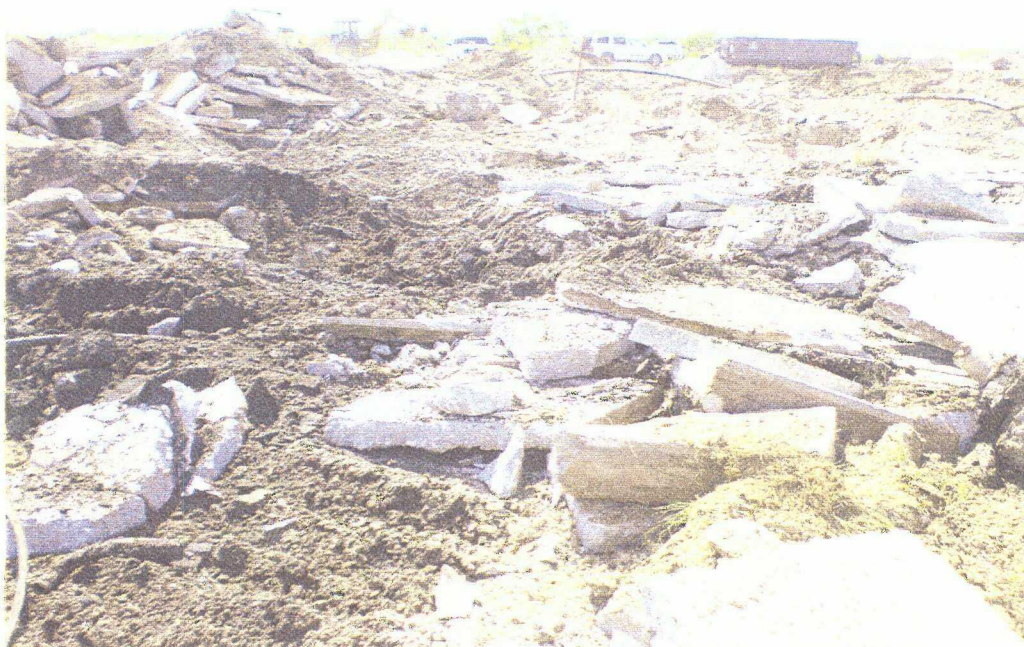
No 44 - This photo is of tower or tank - one of several removed from the pit in Section D.

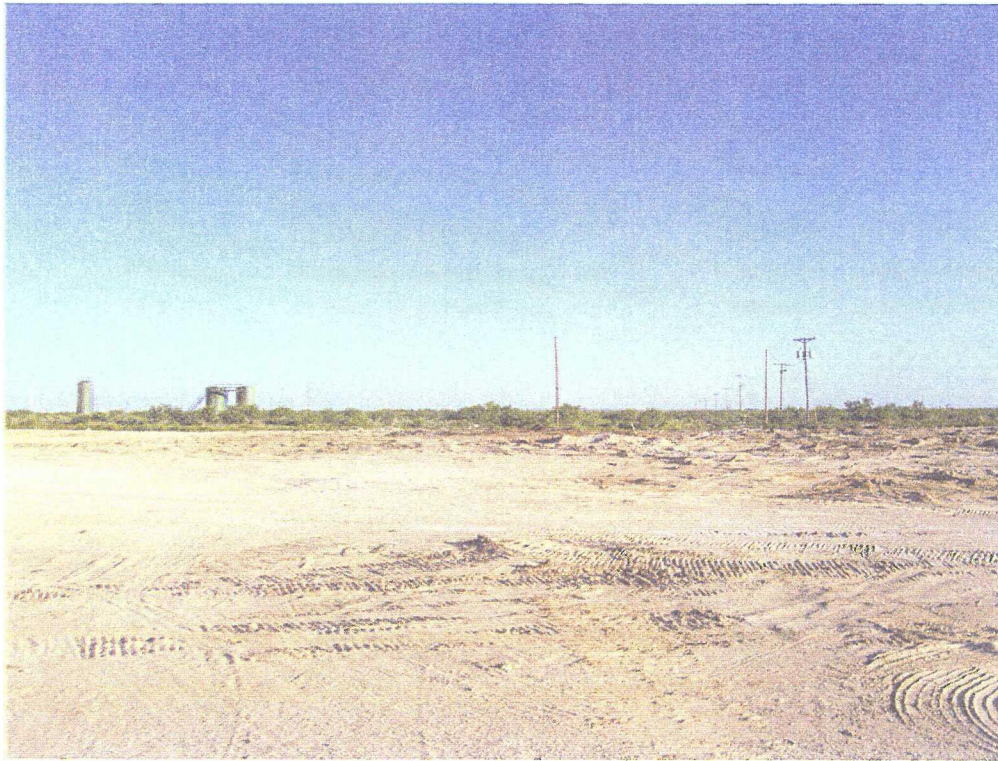
No 53 – View looking east-southeast on June 22, 2007.

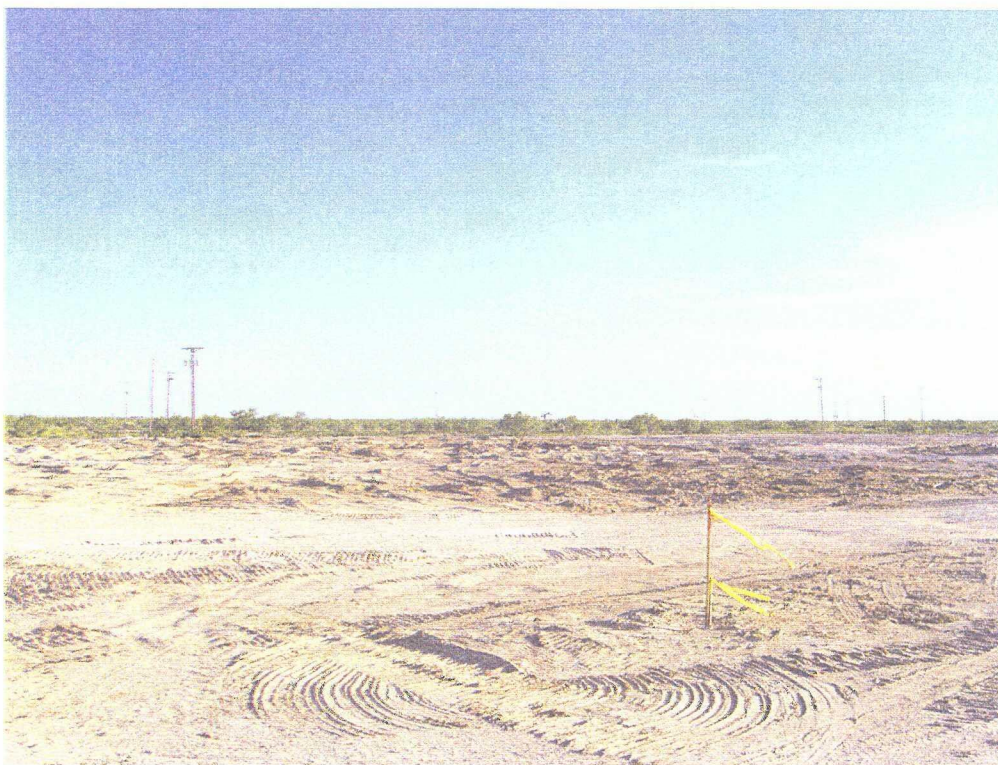
No 54 – View looking south-southeast on June 12, 2007.

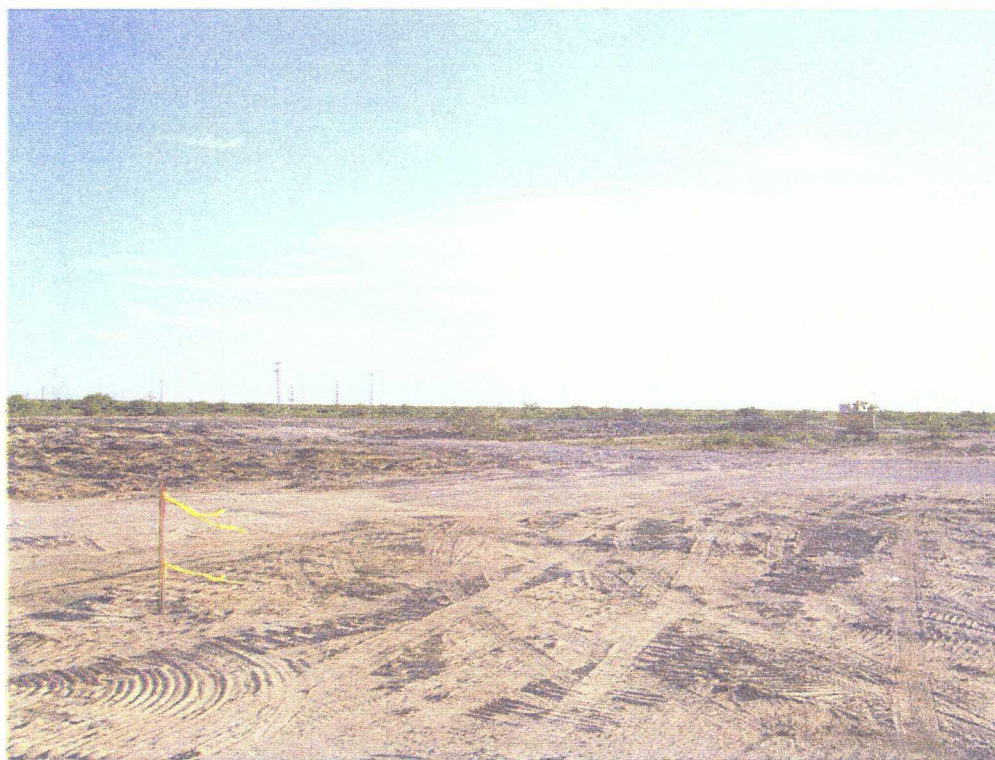
No 55 - View looking south-southwest on June 22, 2007.

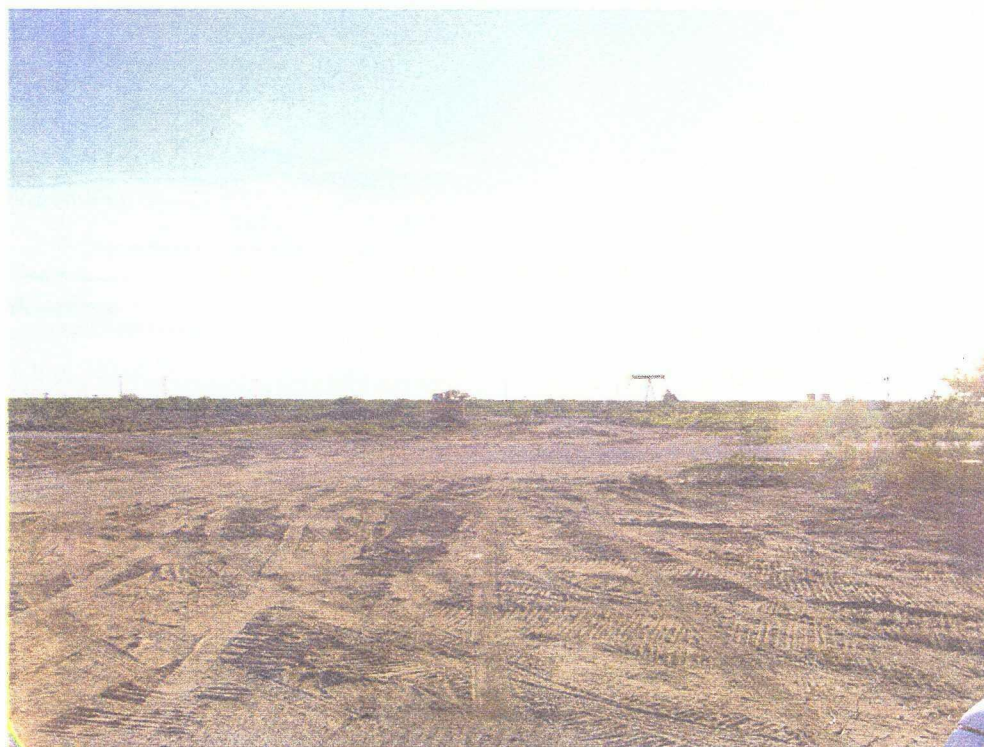
No 56 - View looking west-southwest on June 22, 2007.
